ISP50 Report

INTRODUCTION ISP

1.1 ISP 简介

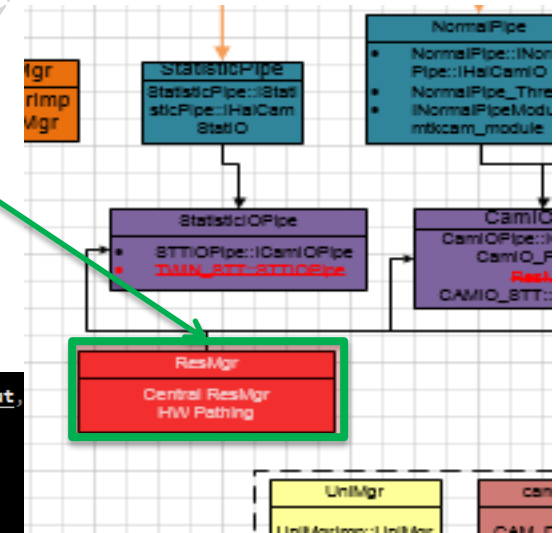
Twin resource allocate

- Central control logic in ResMgr:
 - default: 1st TWIN, 2nd BIN, 3rd ISP_CLK
 - off-bin: 1st TWIN, 2nd ISP_CLK

LPM : 364MHz
HPM : 546MHz

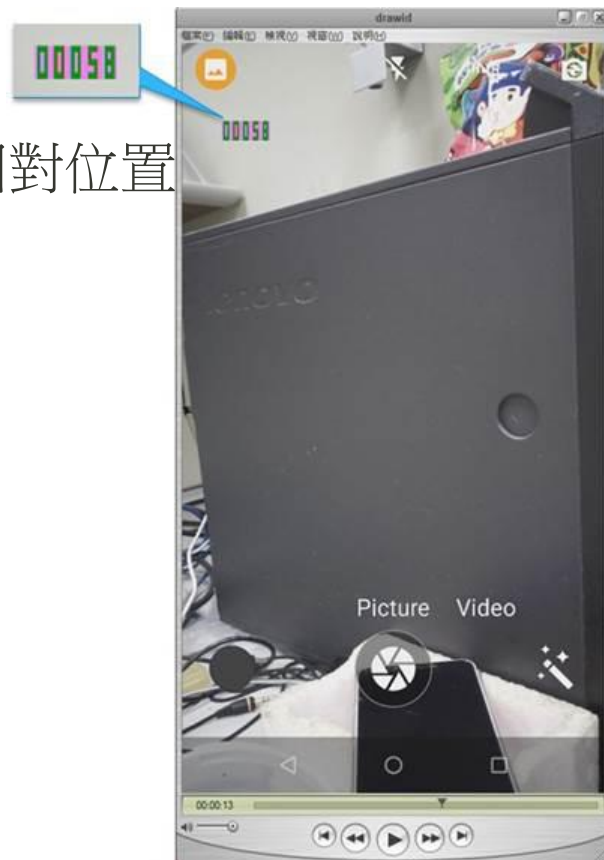
2.1 畫面顯示magic number方法

- 可以快速定位屏幕畫面和錄影過程在log上面的相對位置

```
adb shell setprop debug.cam.drawid 1
```
