# Railway Accident Investigation Unit Ireland

# **INVESTIGATION REPORT**

Operating irregularity during Single Line Working between Dundalk and Newry 23<sup>rd</sup> March 2013

**RAIU Report No: R2014 – 002**

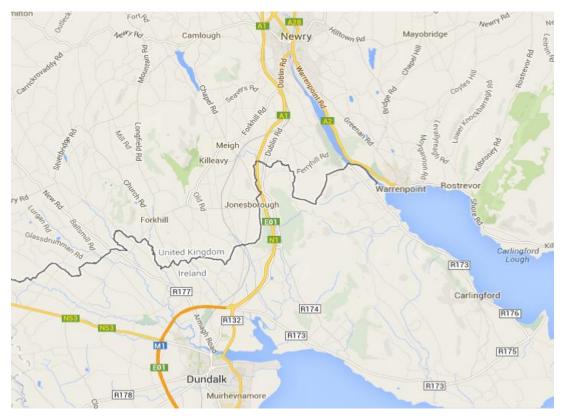
- 5 The train was stopped by an NIR Signalman as an unauthorised movement approximately 800 m from Newry Station, see Figure 1 for location of the incident.

Figure 1 – Location of incident (showing route from Dundalk to Newry)

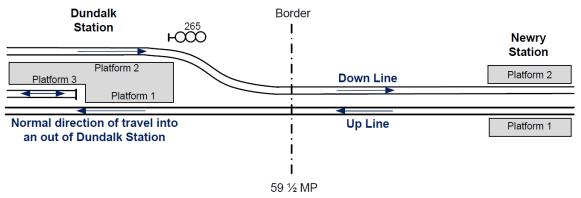
Figure 2 - Normal operations on Up and Down Line

- 15 SLW is introduced when bi-directional travel has to be worked using one line, which is not signalled to facilitate bi-directional travel. To allow such working, a pilotman is required to be appointed as part of the SLW process. SLW is discussed in more detail later in this report.
- 16 In the location of the incident, the *Up Line* (towards Dublin) normally allows for travel from Newry Station to Dundalk Station and the Down Line (towards Belfast) normally allows for travel from Dundalk Station to Newry Station, see Figure 2.

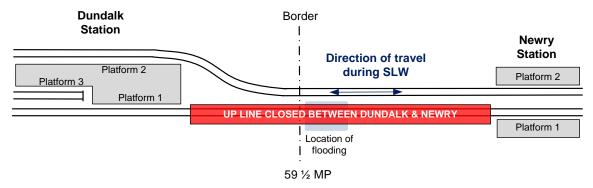
Figure 3 - Closed Up Line and operations on Down Line

- 17 Dundalk Station has three Platforms: Platform 1 is used for trains travelling south to Dublin; Platform 2 can be used bi-directionally but is generally used as the Northbound platform (Signal 265 is the Platform *Starting Signal* for northbound trains); Platform 3 is used for trains travelling south and trains terminating in Dundalk, see Figure 2.
- 18 On the day of the incident, part of the Up Line was affected by flooding leading to the line being closed, see Figure 3. This resulted in all trains operating in both directions on the Down Line, with trains travelling towards Belfast operating in the normal, 'right' direction and travelling towards Dublin operating in the opposite direction to normal, 'wrong' direction.

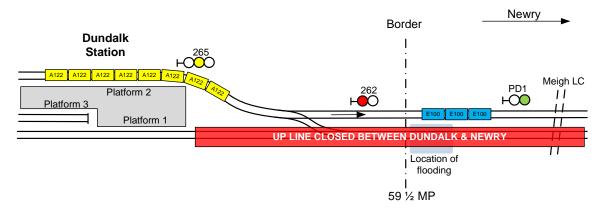
- to Dundalk before Train A122 left Dundalk. NIR Signalman A attempted to contact the Pilotman on his mobile to clarify the situation; however, he was unable to connect with the mobile phone.
- 92 NIR Signalman B phoned the IÉ Signalman to enquire if Train A122 was running late (as the Pilotman was on Train E100). The IÉ Signalman confirmed that Train A122 was at Platform 2 in Dundalk.
- 93 However, during this time (at 08:39 hrs), Train A122 proceeded into the SLW section without a Pilotman (with the driver being unaware SLW was in operation), see Figure 5.

Figure 5 - Train A122 entering SLW section behind Train E100
