ISP50 Report

Agenda

1.1 ISP 简介

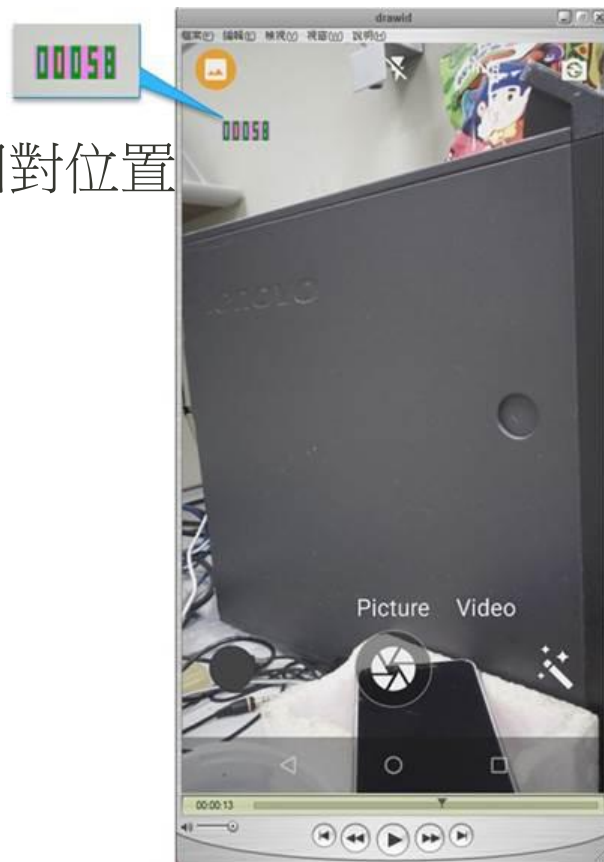
2.1 畫面顯示magic number方法

- 可以快速定位屏幕畫面和錄影過程在log上面的相對位置

```
adb shell setprop debug.cam.drawid 1
```
