Redmi note4 does not read the card

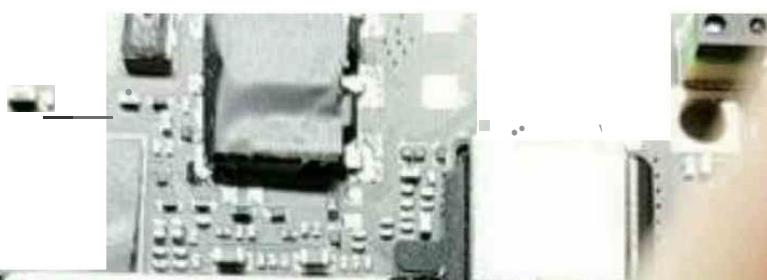
Maintenance process:Switch of the card slot was found in the test, and it was in a thousand-closed state when the card was put in or not.

Under normal circumstances, put in the card, and the shrapnel of Switch will be separated, and one corner will be measured to 1.8v VCC.

normal, and the fault is solved!
