HiSP

FAQs

Issue	01
Date	2019-09-12

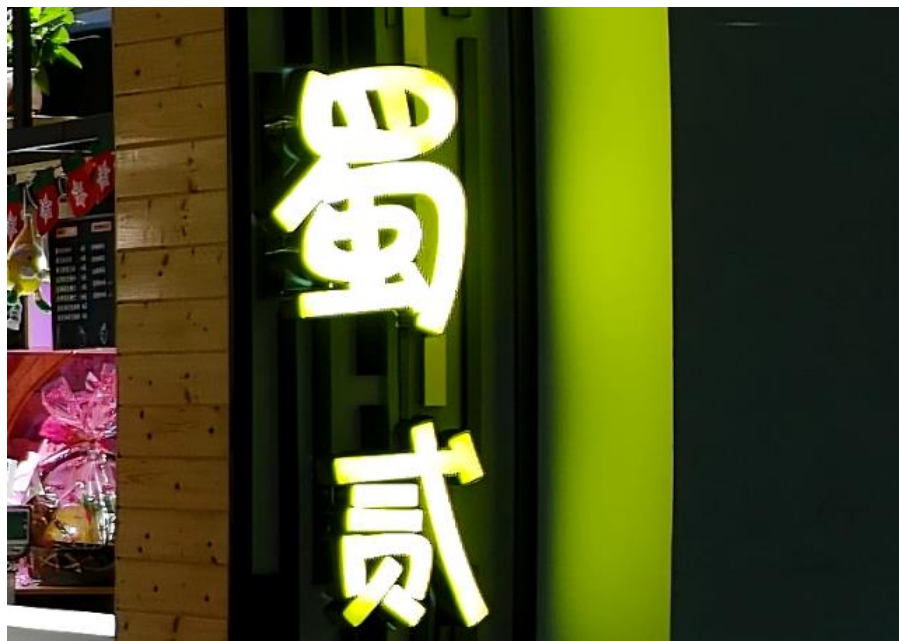
Directional glitch occurs near the illuminant characters in normal illumination as shown in [Figure 1-1](#).

Figure 1-1 Directional glitch near the illuminant characters in normal illumination

- This problem is caused by improper parameter calibration in the global CAC module.

- Check whether the static coefficient for global CAC is proper. If not, re-calibrate the static coefficient as required. If you do not want to calibrate the global CAC static coefficient, disable the global CAC function. [Figure 1-2](#) shows the comparison diagram when the global CAC is enabled and disabled with improper static coefficient.

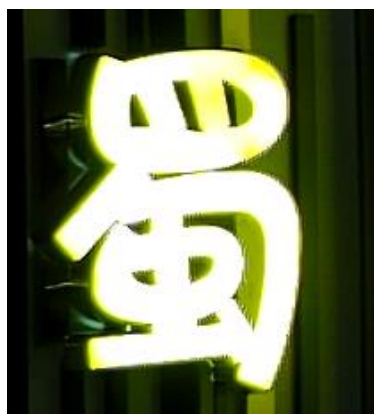
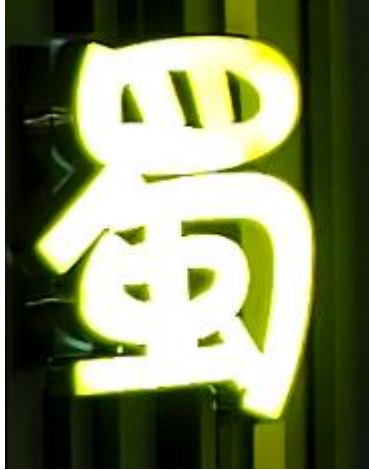
Figure 1-2 Comparison diagram when the global CAC is enabled and disabled with improper static coefficient
