(wafer2,0,7,-1,-1,1,2) Plots and Summary

- Cell Size = 10um
- Number of Times Accessed = 5
- Last Stimulated = 2022/March/28 at 04:27:00PM

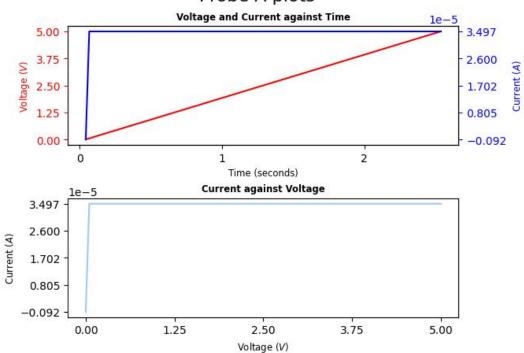
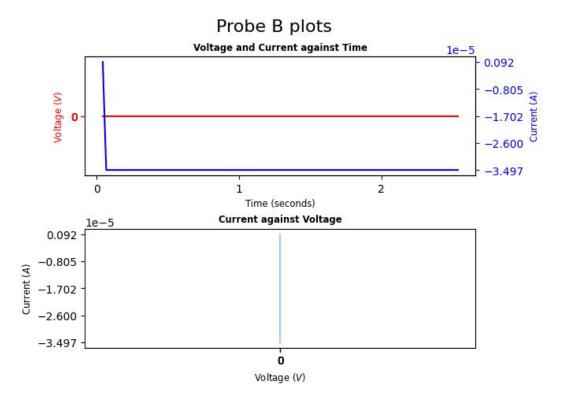
Comments = Formed really quickly, did not reset later on

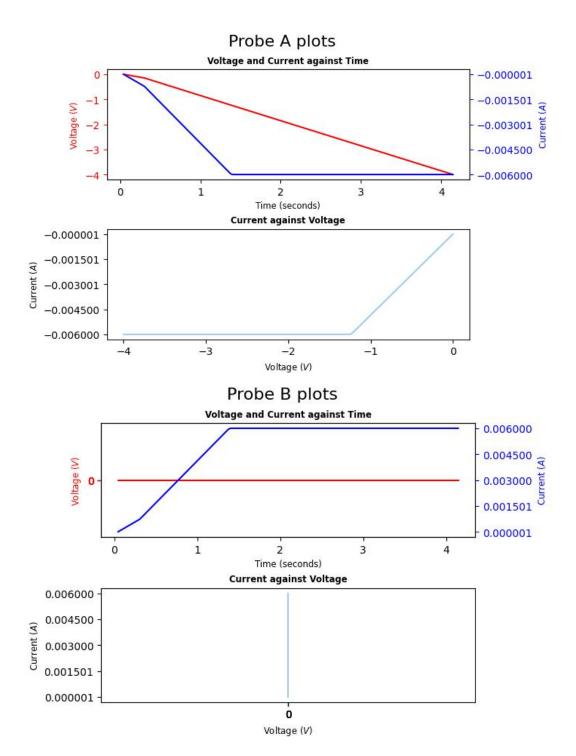
Comments = Did not Reset, bad cell

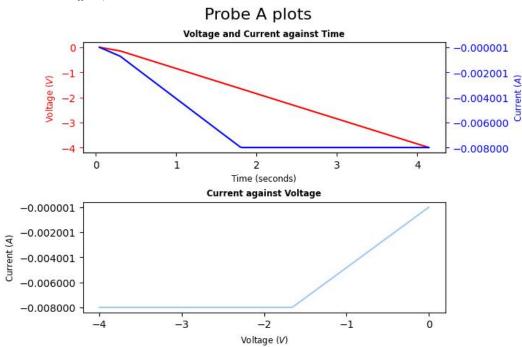
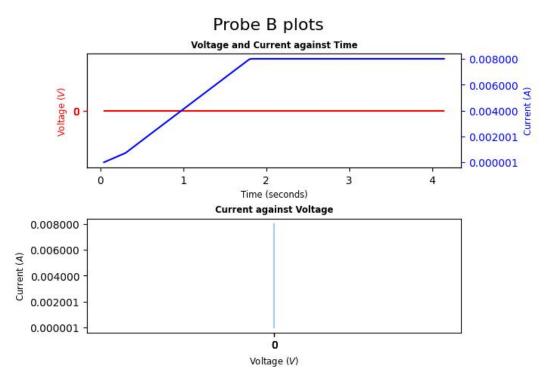
Comments = Did not reset again, bad cell

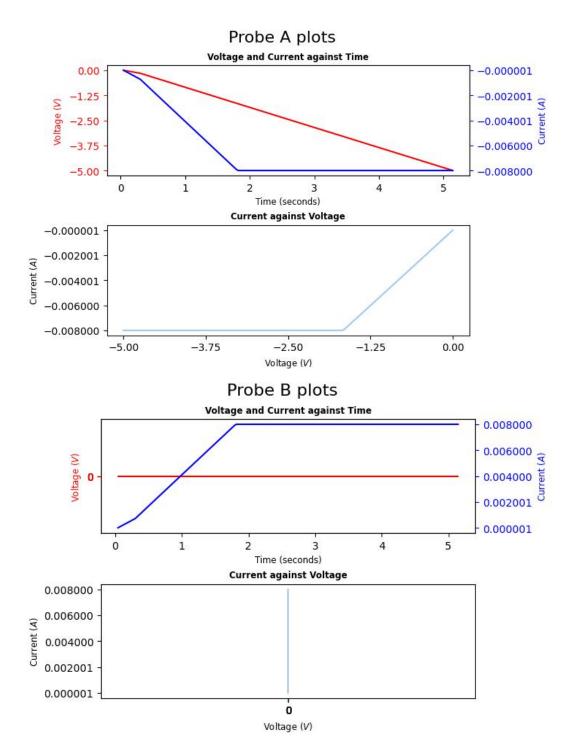
Comments = Did not reset, bad cell
