Tenerife airport disaster

On March 27, 1977, two Boeing 747 passenger jets, operating **KLM Flight 4805** and **Pan Am Flight 1736**, collided on the runway at Los Rodeos Airport^[1] (now Tenerife North Airport) on the Spanish island of Tenerife.^{[2][3]} Resulting in 583 fatalities, the **Tenerife airport disaster** is the deadliest in aviation history.

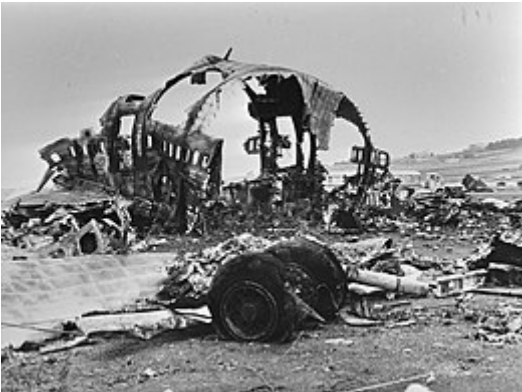
Wreckage of the KLM aircraft on the runway at Los Rodeos

The KLM plane remained briefly airborne, but the impact had sheared off the outer left engine, caused significant amounts of shredded materials to be ingested by the inner left engine, and damaged the wings. The plane immediately went into a stall, rolled sharply, and hit the ground approximately 150 m (500 ft) past the collision, sliding down the runway for a further 300 m (1,000 ft). The full load of fuel, which had caused the earlier delay, ignited immediately into a fireball that could not be subdued for several hours. One of the 61 survivors of the Pan Am flight said that sitting in the nose of the plane probably saved his life: "We all settled back, and the next thing an explosion took place and the whole port side, left side of the plane, was just torn wide open."^[38]

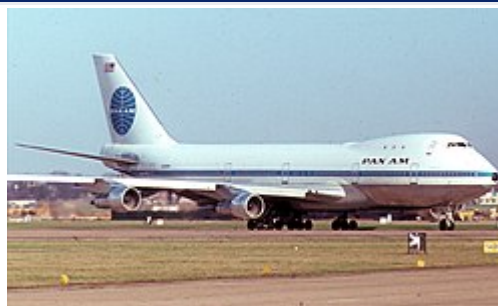
N736PA, the Pan Am Boeing 747-121 involved in the accident

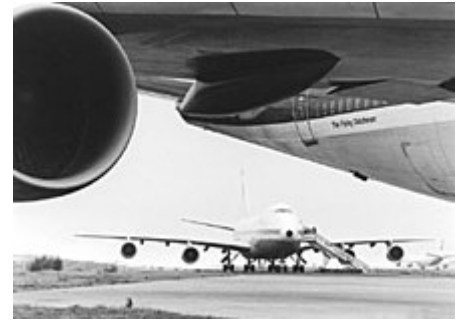
Rijn (foreground) and *Clipper Victor* (center) at Los Rodeos on the day of the accident

The authorities reopened Gran Canaria airport once the bomb threat had been contained. The Pan Am plane was ready to depart from Tenerife, but access to the runway was obstructed by the KLM plane and a refueling vehicle; the KLM captain had decided to fully refuel at Los Rodeos instead of Las Palmas, apparently to save time. The Pan Am aircraft was unable to maneuver around the refueling KLM in order to reach the runway for takeoff, due to a lack of safe clearance between the two planes, which was just 3.7 meters (12 ft).^[10] The refueling took about 35 minutes, after which the passengers were brought back to the aircraft. The search for a missing Dutch family of four, who had not returned to the waiting KLM plane, delayed the flight even further. Robina van Lanschot,^[16] a tour guide, had chosen not to reboard for the flight to Las Palmas, because she lived on Tenerife and thought it impractical to fly to Gran Canaria only to return to Tenerife the next day. She was therefore not on the KLM plane when the accident happened, and would be the only survivor of those who flew from Amsterdam to Tenerife on Flight 4805.

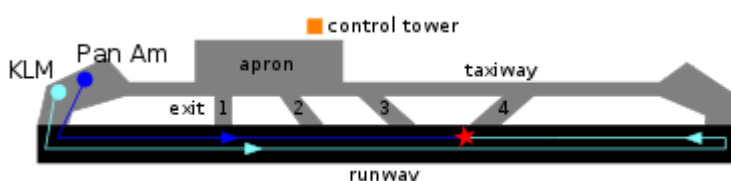
Simplified map of runway, taxiways, and aircraft. The red star indicates the location of impact. Not to scale.

Los Rodeos was a regional airport that could not easily accommodate all of the traffic diverted from Gran Canaria, which included five large airliners.^[15] The airport had only one runway and one major taxiway running parallel to it, with four short taxiways connecting the two. While waiting for Gran Canaria airport to reopen, the diverted airplanes took up so much space that they were having to park on the long taxiway, making it unavailable for the purpose of taxiing. Instead, departing aircraft needed to taxi along the runway to position themselves for takeoff, a procedure known as a backtaxi or backtrack.^[4]

Shortly afterward, the Pan Am was instructed to follow the KLM down the same runway, exit it by taking the third exit on their left and then use the parallel taxiway. Initially, the crew was unclear as to whether the controller had told them to take the first or third exit. The crew asked for clarification and the controller responded emphatically by replying: "The third one, sir; one, two, three; third,

The crew successfully identified the first two taxiways (C-1 and C-2), but their discussion in the cockpit indicated that they had not sighted the third taxiway (C-3), which they had been instructed to use.^[20] There were no markings or signs to identify the runway exits and they were in conditions of poor visibility. The Pan Am crew appeared to remain unsure of their position on the runway until the collision, which occurred near the intersection with the fourth taxiway (C-4).^[21]
