Handover of well NO 34/4-19 S Omega S

1 Handover Certificate from D&W to O&M

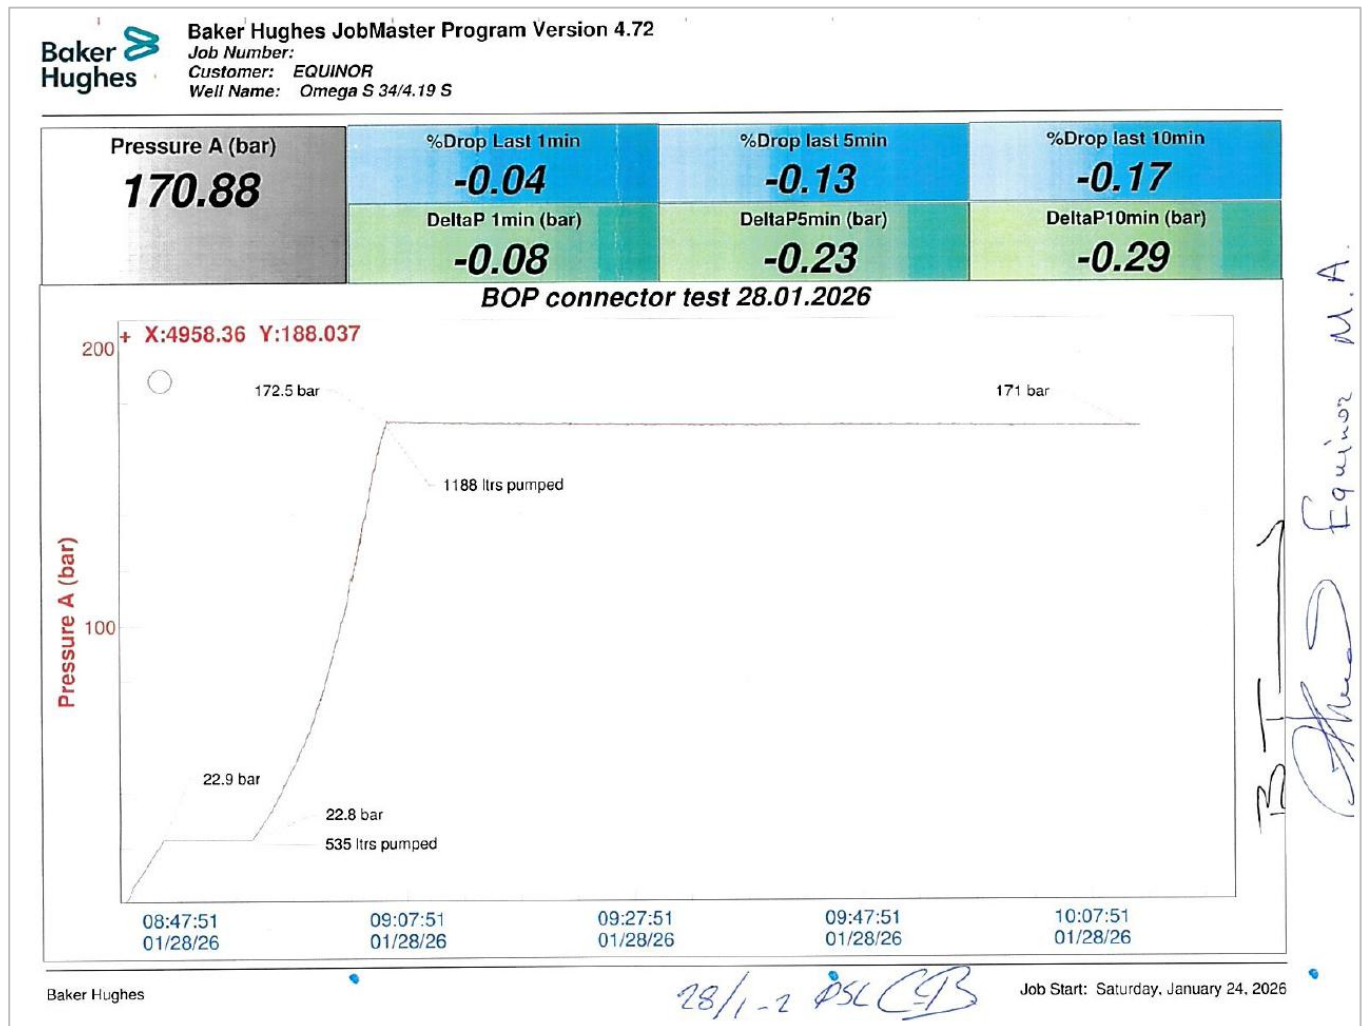
Pressure Test of 20" casing

20" casing was tested to 170 bars (DBR # 8, 28/01/2026).

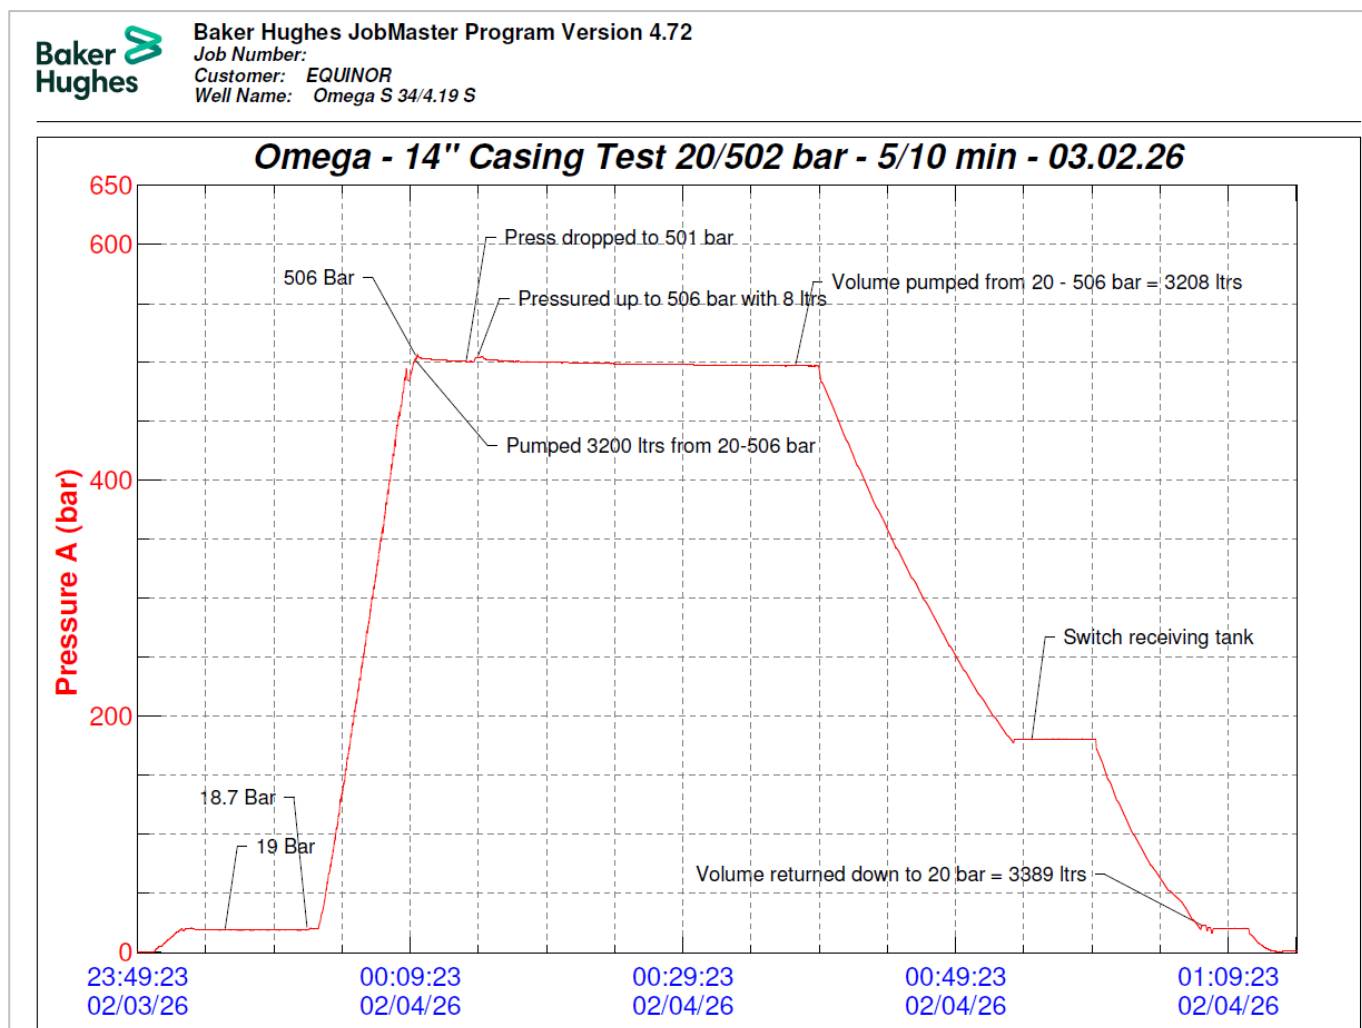
Pressure Test of 14" casing

14" casing was tested to 502 bars (DBR # 14, 03/02/2026).

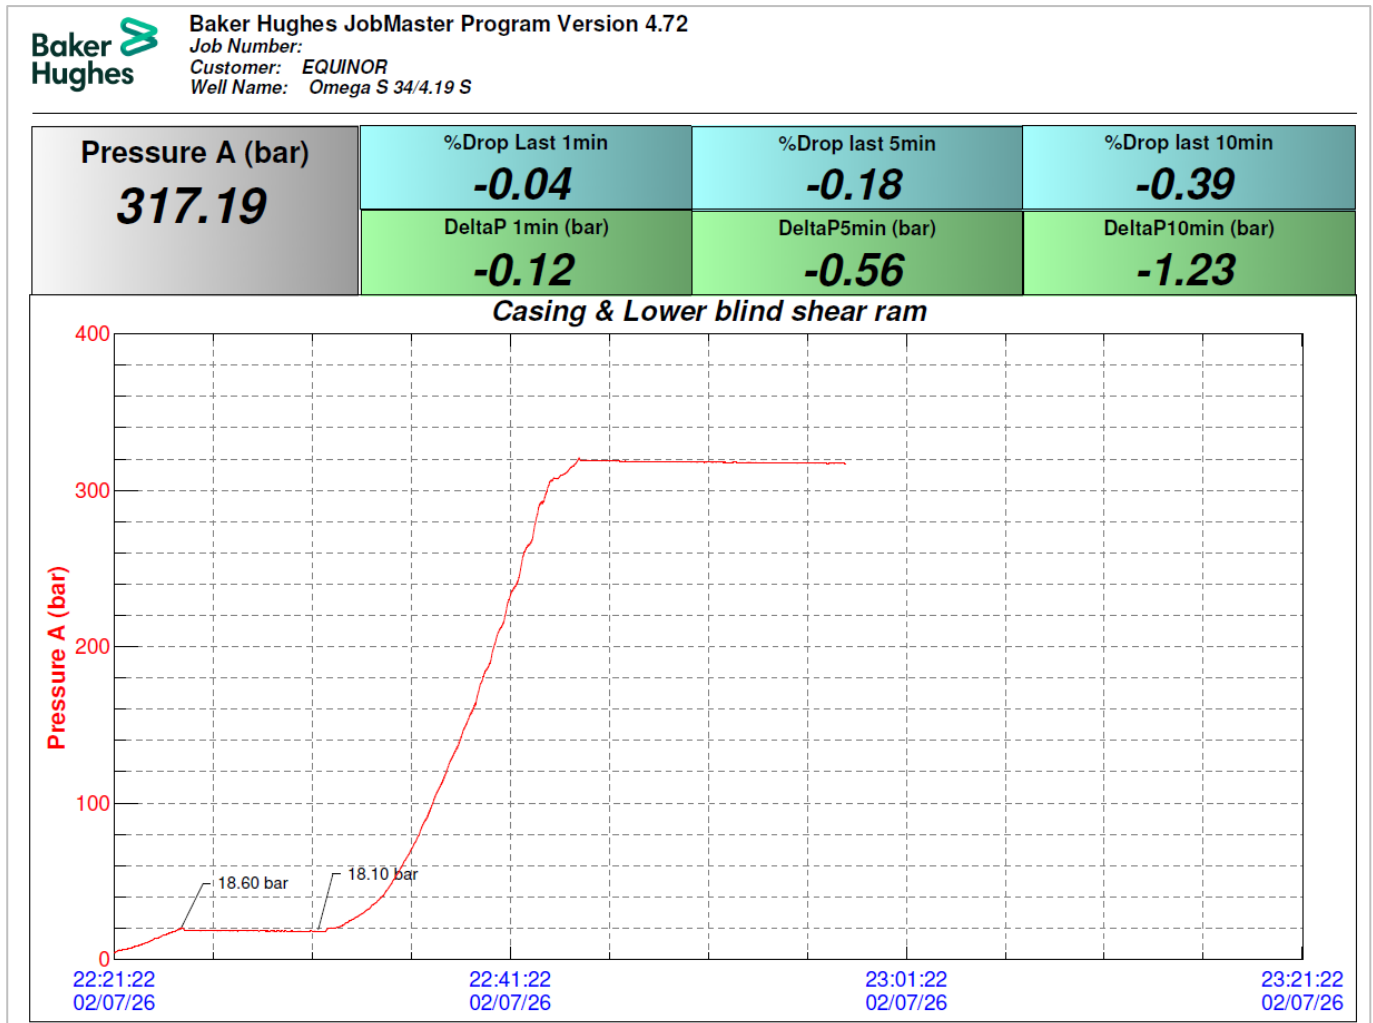
Pressure Test of 9 7/8" liner

9 7/8" liner was tested to 310 bars (DBR # 18, 07/02/2026).
