An Archaeological Study of Glamis: The Role of a 19th-Century Iron Barque

AN ARCHAEOLOGICAL STUDY OF *GLAMIS*:
THE ROLE OF A 19th-CENTURY IRON BARQUE

A Thesis submitted to the
Department of Anthropology
in partial fulfillment of the
requirements for the degree of
Master of Science

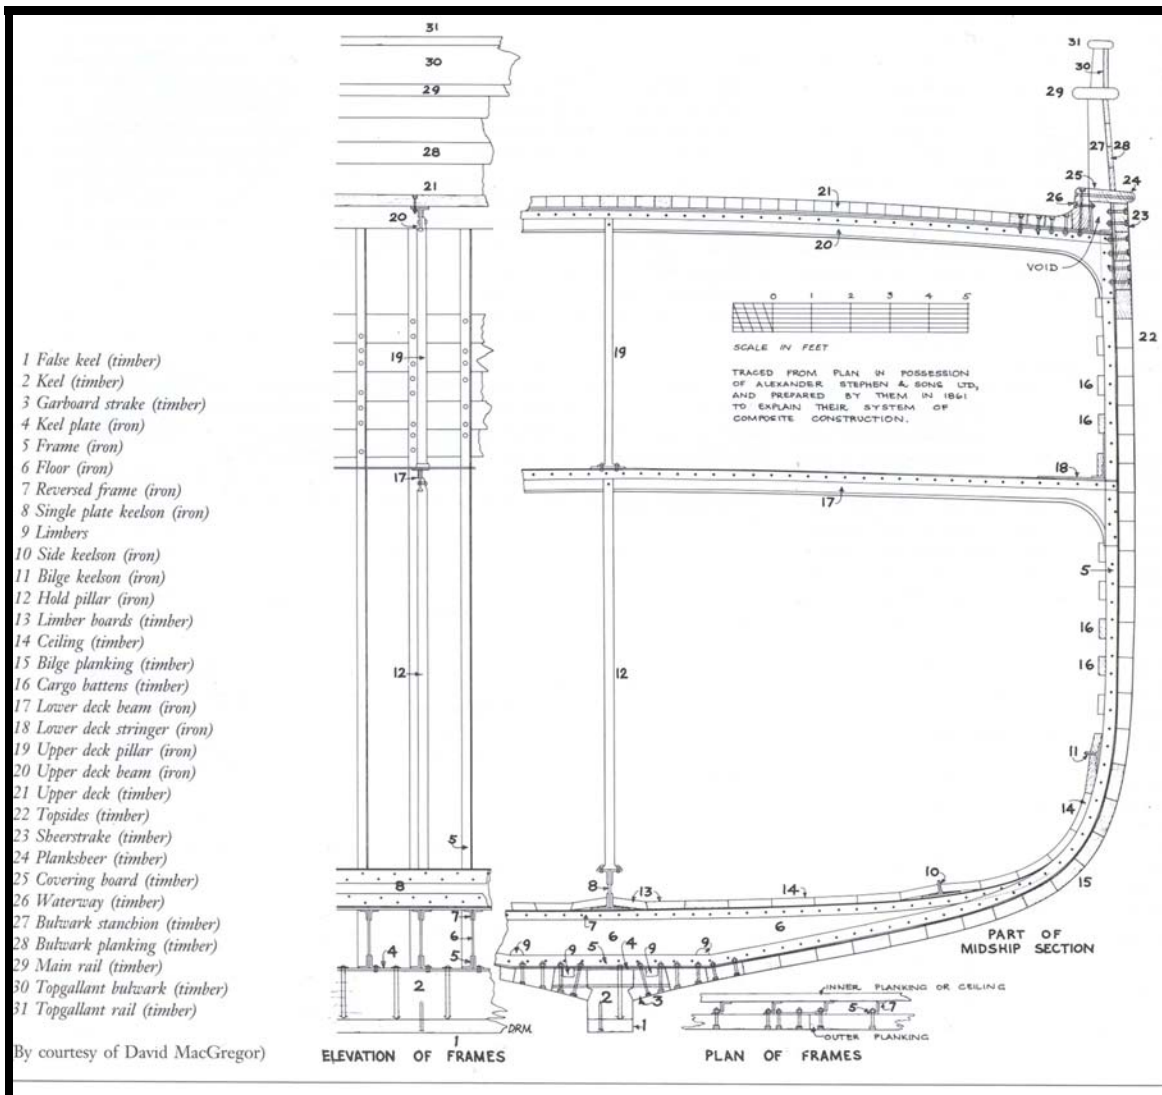
The most prominent weakness in wooden hulls is the lack of longitudinal rigidity (MacGregor 1993:32). Wooden hulls throughout history were constructed by numerous, relatively small individual planks, often overlapping or staggered to increase longitudinal strength (Steffy 1994). While these shipbuilding techniques were effective for centuries of large, wooden ship construction, ships intended for the 19th-century shipping industry required maximum hull volumes and increased rigidity. According to MacGregor (1993:34), ships that began incorporating iron bracing still faced problems of optimizing cargo volume because wooden support structures still occupied internal volume. This led many shipbuilders to incorporate iron framing fully, and completely eliminate wooden supports (Figure 2.1).

Figure 2.1: Cross section of a composite built ship

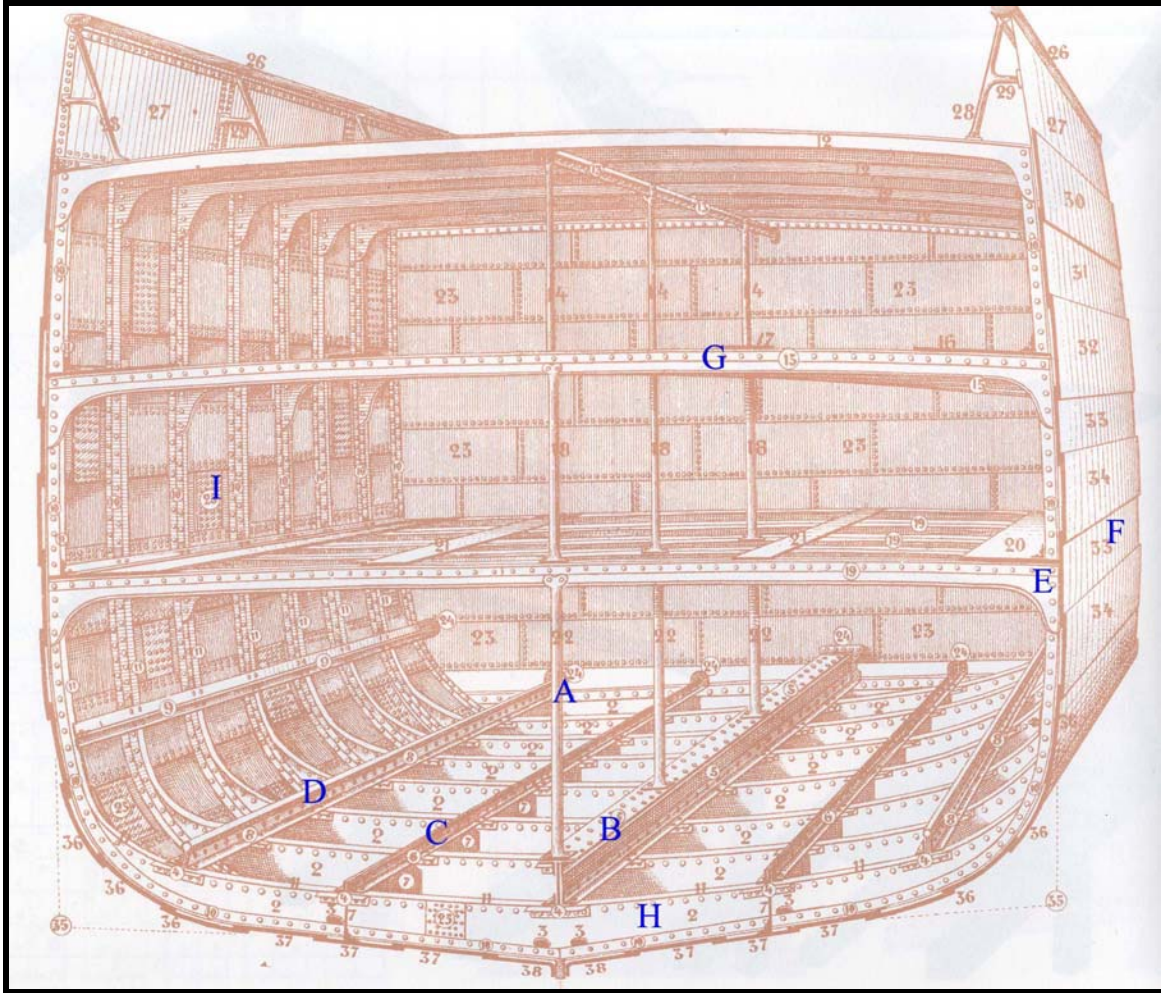
Iron ships continued to build upon composite ship designs by replacing the remaining wooden components with iron (Figure 2.2). Wood outer hull planking was replaced with riveted iron plates bolted to frames. Side and bilge stringers connected frames on the inboard side. Butt plates, flat iron plates with multiple rows of rivets, secured the plates to each other and covered plate seams on the inner face (Kihlberg 1972:39). Iron bulwarks and caprails were fixed on bulwark plating supported by bulwark plates. These features developed from and replaced wooden waterways, bulwark stanchions, and bulwark planking in composite-built ships (Kihlberg 1972:30; MacGregor 1993:36).

Figure 2.2: Riveted iron ship. A: Pillar, B: Keelson, C: Sister keelson, D: Bilge stringer, E: Angle bar, F: Outer plating, G: Deck beam, H: Floor, I: Butt plate (Modified from Kihlberg 1972:30).

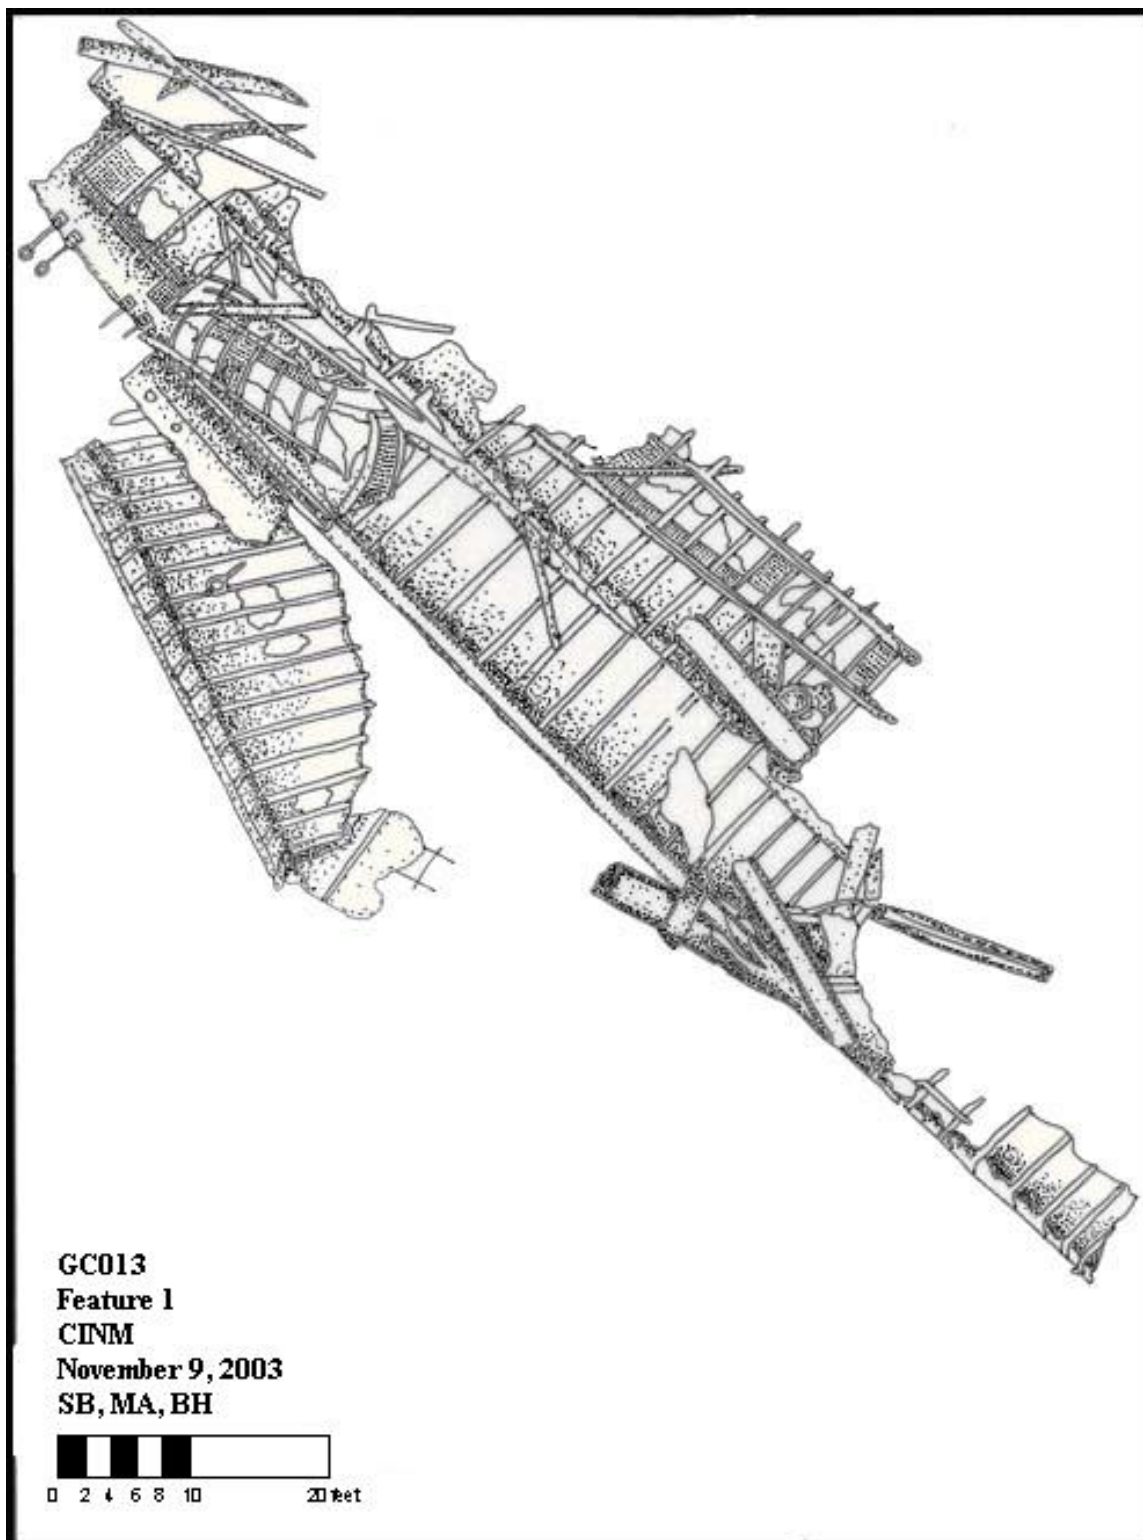
With less than two weeks to complete the project, each diver on each dive had multiple tasks. Equipment used included multiple slates with mylar drawing film, various measuring tapes in units of tenths of feet, and compasses for orientation on site. Two, two-hour dives were completed by each diver daily during the first five days, with post-processing work done during the evenings and on bad weather days. Pencil drawings made during dives were redrawn to scale, and measured and triangulated features were added to the site plan each evening (Figure 3.3).

Figure 3.3: Center hull section, redrawn to scale. (Courtesy of CINM)

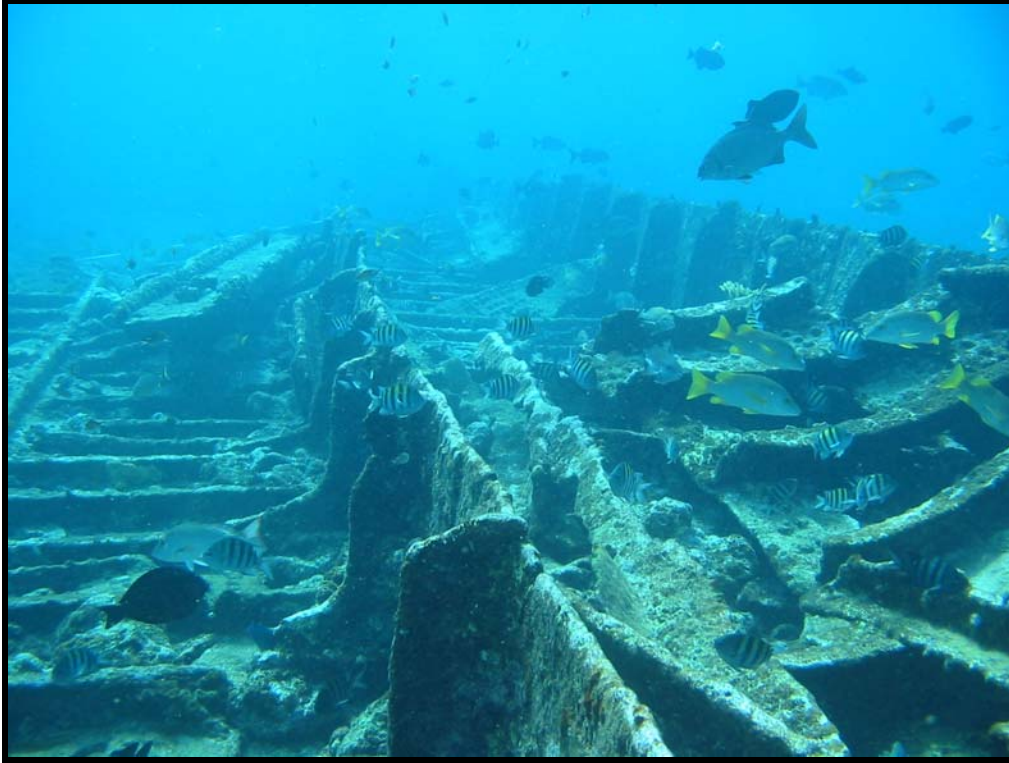
Feature 1 was the largest coherent section and was located in the center of the site. It consisted of three levels of port side deck supports, lying diagonally across one another (Figure 3.6).

Figure 3.6: Feature 1, large hull section located in center of site. (CINM photograph by Dan Schaar)

Each piece contained multiple frames, angle bars, and outer hull plating. Feature 1 hull components were located on the port side of the vessel, and the angle bars supported the main deck and internal poop deck. Four chainplates and two iron straps were also located on the northeast side of Feature 1 on the gunwale. Frame spacing, from center to center, was consistently 4.4 feet, and each arm of the angle bars extended 4 feet from the bend. Possible pillars were scattered throughout the central area of the feature, ranging from two to ten feet long. A small, curved hull section with seven frames was found lying on the western side of the feature. Its original position may have been at the turn of the bilge. We identified riveted butt plates between frames where outer hull plating remained. Areas of the plating had large holes, and all edges were jagged and rapidly oxidizing.

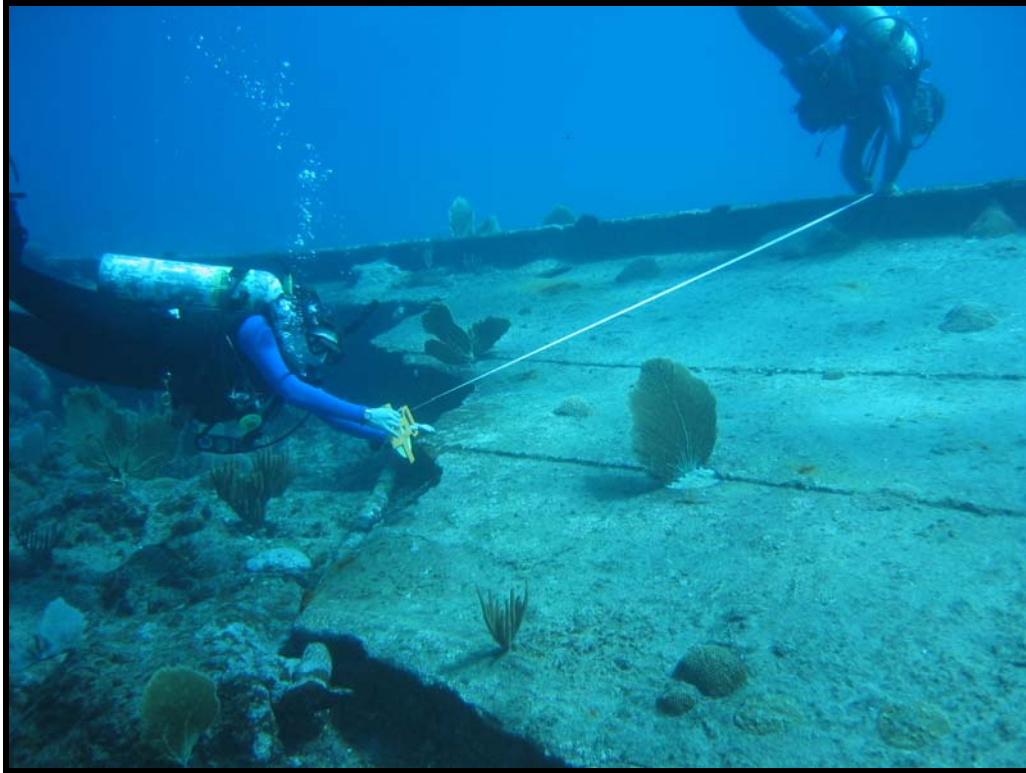
Feature 2 was identified as an inverted portion of the hull with a segment of the keel and keelson. It was found with the outer face of the external plating facing upwards, with the keelson protruding from the west end (Figure 3.7).

Figure 3.7: Feature 2, inverted hull section with keelson. (CINM photograph by Bert Ho)

The length of the attached keel was 78.3 feet, and another disarticulated keelson segment measured 21.1 feet. Garboard strakes extended to both sides of the centerline, with widths of approximately 4.4 feet. Outer hull plating was fastened clinker-style, as indicated by the overlapping seams. Remains of a possible bilge or sister keelson also extended from underneath the feature.

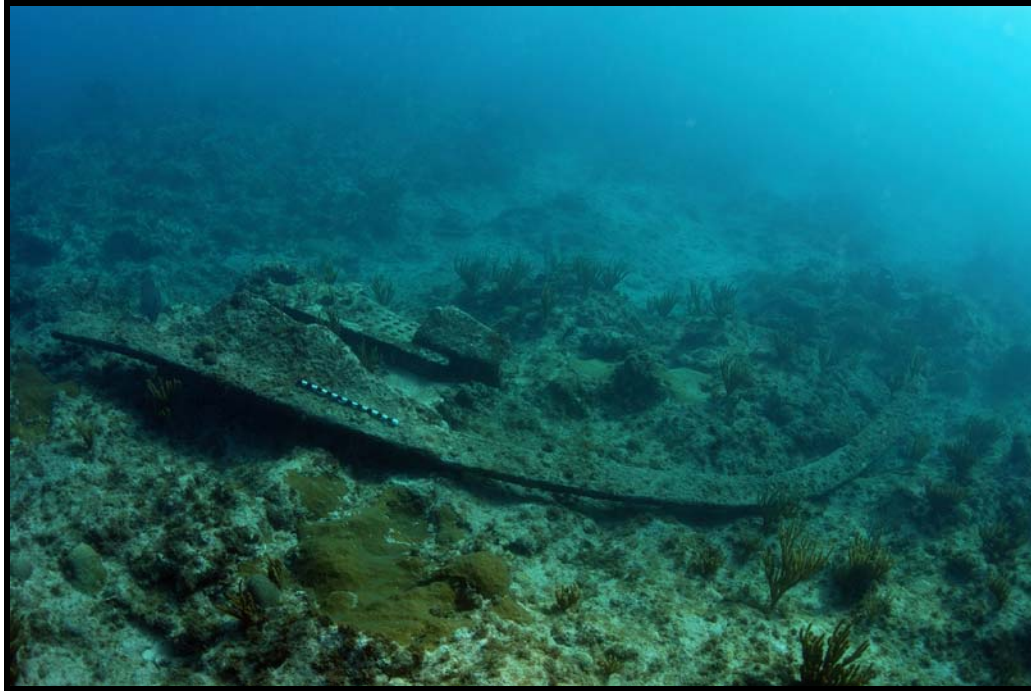
A bow feature identified as a portion of the cutwater was located in the southeast area of the site. Feature 8's total length measured 24.6 feet with a consistent width of $7/10^{\text{th}}$ of a foot (Figure 3.8).

Figure 3.8: Feature 8 Cutwater. (CINM photograph by A. Mustard)

The shape of the cutwater consisted of a gradual curve, with a slight “S-curve” near the point. Fragments of jagged bow plating connected near the point with two riveted butt straps as reinforcements. Another bow feature, Feature 18, remained in the crevices on the extreme northeast side of the site. Five cant frames decreasing in angle formed a point possibly below which a bowsprit located. This feature measured 20.6 feet in length and 13.5 feet at its widest point. Frames were spaced 2.1 feet from center to center with outer plating present between frames.

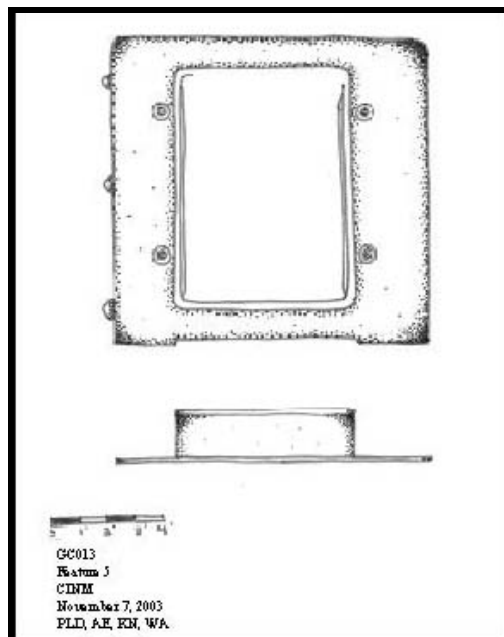
A variety of deck features were found throughout the wreck scatter. These features included a large cargo hatch on the west side of the site, with a base measuring 10.6 feet by 11.6 feet. Its coming extended 1.7 feet above the surrounding lip or base (Figure 3.9).

Figure 3.9: Cargo hatch on west side of site.

The base contained four rings, two on opposite sides, which measured 1.3 feet from the hatch walls. An indentation on the north side of the base extended 6.4 feet and was located at the center of the base edge. The actual hatch opening measured 8.4 feet by 6.4 feet and was positioned in the center of the base.

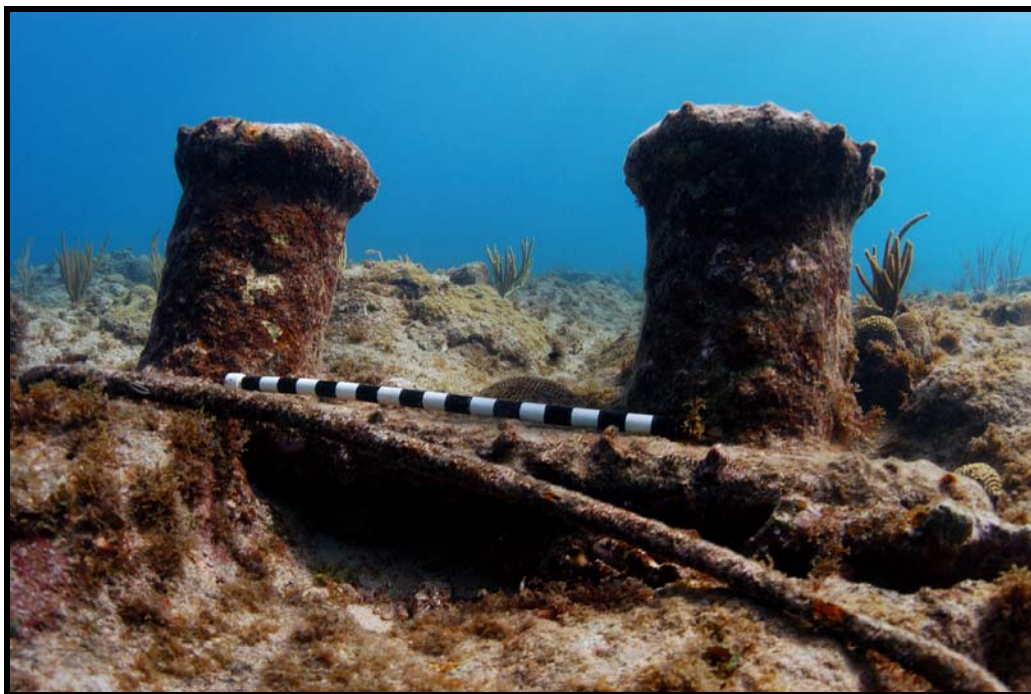
A total of four bollard sets and one single bollard were found around the site. Bollards, or bitts, served as mooring points on large ships, like cleats on small vessels (Figure 3.10).

Figure 3.10: Bollard pair, scale is two feet long. (CINM photograph by A. Mustard)

Mooring lines were wrapped around the cylindrical bollards and secured when ships were docked. The site included three different types of bollards, including paired bollards, staghorn bollards, and a single bollard. Feature 14, 15, and 19 were even-paired bollards, which consisted of two barrels about 1.3 feet in height and 1.2 feet in diameter, standing on a base approximately 4.5 feet in length. A staghorn bollard, Feature 38, also has two barrels, but one barrel is shorter than the other and has a cylindrical extension extending horizontally. The single bollard, Feature

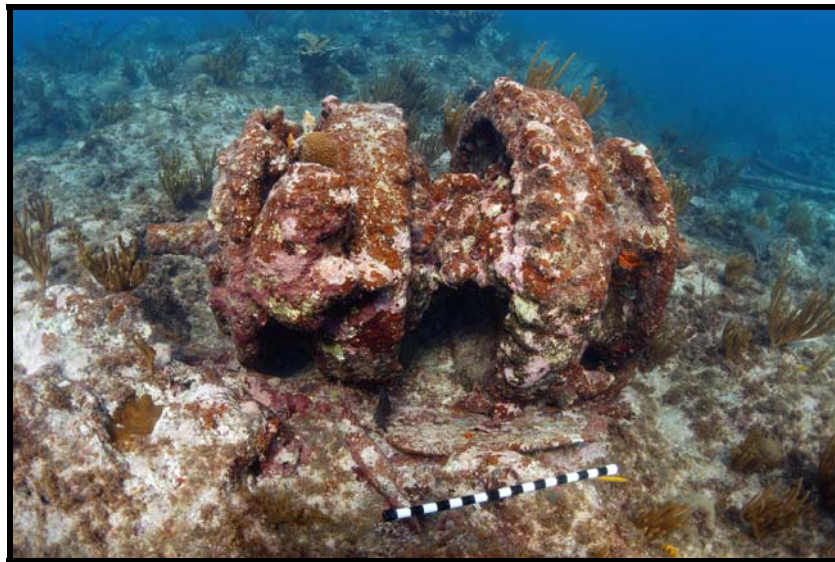
Two mechanical features were found east of the center of the site. Feature 12 was identified as a mid to late 19th-century windlass, similar to an Emerson and Walker patent windlass design (MacGregor 1984:116) (Figure 3.11).

Figure 3.11: Windlass, scale is two feet long. (CINM photograph by A. Mustard)

It was located on the east end of the site near an anchor with chain. Windlasses were used to mechanically raise heavy objects including anchors and yards, by translating rotational power from a capstan with its large gears. The capstan, Feature 13, was located in association with deck frames near the northern center of the site (Figure 3.12).

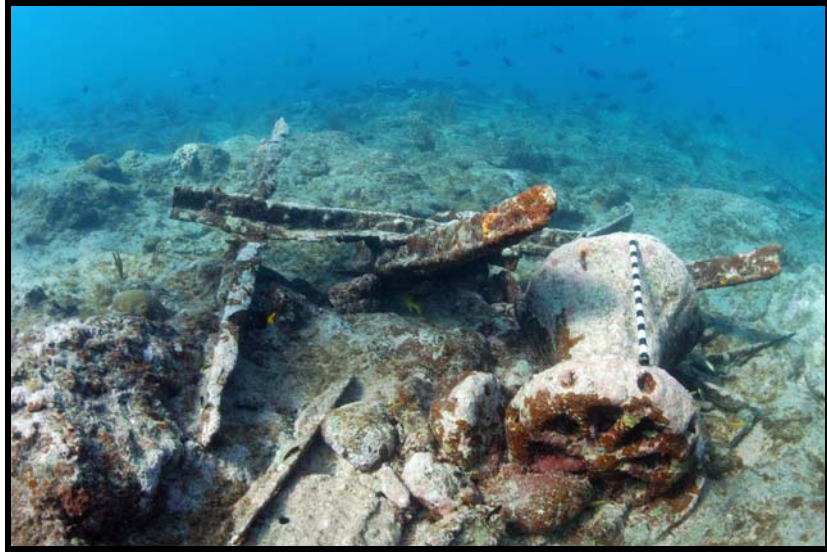
Figure 3.12: Capstan, scale is two feet long. (CINM photograph by A. Mustard)

It measured 2.9 feet in height, 2.6 feet in base diameter, and 1.8 feet in drum head diameter. The iron and wood barrel was complete with socket holes spaced evenly around the rim of the drum head.

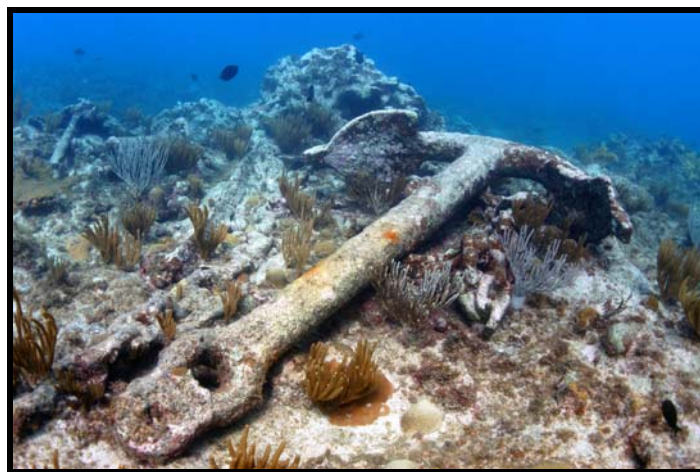
The anchor, Feature 10, associated with the machinery lay next to a large pile of stud-linked anchor chain. It was located on the east side of the site, amidst a variety of soft and hard corals (Figure 3.13).

Feature 3.13: Anchor with chain pile.(CINM photograph by A. Mustard)

Because no stock was present, the anchor lies relatively flat on the bottom. It measured 10.6 feet in length and 7.5 feet between the bills. The shank's width was 1 foot at the crown and tapered to $\frac{7}{10}$ ths of a foot at the stock ring. Each fluke measured 1.8 feet wide and 2.7 feet long, and the inner diameter of the stock ring was 1.2 feet. A large pile of encrusted anchor chain was just east of the anchor and two sections of chain extended to the west 50 feet and southwest 25 feet. The pile, approximately 20 feet long and 10 feet wide, stood nearly 5 feet off the bottom. Each stud link measured 1 foot long and $\frac{7}{10}$ ths of a foot wide and was oval-shaped with a bar crossing the middle. A second anchor, Feature 11, was found south of the center of the site, with its iron stock in place (Figure 3.14).

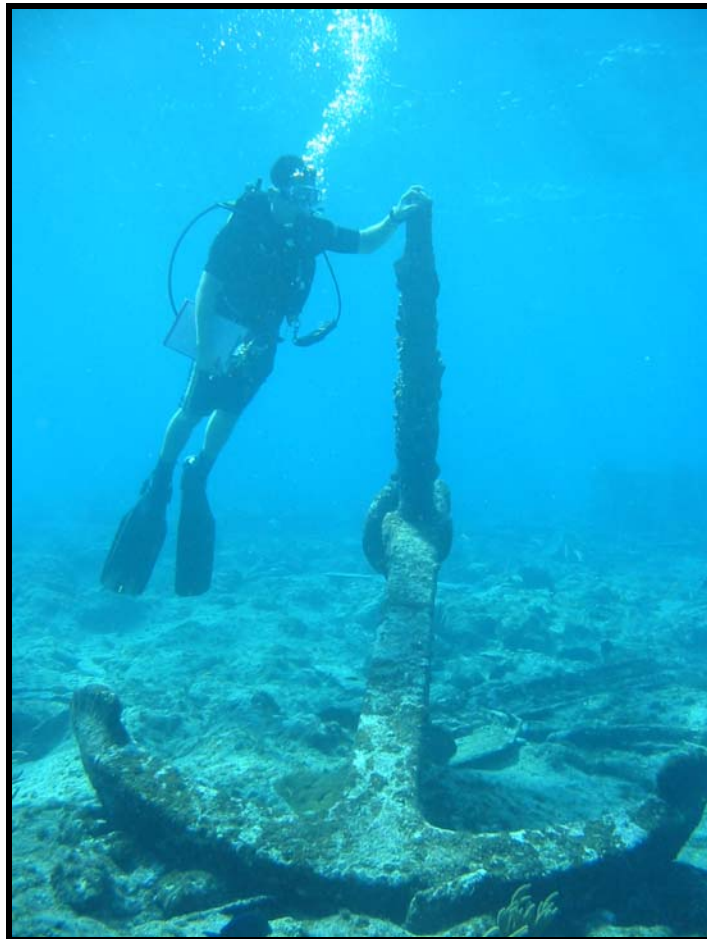
Figure 3.14: Author with iron-stocked anchor. (CINM photograph by Dan Schaar)

This anchor leaned on the ball-end of its stock, raising it approximately 10 feet above the bottom. It measured 9.8 feet in length and 7.9 feet wide between bills, with a non-tapering shank 1 foot wide. A stock ring was also attached. Its inner diameter was 1.5 feet. The stock measured 9.4 feet in total length, but portions of the distal end were heavily eroded.

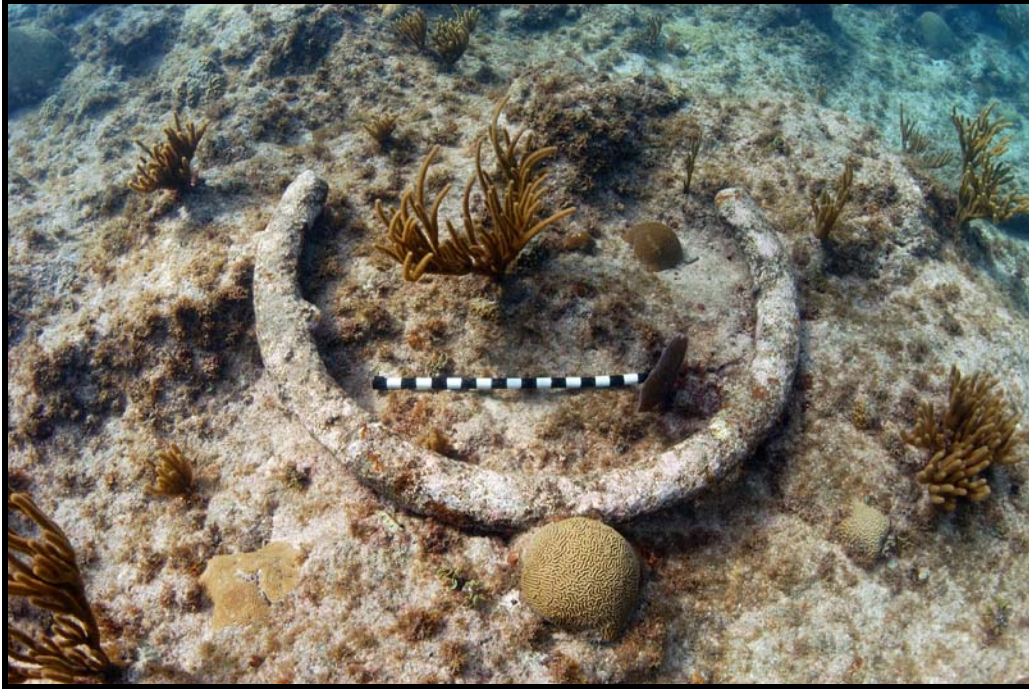
Some small features were recorded because of their unique form and possible significance. On the east side of the site, just south of Feature 2, a probable ship's wheel was recorded. Its outer diameter was 4 feet, and a segment of its circular form was missing. Inside the wheel feature, four small protrusions were spaced an equal 1.6 feet around the inner curve (Figure 3.15). A possible wheel center was also found on the east side, near Feature 2. It measured 1.4 feet in outer diameter with a thickness of $4/10^{\text{th}}$ of a foot. Three small protrusions spaced equally apart were present around the outer ring. Keith Neale of the DOE first discovered the feature was brass because of its coloration.

Figure 3.15: Possible ship's wheel, scale is two feet. (CINM photograph by A. Mustard)

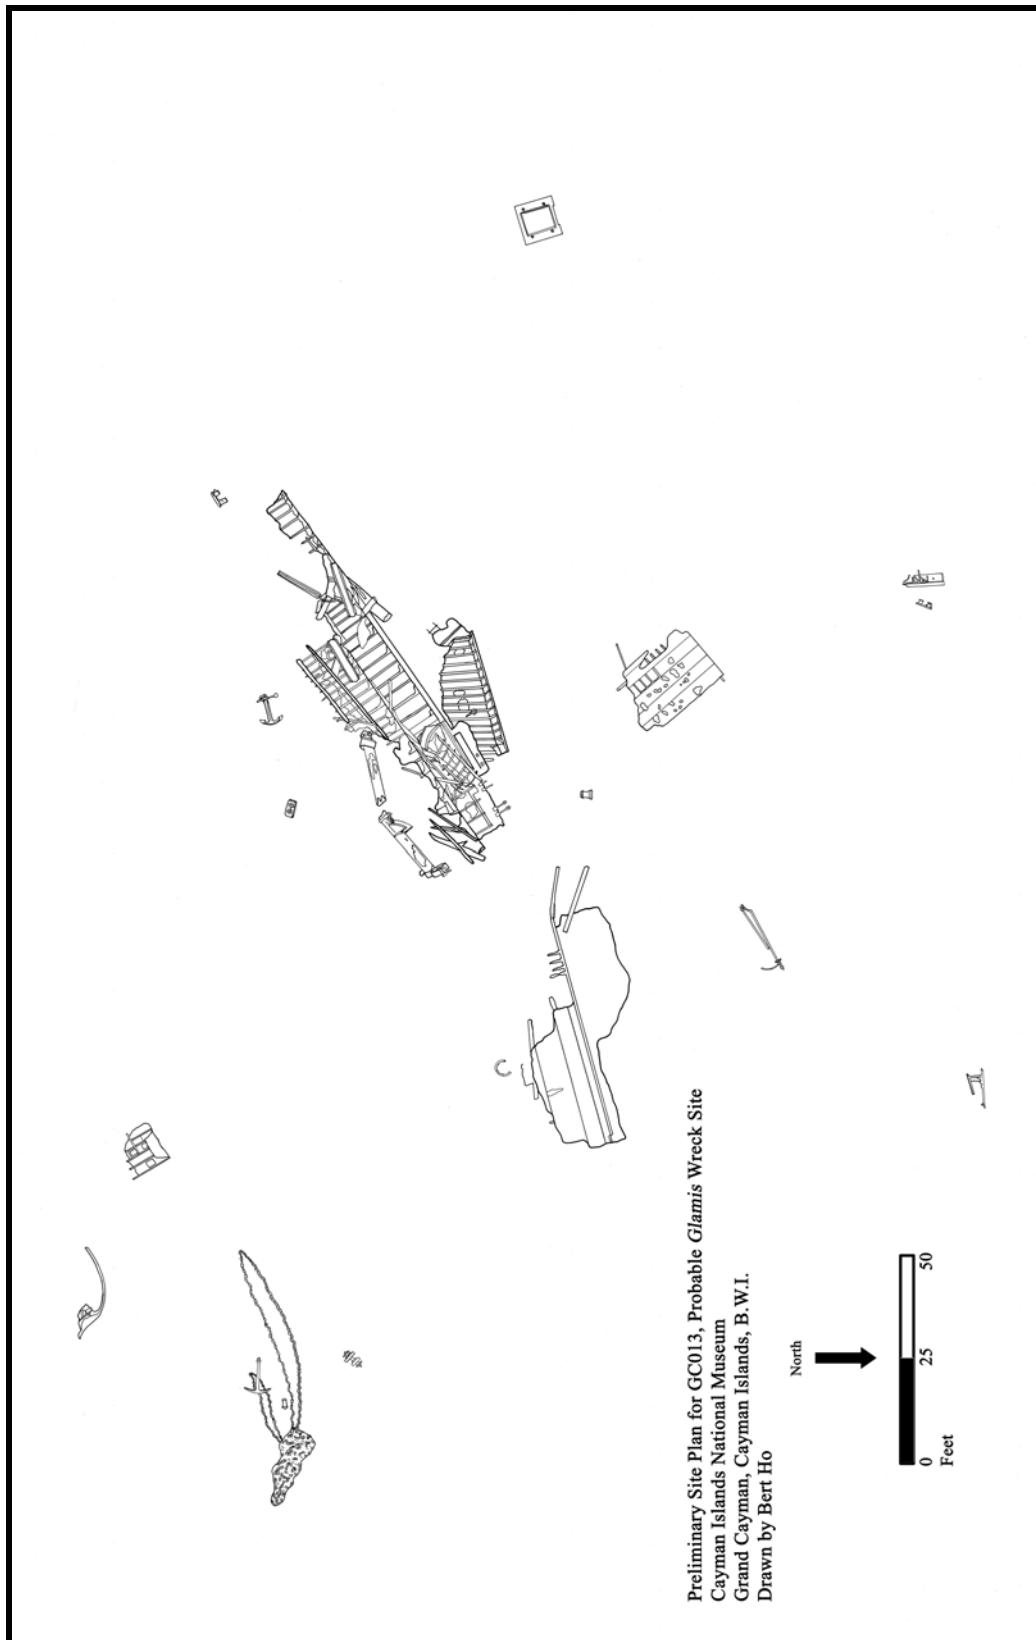
Evidence from the mapping project, especially the identified features and their locations, indicated an iron sailing ship wrecked stern first on the reef. Historical reports discuss an iron barque, named *Glamis*, wrecked off the East End of Grand Cayman in roughly the area of the site investigated. Local information gathered as part of INA's 1980 investigations included the name *Glynnis* as the identity of the shipwreck. Further investigations by the CINM produced no known ships by the name *Glynnis*, leading to the belief that the shipwreck was actually the similarly spelled *Glamis* (Leshikar-Denton and Ho 2004). What has been presented in this thesis so far about *Glamis* is necessary to understanding the archaeological site and what remains today

Figure 3.16: Preliminary site plan. (Drawing by Bert Ho)

The most challenging feature of the shipwreck site was the large area of the debris scatter. Wreckage extended nearly 360 feet east to west, and approximately 170 feet north to south. Other features identified as parts of the bow and jibboom were located in deeper crevices approximately 150 feet further east, with possible hull components and superstructure closer to shore inside the reef. In order to effectively map the large area, a baseline was oriented along the East-West axis and made long enough to incorporate the site. Two 150-foot measuring tapes were mated together to form the baseline, and they were secured approximately every 10 feet. The baseline was positioned in the center of the main wreckage, close to the larger features. This enabled more accurate measurements to the large hull fragments, by decreasing the distance between the features and the baseline. Smaller features further from the baseline were triangulated to the larger hull features, and placed into the site plan.

Once the baseline was laid, offset measurements were taken to accurately plot the features on the site plan. Prior to the mapping project, a rough sketch of the site was drawn by Leshikar-Denton. The research team used this sketch to properly plan each day's work (Figure 3.4). Divers were directed to work areas and assigned features to record during pre-dive briefings. Teams of two or three including at least one archaeologist measured and drew features individually, often recording multiple features per dive. Despite strong surges and a stiff current, measurement accuracy was achieved by placing multiple divers along the measuring tape to reduce slack. Perpendicular transects were completed with compass bearings, after determining the iron wreckage had little to no effect on the accuracy of compasses.

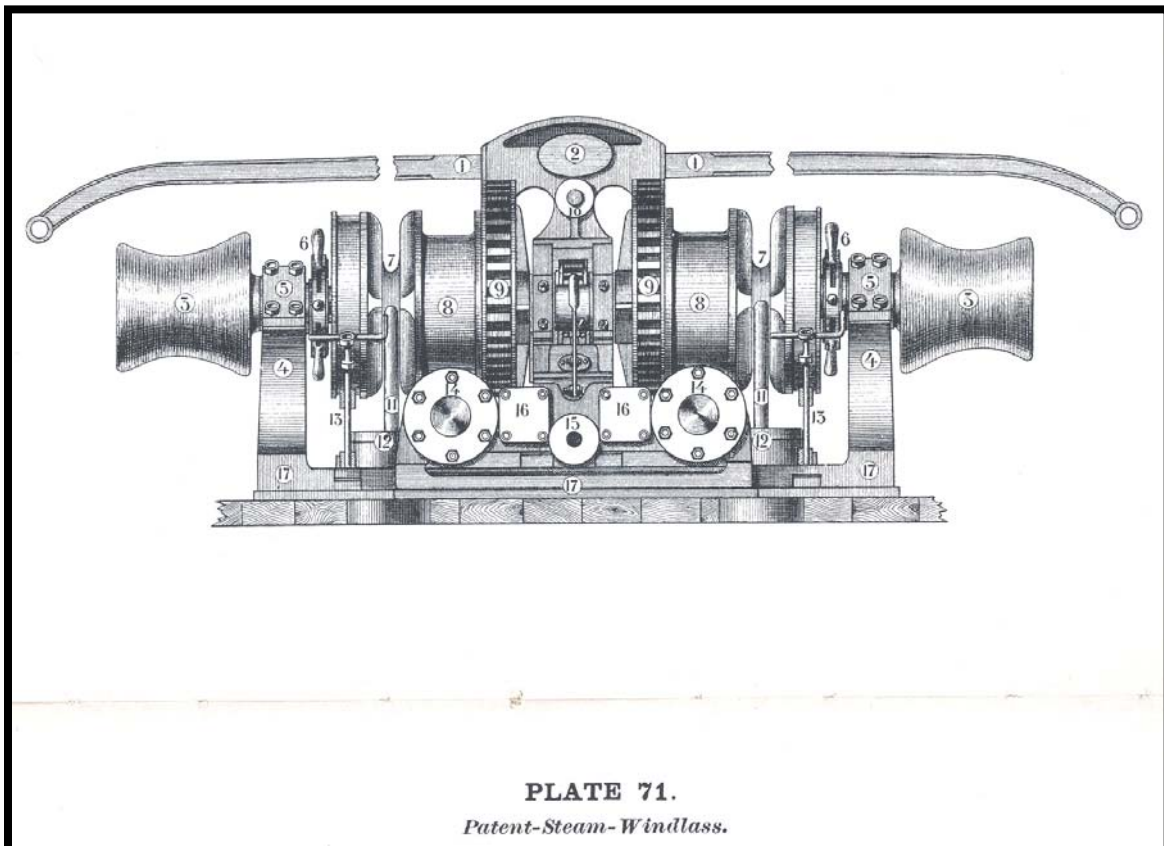
Along with continual improvements in the shipping industry, demands for innovation in ship design forced the improvement in the efficiency of large bulk carriers (MacGregor 1984b). Innovations on these sailing iron-hulled ships were mostly concentrated on the decks and rigging. Replacing the round, rotating windlass that had been in use for nearly three centuries, the "Patent" windlass was fixed below the main deck, aft of the bow (MacGregor 1984b:129) (Figure 4.1).

Figure 4.1: Patent windlass.

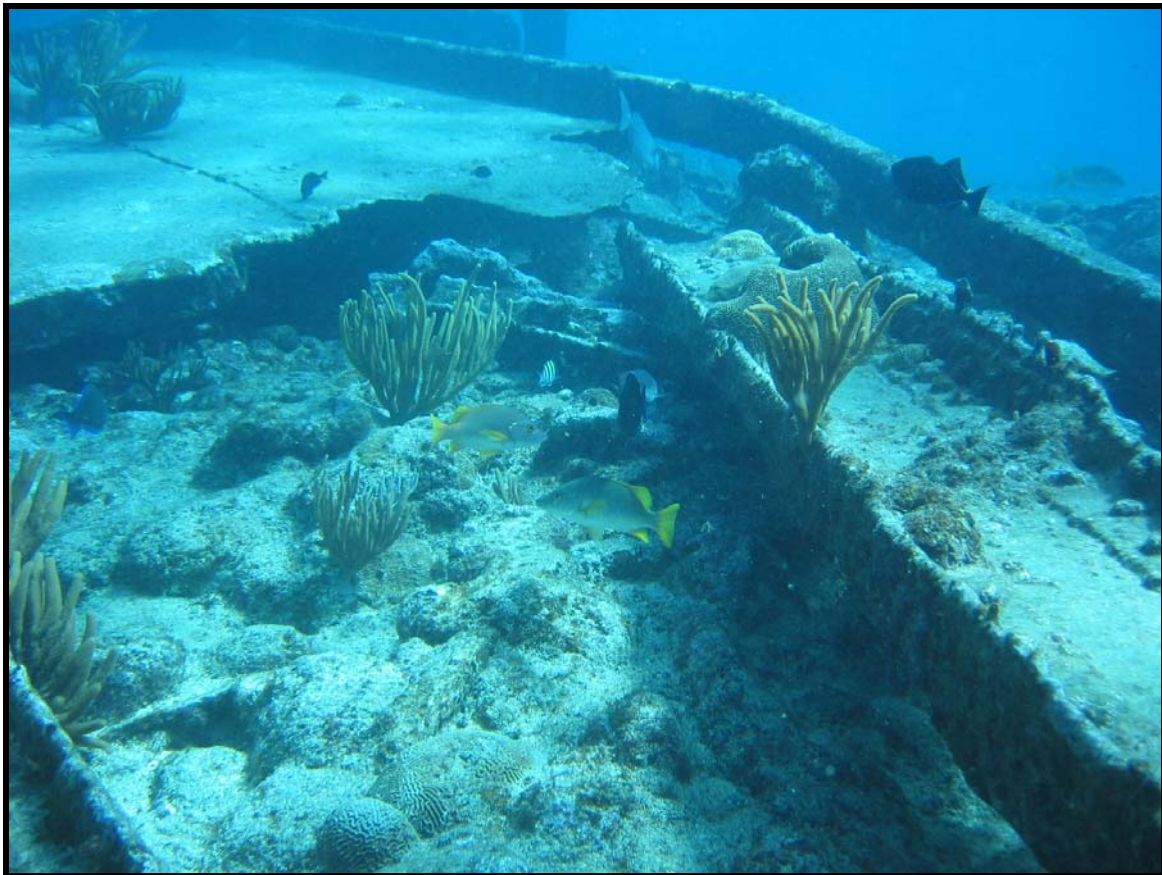
Lying northeast of Feature 1, is a large section of the bottom hull with a keel and a broken piece of a keelson. Garboard strakes have been identified as well as several floors and possibly a sister keelson, which projects from under the hull. Dimensions are 80 feet in length from the tip of the projecting keel to the edge of the outer hull. Its width from its greatest extremes is approximately 36 feet. Hull planks project off the northwest side from the keel and from the south east side from the keel. The western portion of the feature also has floors

projecting south from underneath the hull, and remains of the keel point westward, with a bent portion of the keelson projecting northwest. The curvature of the hull from the centerline further indicates the location of the keel and keelson. Remains of a possible bilge keelson project from the south side of the keel westward. It should also be noted that there are several possible pillars or stanchions projecting from underneath the large hull section (Figure B.2).

Figure B.2: Feature 2, portion of keelson. (CINM photograph by Bert Ho)

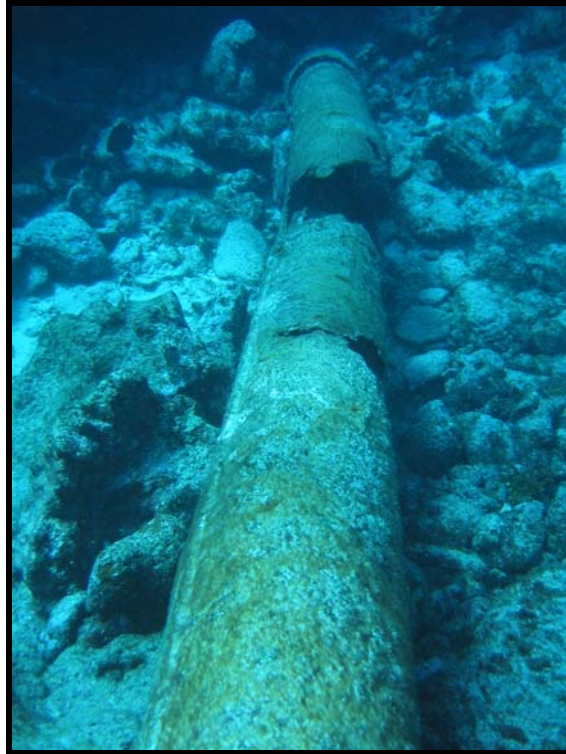
Located in the extreme north east area of the site, within a finger canyon, is a 25 foot section that is possibly the remains of the jibboom. It measures 25 feet in total length with a diameter of 1.4 feet throughout. There are a number of rings spaced variably on the iron jibboom, suggesting that they were areas for connecting rigging. It is also located in the extreme northeast area of the site next to a portion of the bow. Three similar sized rings are located on the Jibboom at distances of 4.6 feet, 16.8 feet, and 23.4 feet from the eastern most end. A larger ring with a clamp or ring assembly is located 5.7 feet from the east end, and it has a width of $\frac{4}{10}$ foot. It is likely to have secured the jibboom to the bowsprit or to stays. On the west end of the feature, a large crack splits and bends the jibboom, but does not completely separate the section. A small hole is also found at 16.8 feet from the east end of the feature, and it has a shape of a key hole (Figure B.3).

Figure B.3: Feature 7, possible jibboom. (CINM photograph by Bert Ho)

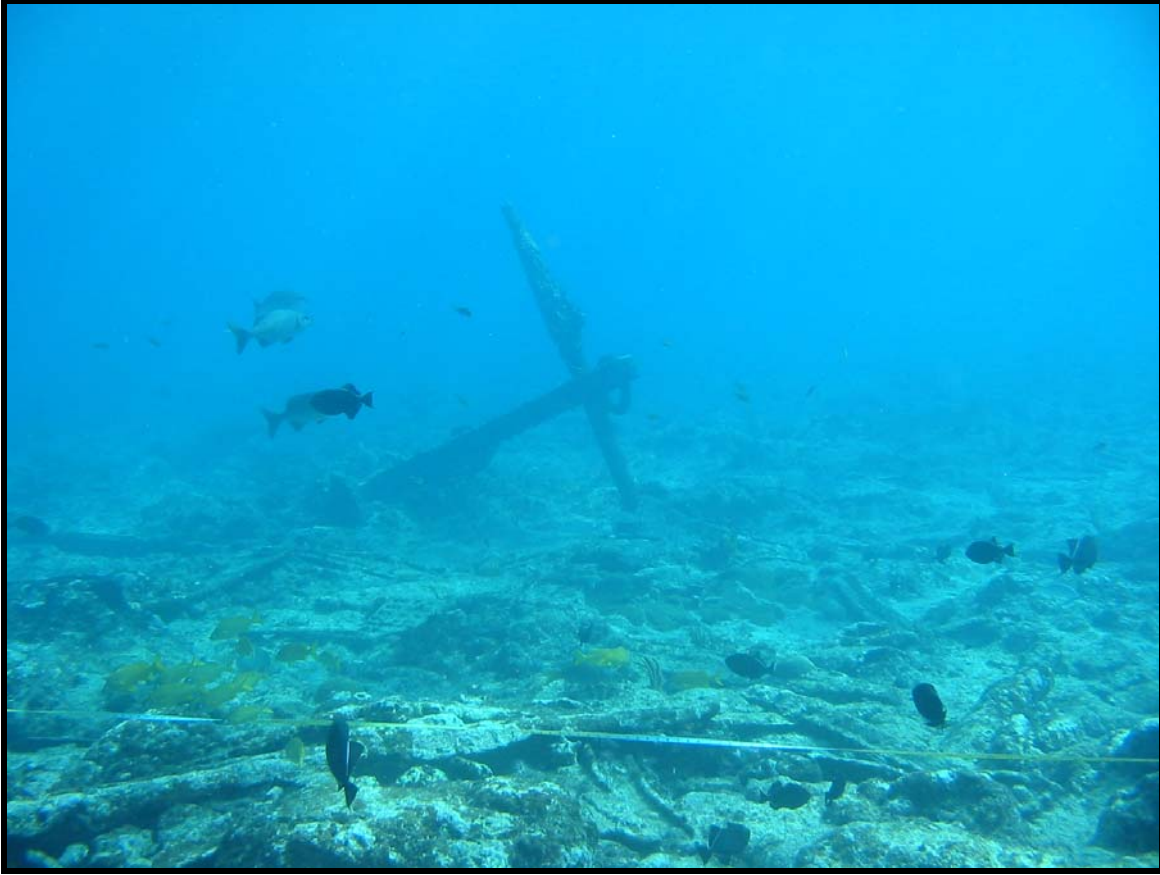
A second anchor is found due south of the center of the site. It is similar to feature 10, but it has its stock in place standing it off the bottom at an angle. There is no anchor chain associated with the feature and no bollards. Dimensions of the anchor vary slightly from Feature 10. The total length is 9.8 feet and the width from bill to bill is 7.9 feet. Tapering of the shank is nonexistent, as the width remains an even 1 foot throughout. The length of the stock ring and the anchor ring measure 1.5 feet. Though the ball end of the stock is partly encrusted into the coral bottom, the stock still measures approximately 9.4 feet in length, with some deterioration on the upper end. There is also an anchor ring in the ring on the top of the anchor shank, but no anchor chain is connected. It has the highest point of relief on the site, standing nearly ten feet off the bottom surface, and it will most likely serve as a visual marker for the wreck site (Figure B.4).

Figure B.4: Feature 11, anchor with stock amidst wreck scatter. (CINM photograph by Dan Schaar)

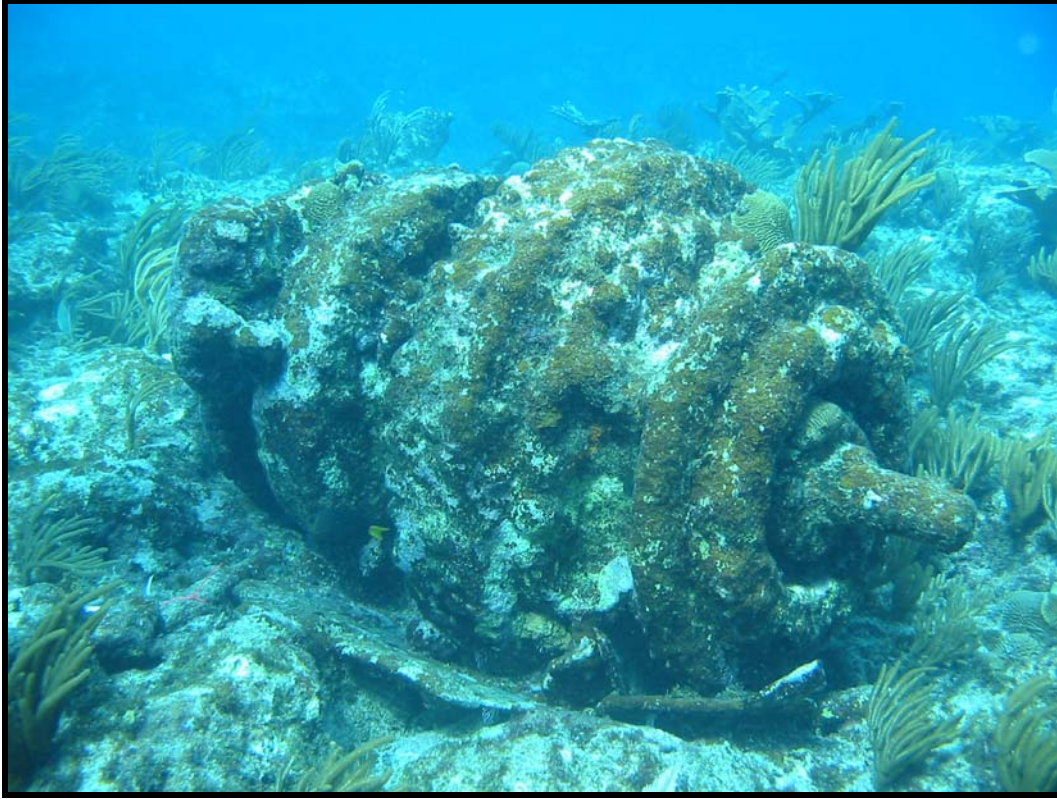
Located on the East end of the site's baseline, lies a mid to late 19th century windlass associated with the raising of the bow anchor. Its length is approximately 6.2ft long with a large gear rotated by a pinion powered by the capstan on the deck of the forecastle. The windlass appears to be similar to that of an Emerson and Walker patent windlass. Power created by the rotation of the capstan above the deck would drive the pinion's teeth into a large gear on the right side of the windlass (MacGregor 1984b: 116) (Figure B.5).

Figure B.5: Feature 12, windlass. (CINM photograph by Dan Schaar)

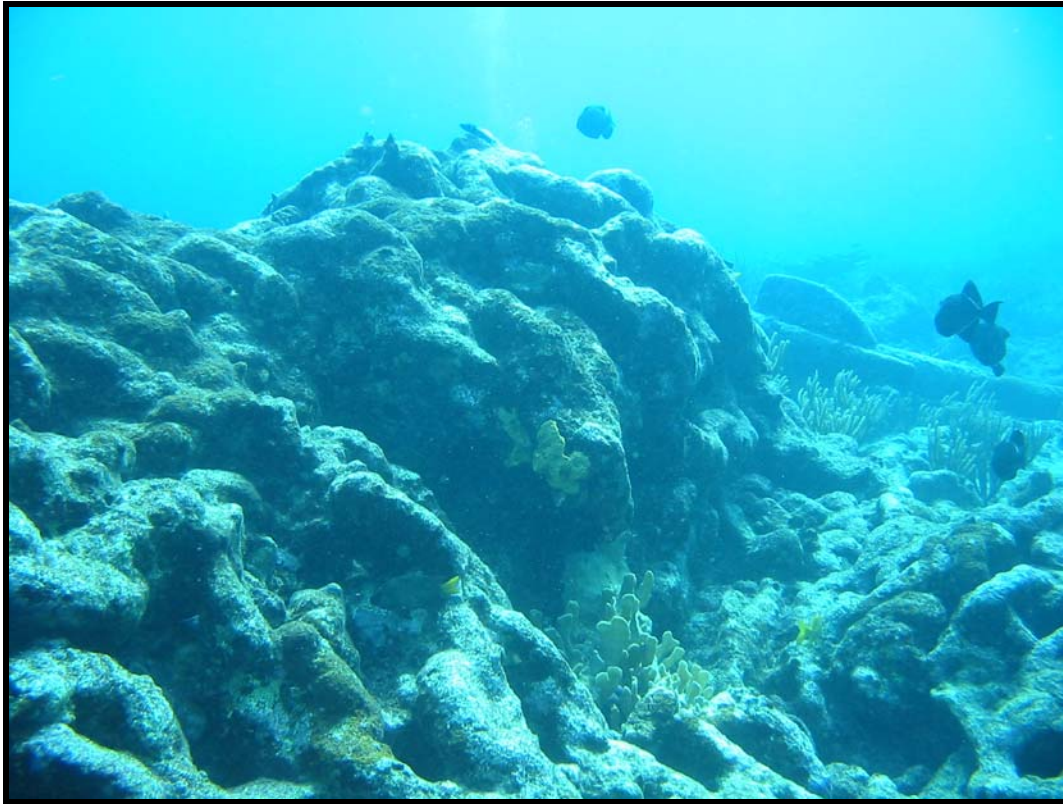
The south east side of the site is marked by Feature 10 and the associated pile of anchor chain. It is impossible to determine how long the chain is because of the heavily encrusted pile that the chain has amassed. A majority of the chain lies in a mound approximately five feet high from the bottom surface, with chain drawn out to nearly 50 feet to an unidentified iron object and chain drawn underneath the anchor to about 25 feet from the pile. The chain pile extends nearly 20 feet long by 10 feet wide at its widest point. It is made up entirely of stud links that are one

foot by 7/10 foot in dimension, with a bisecting arm through the center. Links all appear to be connected with one another, with no single links disarticulated (Figure B.6).

Figure B.6: Feature 21, anchor chain pile. (CINM photograph by Dan Schaar)

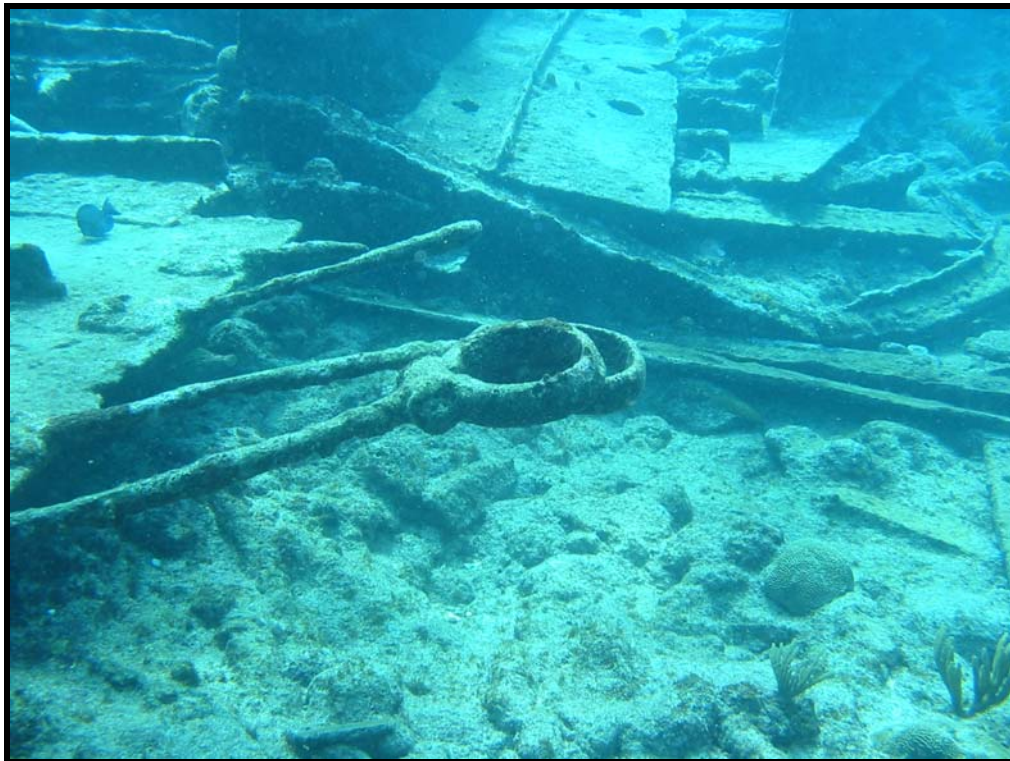
Feature 1 has two chain plates extending from its easternmost hull section. Though the feature is missing its deadeye, another chain plate that is nearby and disarticulated from the hull does have a complete wooden deadeye. Drawings were done with a simulated deadeye in its appropriate orientation on the feature (Figure B.7).

Figure B.7: Feature 31, chainplate. (CINM photograph by Dan Schaar)
