An Archaeological Study of Glamis: The Role of a 19th-Century Iron Barque

AN ARCHAEOLOGICAL STUDY OF *GLAMIS*:
THE ROLE OF A 19th-CENTURY IRON BARQUE

A Thesis submitted to the
Department of Anthropology
in partial fulfillment of the
requirements for the degree of
Master of Science

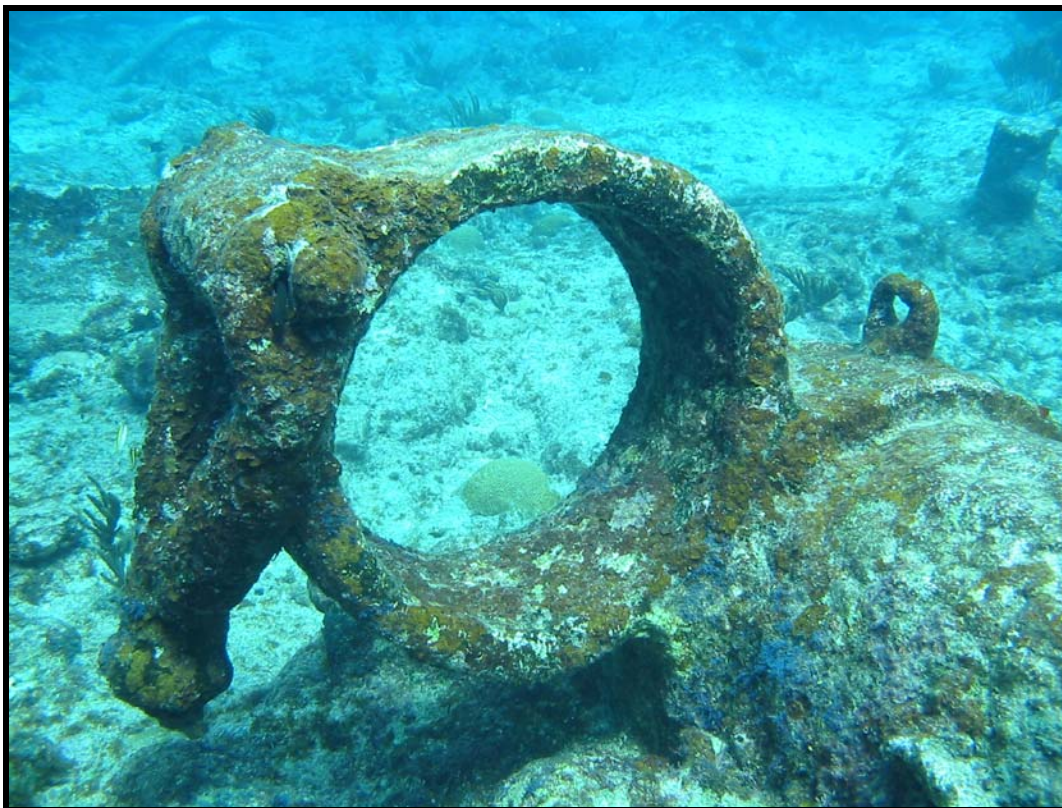
A portion of the main mast lies in the center of the site just below Feature 1. It is broken into two pieces, 21.9 feet and 19.9 feet in length. The longer portion has a mast ring fastened on one end that is complete and hollow. It has a large hole approximately 8 feet in length between the mast ring and the iron mast top. Both sections of the main mast are hollow, leaving only the iron plating that surrounded the original wooden mast. Near the broken end of the larger portion is a ring that most likely connected rigging and stays. The shorter section of mast has two rings on its lower end. One ring is in its original location and it appears to be a portion of a shroud, minus the extending ring (Kihlberg 1972: 83). The larger displaced ring circles the mast at an angle, and it may represent a ringed cap or support above the location of the shroud ring. A third portion of the main mast is pinned under the northern end of Feature 1, and based on its location and orientation to this feature, it has been interpreted to be part of the main mast (Figure B.8).

Figure B.8: Mast ring on Feature 34, main mast. (CINM photograph by Dan Schaar)
