Variante (se aplicável): [No Variations]			
Title			Organization
Size: A4			Country
Number: 1			My Address
Revision: V.1.2			My State
Date: 2025-11-18			My Zip Code
Time: 20:16:37			
Sheet1 of 1			
File: DONGLE02.SchDoc

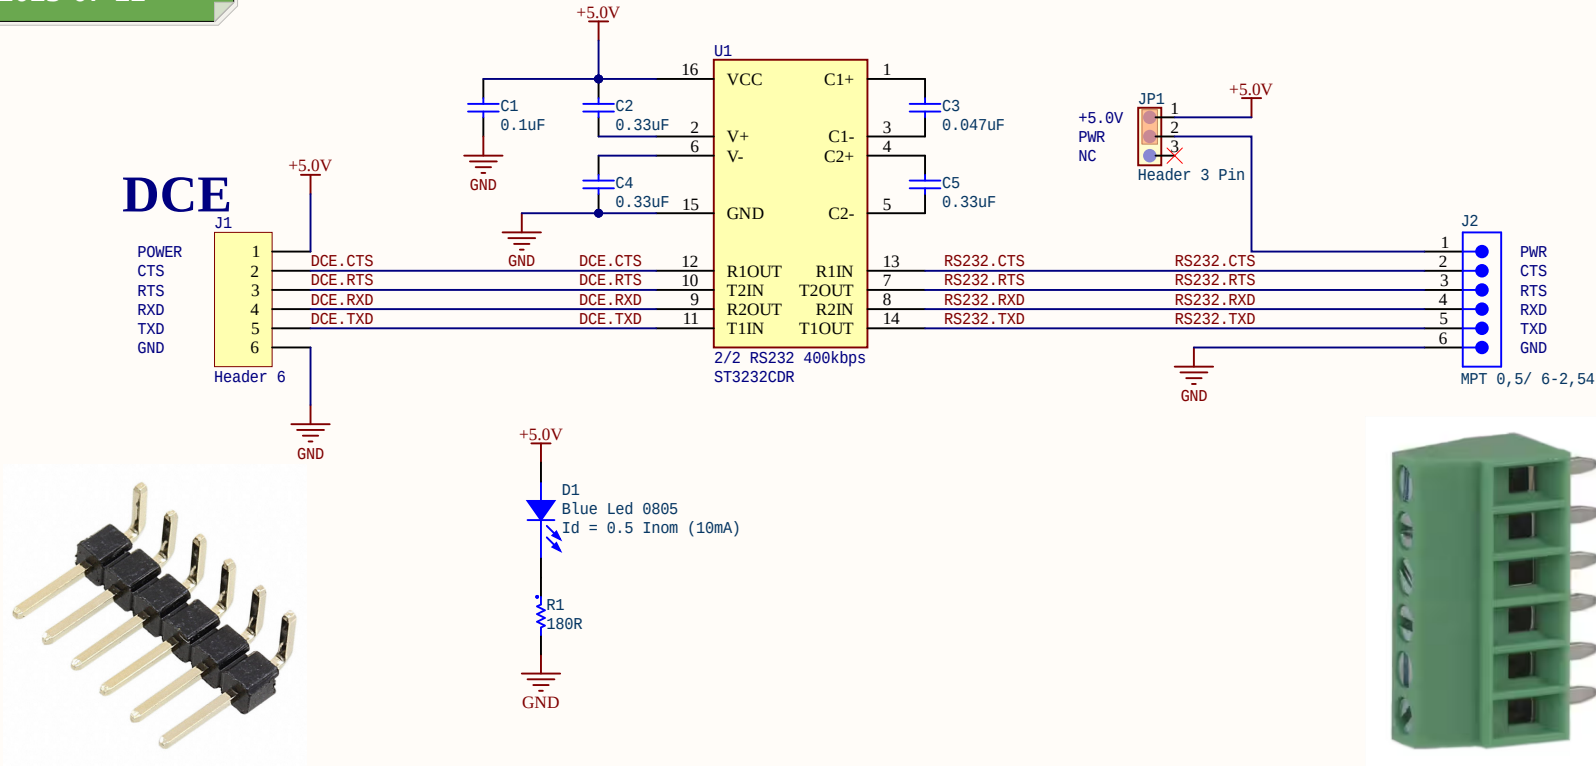
Bug detected: RX,TX,RTS and CTS need to be swaped. New version of PCB needed.

Bug Fixed at 2025-07-22
