POWER BOARD Change Part

Change list

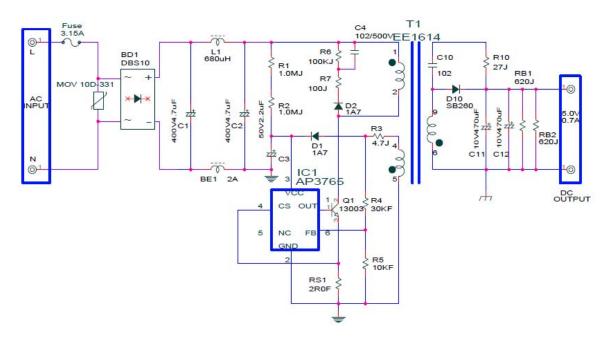
Before

Item	before	after	비고
Varistor	10D331	10D471	Value change
Bridge Diode	DBS10	DF1510S	Part change
Thermisitor	-	WTR08D100M	Circuit add
Transistor	APT13003EZ(EU)TR-G1	KSC5026M	Part change
