S/1996/509  
1 July 1996

Letter dated 28 June 1996 from the President of the Council of the International Civil Aviation Organization addressed to the Secretary-General

Pursuant to the request of the Security Council, I have the honour to transmit to you the report (C-WP/10441) and information paper No. 1, presented to the Council of the International Civil Aviation Organization by the ICAO Secretary General entitled "Report of the investigation regarding the shooting down of two U.S.-registered private civil aircraft by Cuban military aircraft on 24 February 1996".

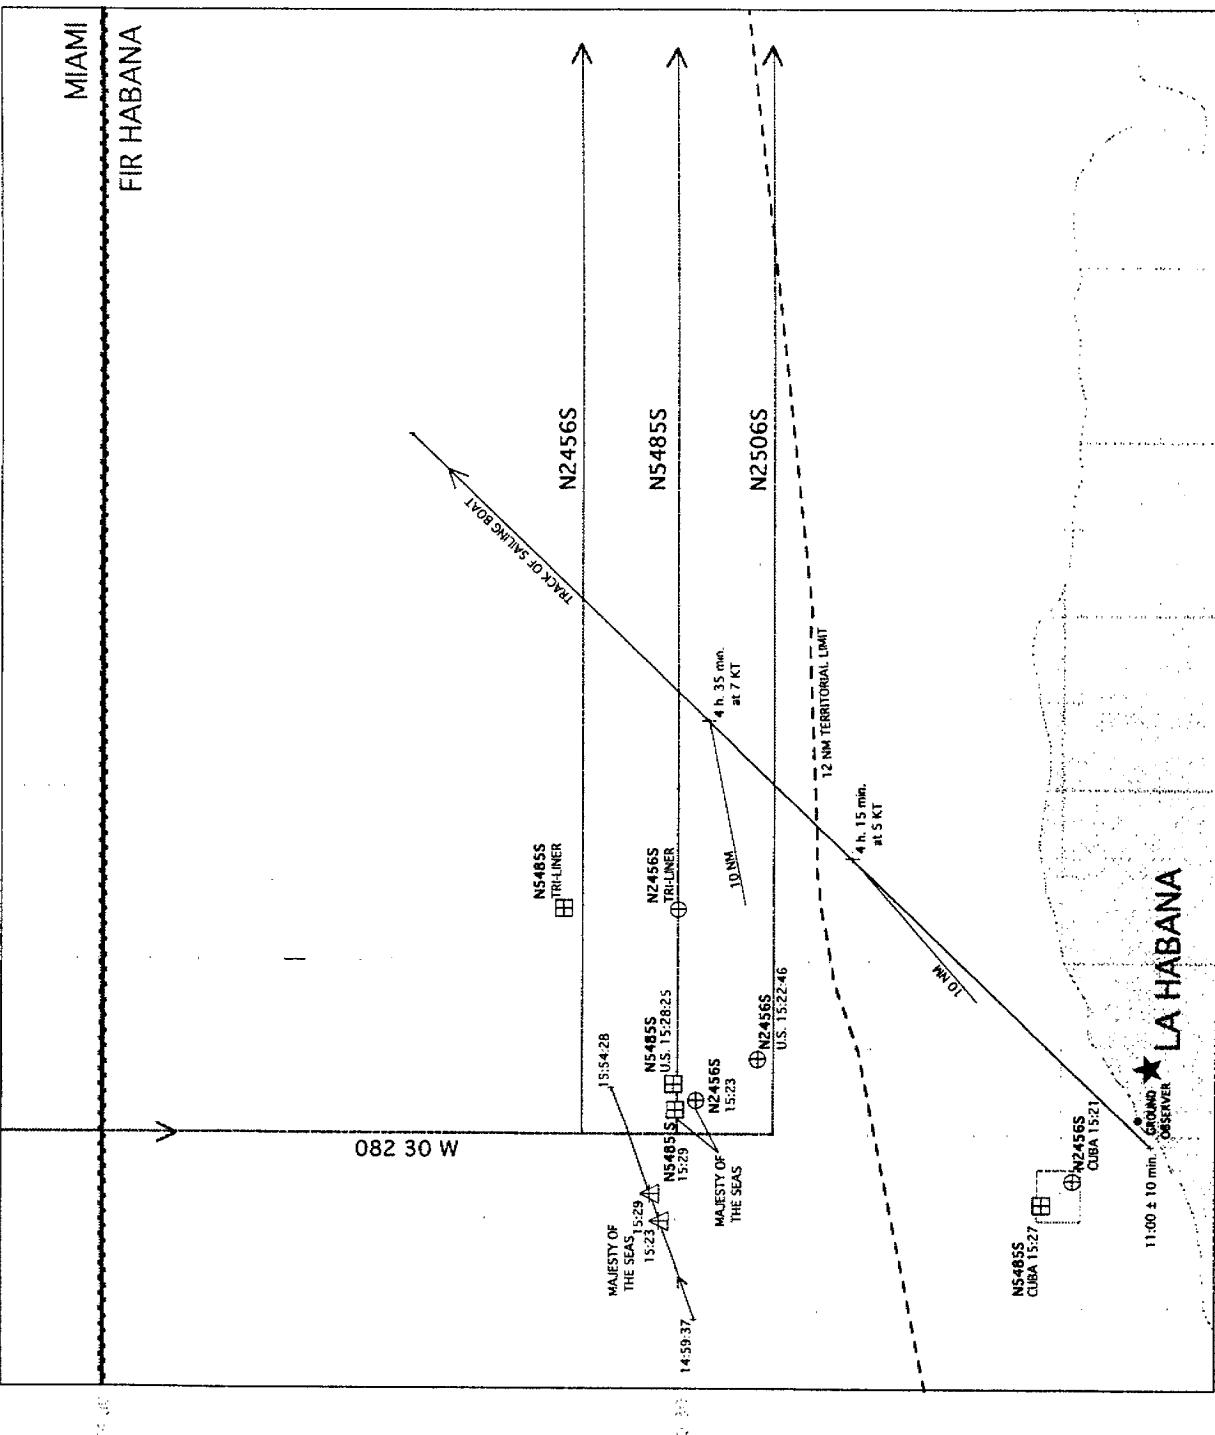
Chart 3 - Positions of the shoot-down of N2456S and N5485S according to Cuban and U.S. radar data, the Majesty of the Seas and the Tri-Liner.

1.1.31 The watchkeeping staff on the bridge of the *Majesty of the Seas*, at 15:23 hours in position 23 30.9N 082 35.1W, observed an explosion in the air at a height of 500 to 1 000 ft, on a bearing of 115°T, distance 6 to 7 NM. Debris was observed to fall into the sea beyond the fishing boat *Tri-Liner*, which they had been monitoring. The location was established as 23 29N 082 28W, based upon the position of the ship and the bearing and radar distance of the fishing boat. The *Majesty of the Seas* observed the fishing boat turn and head towards the impact position of the debris. Shortly thereafter the fishing boat was seen to resume its northerly course. A number of passengers and other crew members also saw the explosion and the falling debris. The occurrence was recorded in the ship's log.

1.1.32 A crewman of the *Tri-Liner* heard and saw an explosion directly overhead, and called the master, who was below deck. Both observed an aircraft on fire tumbling into the water 200 to 400 yards astern of their vessel. A military type aircraft was also seen. The fishing boat turned around, approached the impact position, and observed some small debris and an oil slick. A 1.5 ft square orange-coloured box or float, with a yellow line attached, was seen but not recovered. The boat remained on the scene for about ten minutes; no other items came to the surface. The *Tri-Liner* then resumed its course to the north. The master later estimated the time of the explosion as 15:15 hours and the position as 23 30N 082 17W.

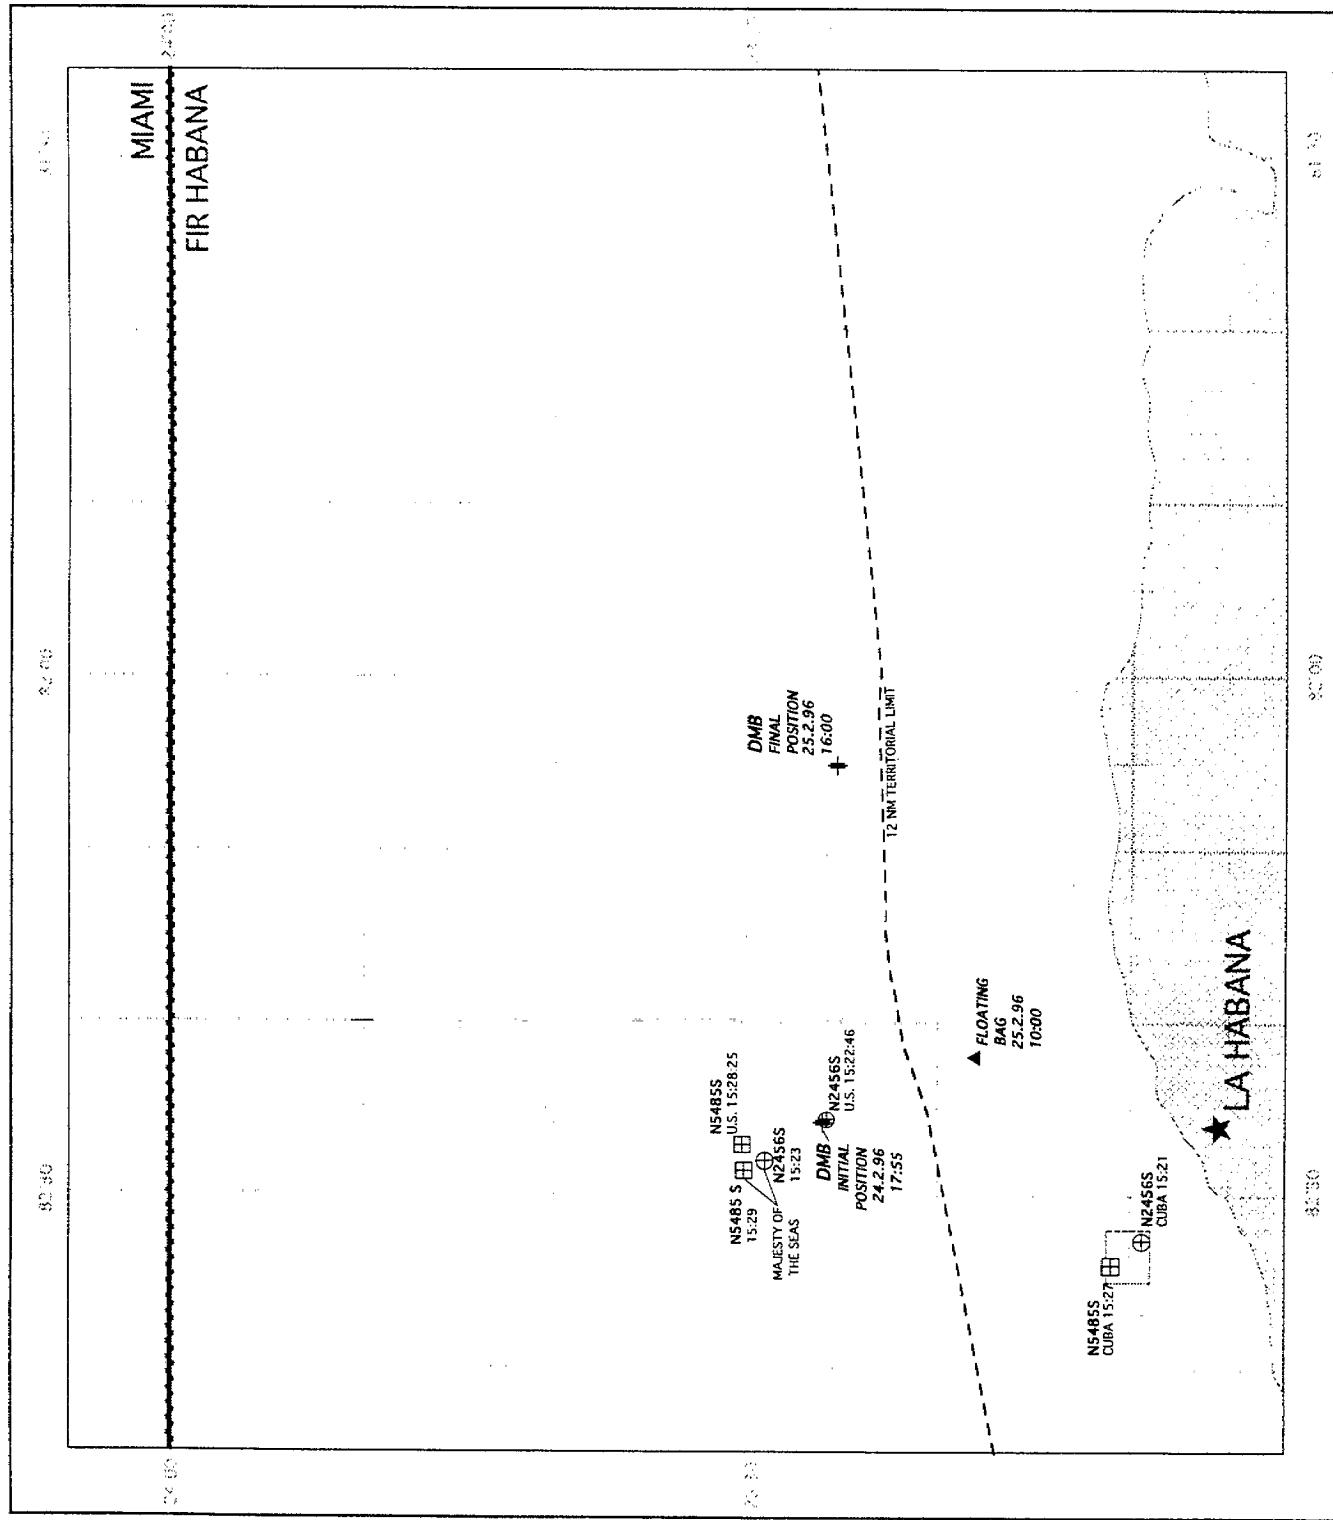
Chart 4 - Positions of the shoot-down of N2456S and N5485S according to Cuban and U.S. radar data, the Majesty of the Seas and the positions of the floating bag and the data marker buoy.

1.14.1      There was no indication of fire in either of the two Cessna aircraft prior to the explosion of the missiles. According to eyewitnesses some burning wreckage was seen falling into the sea and a fair amount of smoke was observed. The smoke was also evident from video recordings made by the pilot of N2506 and by a passenger on board the cruise ship *Majesty of the Seas*.

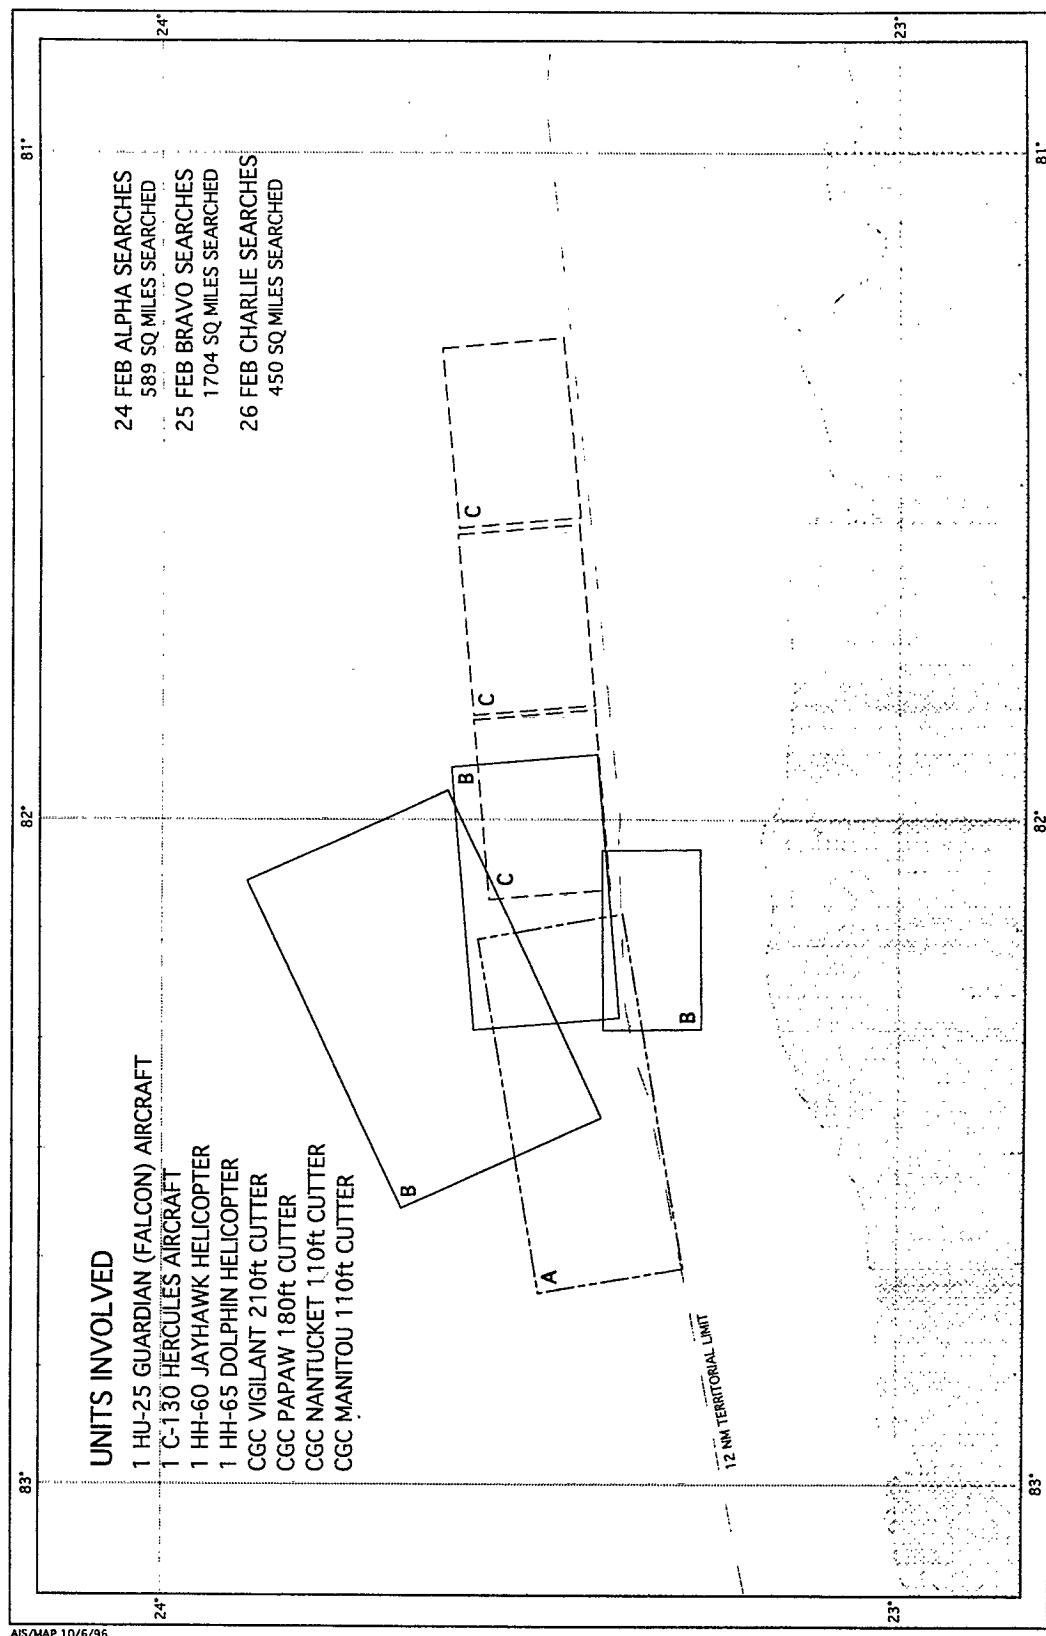
Chart 7 - Search and rescue activities by the United States  
from 24 to 26 February 1996

1.12.2      According to the authorities in the United States involved in the search and rescue effort some floating debris and two oil slicks were spotted in the hours after the shoot-down. However, no debris was later found floating, nor was any debris recovered.

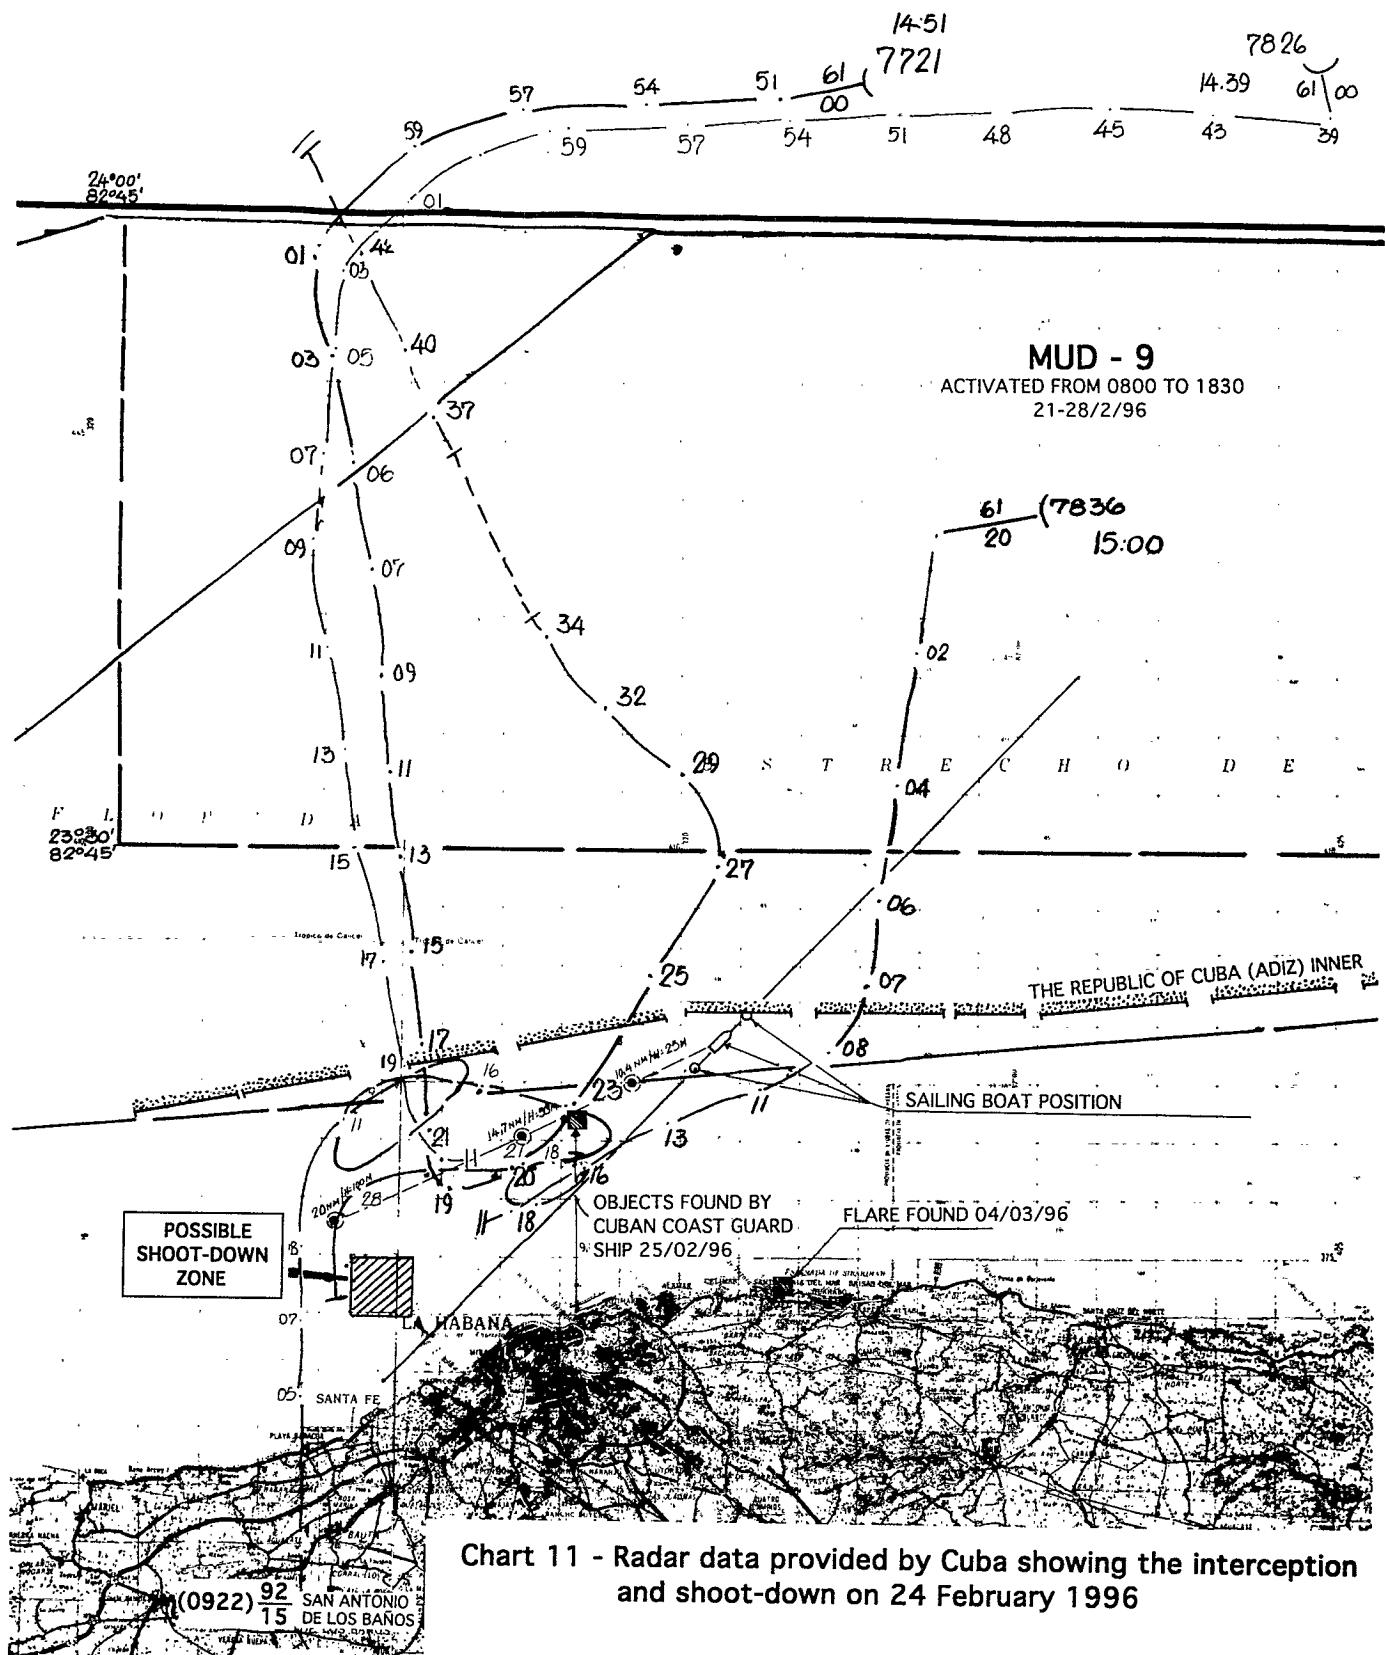
**Chart 11 - Radar data provided by Cuba showing the interception and shoot-down on 24 February 1996**

2.3.5.1.4 The third aircraft (N2456S) was first observed at 15:00 hours at position 23 41N 082 07W, well within the MUD-9 danger area, and heading south. According to the Cuban radar records, this aircraft penetrated the 12 NM Cuban territorial limit at 15:07 hours and continued on a southwesterly track until it was shot down in an area about 5 NM north of Baracoa at about 15:21 hours.

2.3.5.1.5 N2506 and N5485S penetrated the 12 NM limit at about 15:17 and 15:19 hours, respectively. The track of N5485S continued south until this aircraft was shot down in the same area as the first aircraft. N2506 turned northeast at about 15:20 hours and left Cuban territorial airspace at 15:24 hours. At 15:28 hours N2506 turned northwest and crossed the 24N parallel northbound at 15:43 hours at about 082 30W.

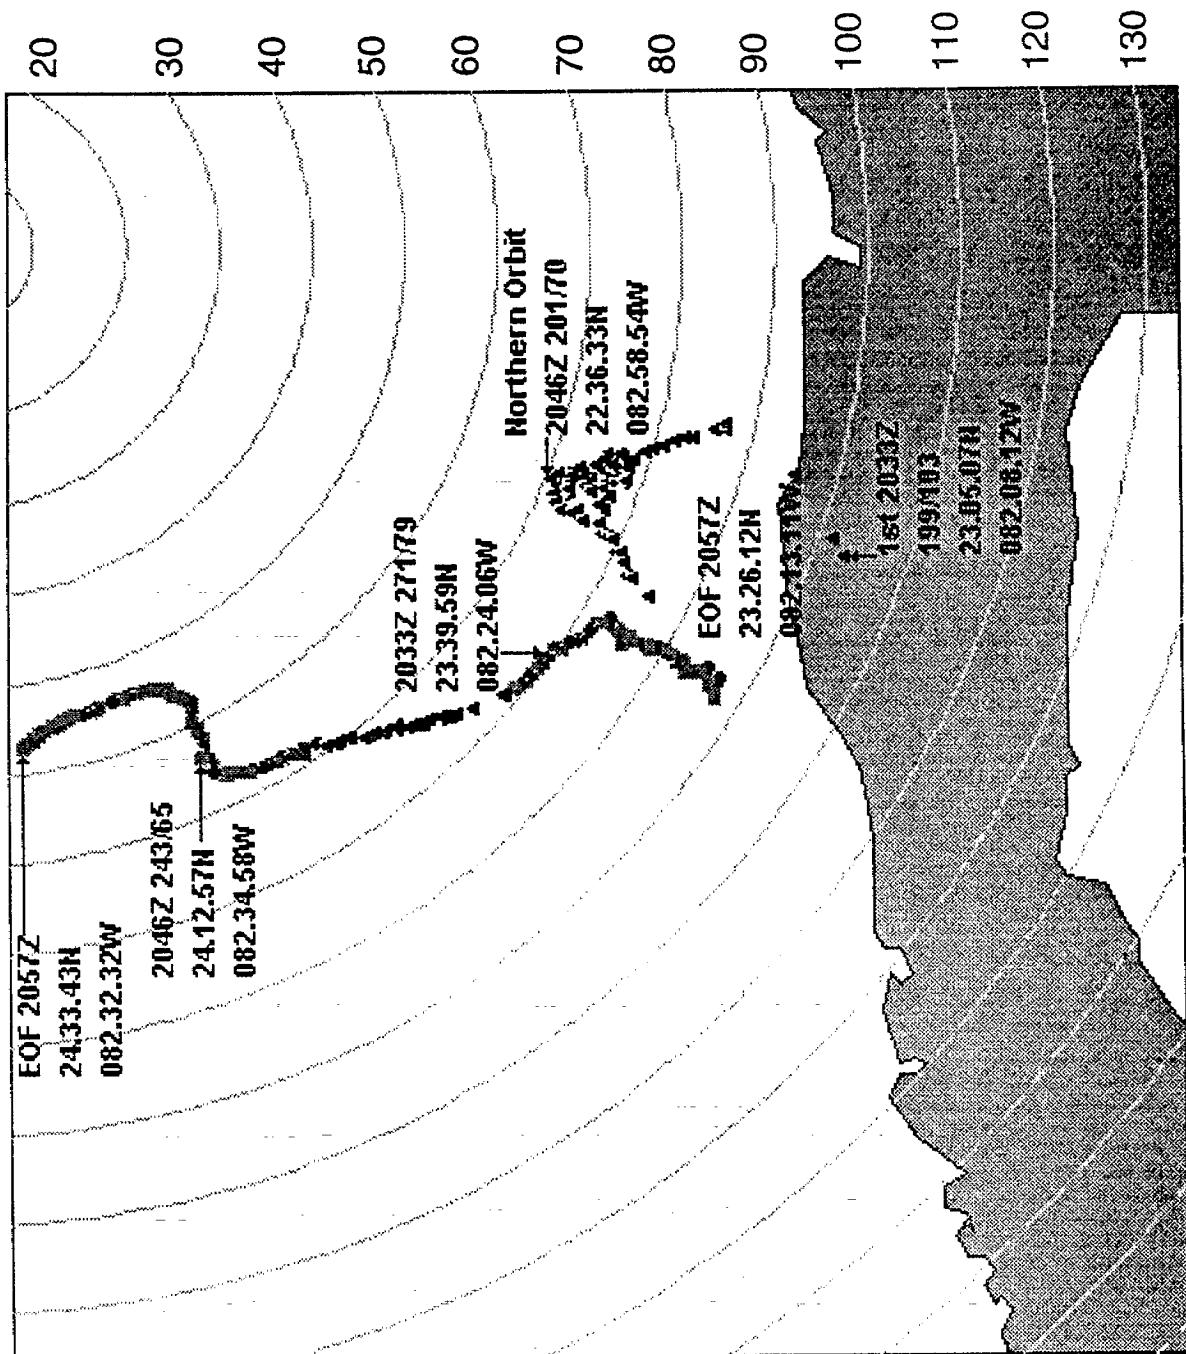
Chart 15 - The return flight of N2506 and the second pair  
of Cuban MiGs as recorded by United States radar

1.1.45 The occupants of N2506 observed a flare and a ball of smoke at 15:28 hours. Subsequently, N2506 called both N5485S and N2456S without success. The pilot decided to leave the area, and he stated that he switched off the transponder and sought cover in scattered clouds. The Cuban radar record showed this aircraft tracking to the north and crossing the 24N parallel northbound at 15:42 hours at 082 25W. The United States radar record also showed a northerly progress; it showed no transponder return for N2506 from 15:33 hours in position 23 41.7N 082 26.0W to 15:42 hours in position 24 02.6N 082 32.2W. This record also showed that N2506 was at a very low altitude until the loss of transponder returns at 15:33 hours; was at 2 900 ft when the transponder returns were again received from 15:42 hours; and was at position 24 13N 082 35W at 15:46 hours.

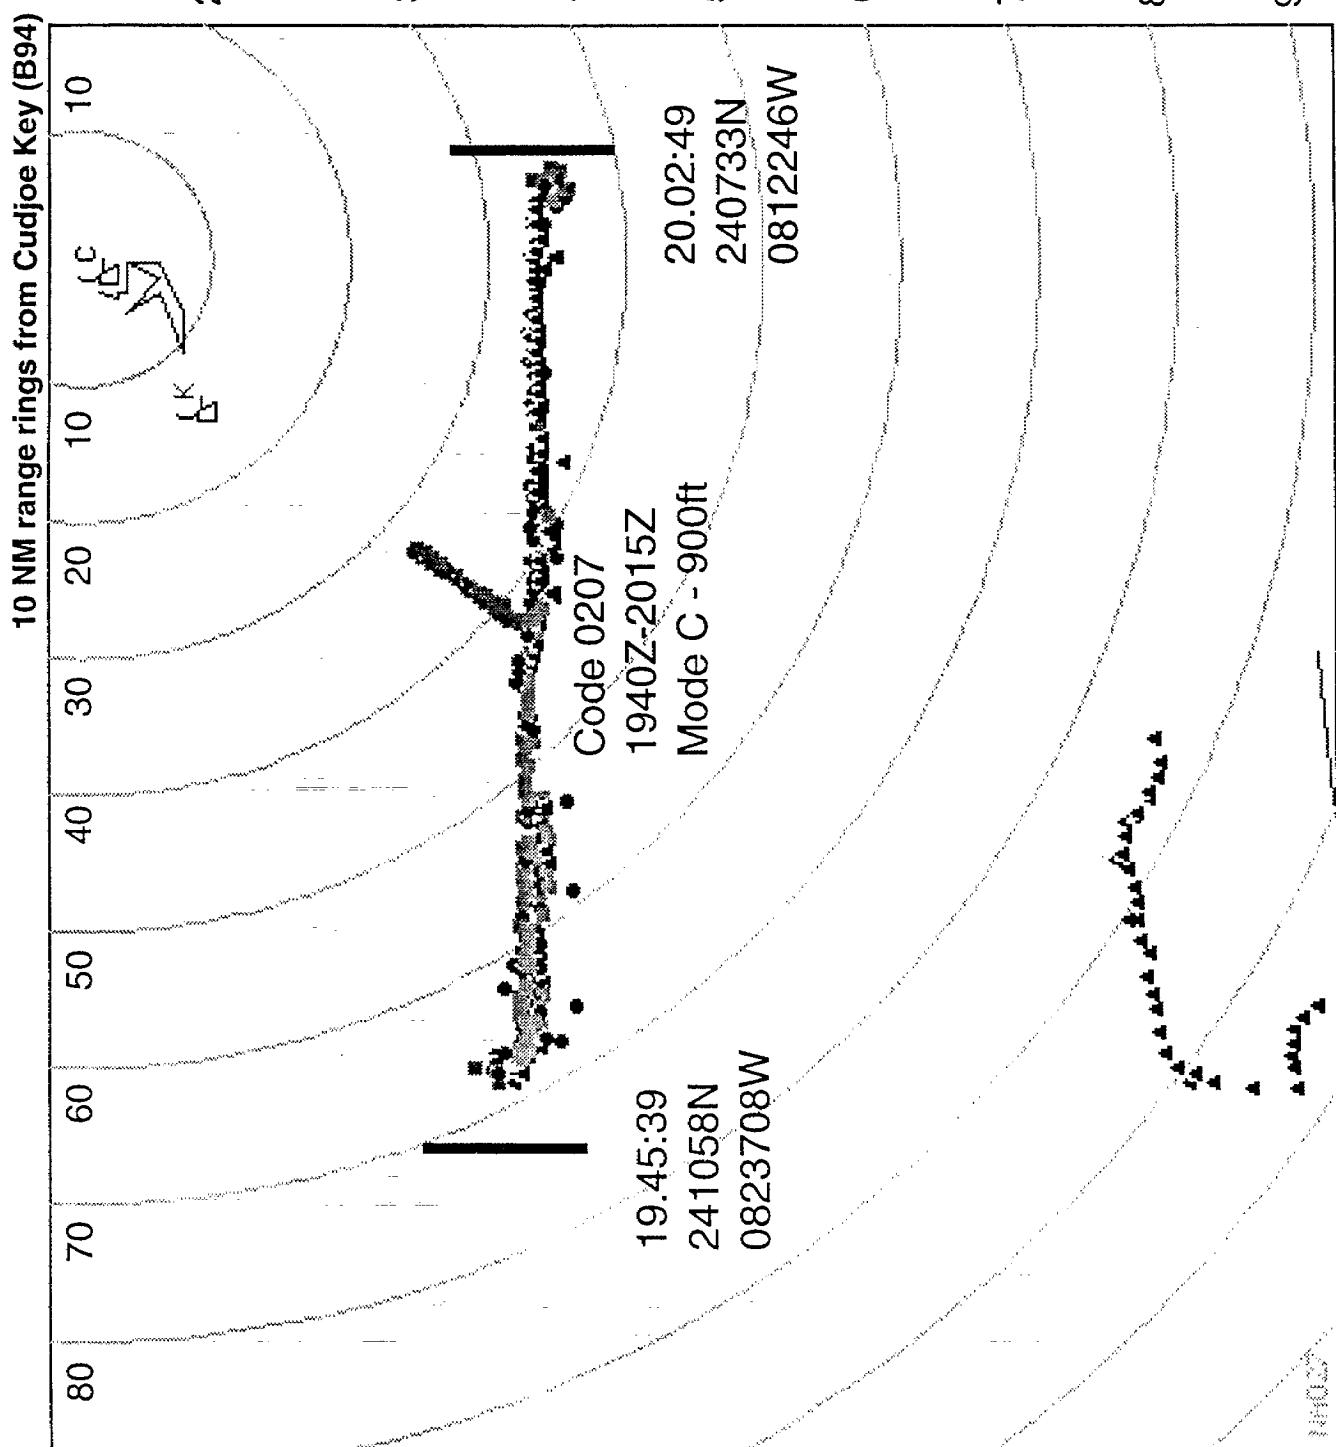
Chart 16 - The flight of US Navy P-3 Orion as recorded by United States radar

"On the afternoon 24 February 1996, the day of the Brothers to the Rescue shootdown by Cuban MiGs, I was the pilot in command of a sonobuoy test flight operating in an area to the SSW of Key West approximately 5 to 8 miles north of the Cuban ADIZ. By mid-afternoon we were conducting a series of range runs which involved flying legs east to west and back at 1 500 feet AGL centred on a previously deployed sonobuoy. After reaching the end of our west bound leg we turned east and proceeded back to the sonobuoy at 250 KIAS, 1 500 feet and on a heading of 090 magnetic. Shortly after commencing this leg the Flight Engineer called traffic at our altitude opposite direction and closing. I sighted 2 small aircraft at our 11 o'clock at our altitude, opposite heading passing to the north at 500 to 1 000 yards. Sufficient separation existed so no evasive action was taken and we continued to complete our range run. We completed one more run to the east side of the buoy, returned to it and departed station to return to base;" and

"At no time did we establish communication with the subject aircraft. We were operating VFR, using a working frequency in the UHF range to maintain communication with the "38" boat which was adjacent to the deployed sonobuoy. We were monitoring UHF guard and heard no traffic calls or any other communication on 243.0 MHz. All of this occurred at the end of a planned 6-hour mission, and since we were approaching our minimum recommended fuel reserve of 8 000 lbs we proceeded directly to NAS Key West after checking off station with the "38" boat. During the flight we were in communication with Miami Center, Key West Departure and Approach control and NAS Key West tower during transit to and from our operating area. From time of sighting the aircraft until touchdown was approximately 30 minutes."
