Technical service bulletin Pressure Sensor Maintenance

Buderus

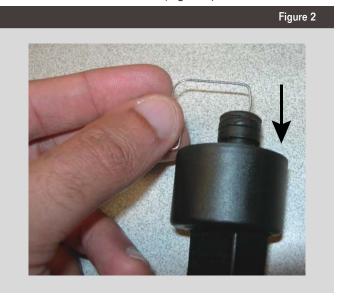
Pressure sensor (Part No. 8718600019) is giving erratic pressure readings or is reading P00.

Debris build up from system water may have clogged/ blocked opening of sensor.

Blockage must be cleared for sensor to operate properly.

- Shut off boiler switch.
- 2. Close supply and return valves on the boiler manifold.
- Open the drain valve on the manifold and relieve all pressure on the boiler.
- 4. Remove Pressure Sensor
 - a. Behind the sensor is a brass clip, hold sensor and pull the clip then remove the sensor. (Figure 1)
