BMW 3-Series (92-98) & Z3 (96-98) Haynes Online Manual

## Engine Bearing Analysis

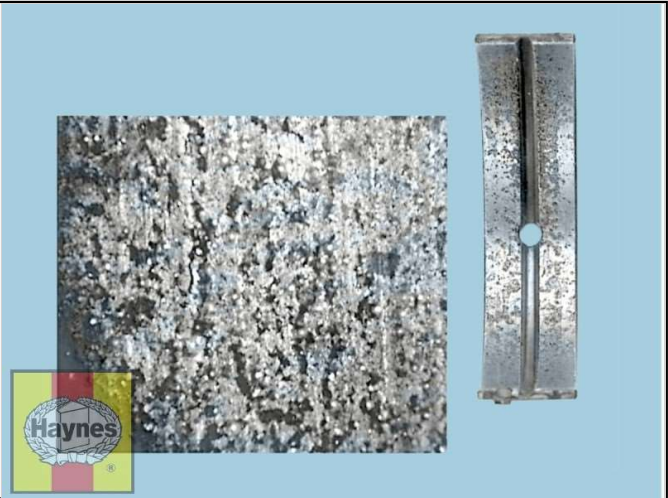
**Aluminum bearing embedded with glass beads. Microscopic detail of glass beads.**

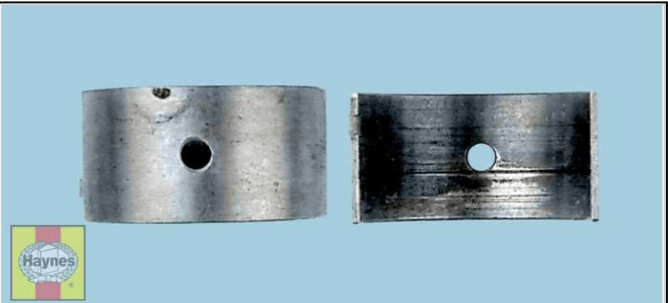
**Damaged lining caused by dirt left on the bearing back.**

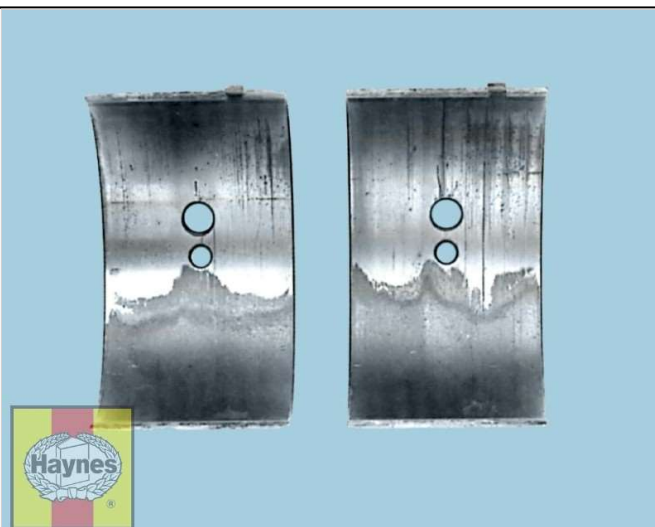
**Damaged upper connecting rod bearings caused by engine lugging; the lower main bearings (not shown) were similarly affected**

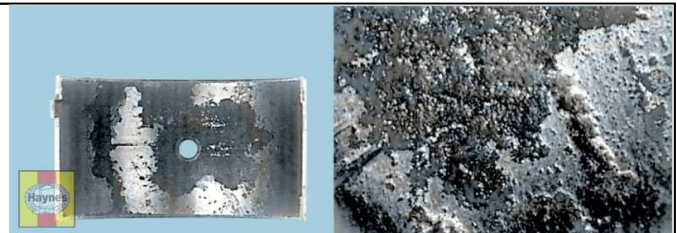
**Corrosion is an acid attack on the bearing lining generally caused by inadequate maintenance, extremely hot or cold operation, or inferior oil or fuels. Microscopic detail of corrosion**

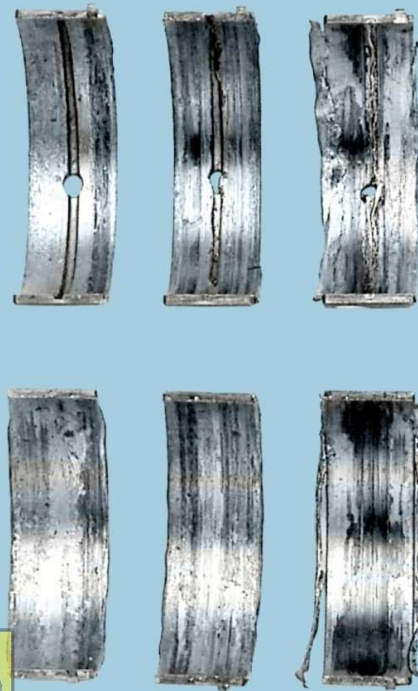
**Result of a low oil supply or oil starvation**

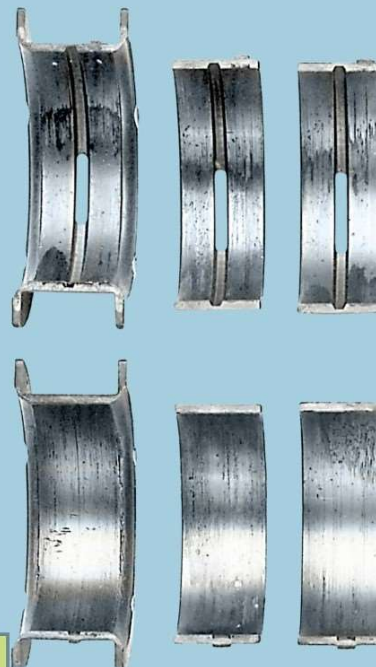
**Severe wear as a result of inadequate oil clearance**
