### NATIONAL TRANSPORTATION SAFETY BOARD

# GROUP CHAIRMAN'S FACTUAL REPORT ADDENDUM 2

# REPORT BY RONALD A. HESS "AN INQUIRY INTO WHETHER A PILOT-INDUCED OSCILLATION WAS A FACTOR IN THE CRASH OF AMERICAN AIRLINES FLIGHT 587"

Time: 0916 eastern standard time Aircraft: Airbus A300-600, N14053 NTSB Number: DCA02MA001

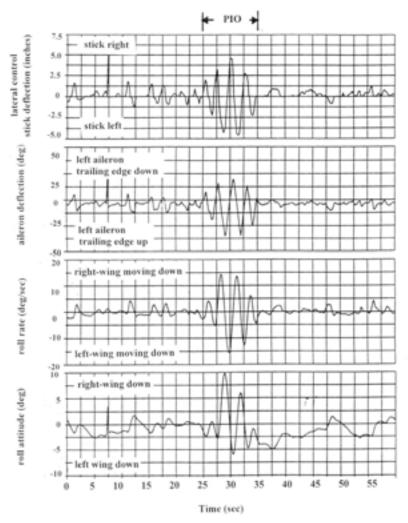
These oscillations are distinguished from the other control/response oscillations by their magnitude and regularity. As Fig. 1 indicates, the PIO was effectively eliminated by the pilot sharply reducing lateral stick inputs from t = 35 sec to t = 42.5 sec.

The oscillations apparent in Fig. 1 may appear at first glance to be little more than a transitory annoyance. However one must realize that, in the 10 sec period in which the oscillations are apparent, the pilot has effectively lost control of the aircraft. The fact that the incident occurred in a landing approach obviously made it quite dangerous. In an environment in which large dynamic pressures<sup>1</sup> are in evidence, a PIO can lead to structural failure. One such event occurred at White Sands NM on May 18, 1961. An Air Force F-4 fighter aircraft was attempting to set a low-altitude 3 kilometer speed record. A longitudinal PIO developed in the attempt and the aircraft disintegrated due to the extreme aerodynamic forces caused by high-dynamic pressure [3].

Figure 1 C-17 lateral-directional PIO

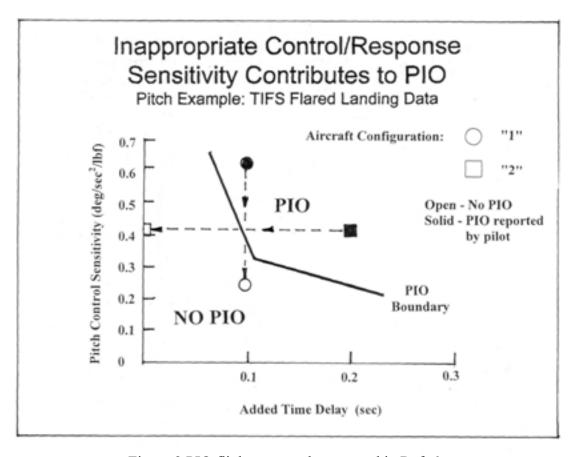
A useful example of a control system characteristic conducive to a PIO is provided by Fig. 2. This figure, adopted from Ref. 6, portrays a subset of results from a series of flight tests conducted with a large variable stability aircraft that concentrated on the pitch axis. The flight condition was landing approach. Two different vehicle configurations are shown in Fig. 2, defined respectively as "1" and "2". For Config. 1, the pitch control sensitivity was varied from approximately 0.6 to 0.25 (deg/sec² of aircraft pitch acceleration per lbf of column force) with 0.1 sec added time delay in the pitch-attitude control loop. For Config."2" an added control system time delay was varied from approximately 0.2 to 0 sec with a constant pitch control sensitivity of approximately 0.42 deg/sec²/lbf. The solid symbols indicate that PIOs occurred in flight with the particular time delays and sensitivities indicated, while the open symbols indicate that no PIO occurred. The combinations of time delay and sensitivity that define the solid symbols would clearly constitute control system characteristics conducive to PIOs. The large font legend at the top of the figure is taken directly from Ref. 6 and emphasizes the role that control sensitivity can play in PIOs.

Figure 2 PIO flight test results reported in Ref. 6.

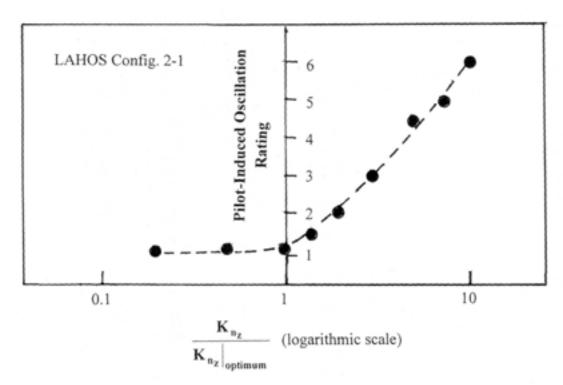
Figure 3 Effect of varying control sensitivity on the PIO susceptibility of a fighter aircraft

Figure 3 clearly shows that by increasing the control sensitivity, alone, an aircraft with exceptional handling qualities (Cooper-Harper rating of 2.0 and PIOR of 1) can be made to be very PIO prone (PIOR of 6). The results of Fig. 3 are for a fighter aircraft. However, the authors of Ref. 7 go on to state the following:

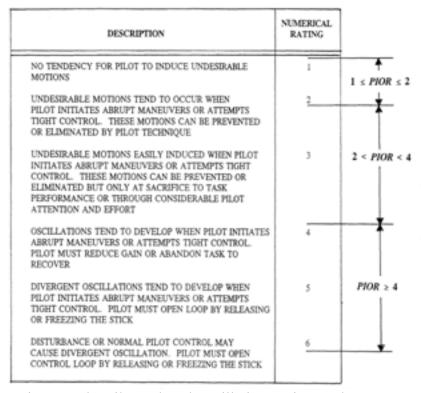
Figure 4 The Pilot-Induced Oscillation Rating Scale

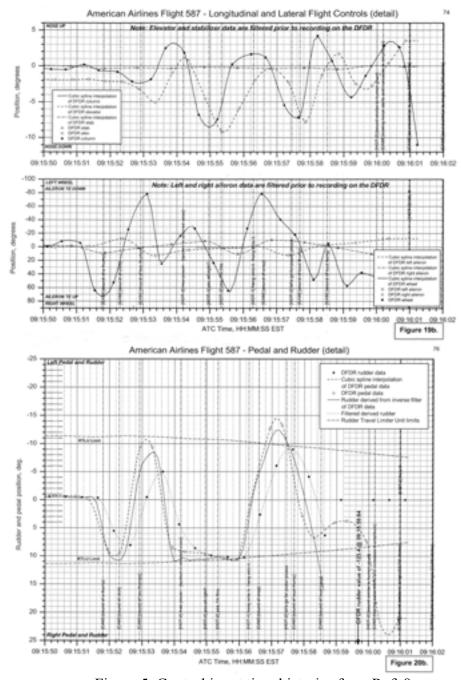
Figure 5 Control input time histories from Ref. 8

An examination of the FDR time histories from Ref. 8 clearly indicates that oscillatory pilot/vehicle responses were in evidence after the second wake encounter. This is particularly true for the control inputs (wheel, column and rudder). Figure 5 is taken from Ref. 8 and shows these inputs. With the possible exception of the constant and maximum right pedal input occurring from 9:15:54 to 9:15:56, continuous oscillation of the cockpit controls are in evidence. The column inputs exhibit an approximate frequency of 0.46 Hz (2.89 rad/sec). The regularity of the wheel input is affected by the constant pedal input evident in Fig. 5. Focusing upon the wheel inputs before the constant pedal input was initiated at 9:15:54, one can approximate a frequency of oscillation of 0.54 Hz (3.43)

rad/sec). Identifying a pedal frequency of oscillation is somewhat problematic because of the aforementioned 2 sec "hard-on-stop" behavior of the pilot. However, an approximate 0.5 Hz (3.142 rad/sec) frequency can be gleaned for one cycle before the aforementioned 2 sec amplitude limit. The fact that a "pure" sinusoidal frequency is absent from these time histories should not necessarily preclude describing this incident as a PIO. The necessity of having to approximate a PIO frequency in such incidents is not uncommon [3].

A plausible triggering event can be established in the accident, namely, the large cockpit lateral accelerations that occurred immediately after the pilot initiated pedal inputs. Depending upon the methodology used to calculate the cockpit accelerations, Ref. 8 indicates an initial maximum lateral acceleration approaching 0.5 g's (nose right) occurring about 0.2 sec after the pedal was driven to its limit (right pedal) for the first time. This is a large acceleration for a transport aircraft of this size. It is likely that the impetus behind the large wheel and pedal inputs that produced this triggering event was the PF's desire to bring the aircraft to a wing's level attitude after the initial vertical and roll accelerations in the second wake encounter. It is likely that both wheel and pedal inputs were employed with this goal in mind. Recall that these initial accelerations were in a sense that would increase the 25 deg left bank that the aircraft was experiencing at the time.

It is apparent from Fig. 5, that column inputs as well as wheel and pedal inputs were applied in the moments before the loss of the vertical stabilizer on AA 587. It is possible that such a longitudinal-axis PIO was triggered by vertical accelerations that occurred when the wing spoilers were brought into play to assist the ailerons. The spoilers on the A300-600 are employed to increase roll control power when wheel inputs exceed certain magnitudes. As opposed to aileron deflections, spoiler deflections can sharply reduce the overall lift that an aircraft is developing. This loss of lift would, in turn, induce Significant column inputs do not appear until aircraft vertical acceleration. approximately 9:15:54, some three seconds after the initiation of large wheel inputs. At approximately 9:15:54, the average normal load factor in the cockpit drops well below the 1g level to approximately 0.58 g's and remains there. This is indicated in Fig. 7, taken from Ref. 8 and annotated for emphasis. Other sources of this normal load factor decrement are, of course, possible. Among these are changes in angle of attack and sideslip. Figure 12b in Ref. 8 shows an angle of attack reduction also occurring in the same time frame.

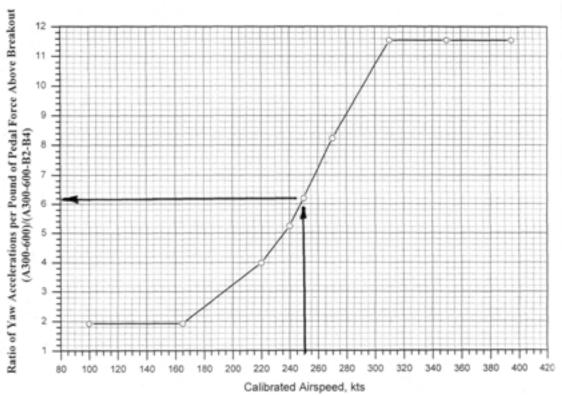
Figure 6 The ratio of yaw accelerations per pound of pedal force at 40 lbf (A300-600)/(A300-600-B2-B4)

A final comparison can be made between the A300-600, and its predecessor series, the A300-600B2 and A300-600B4. As Table 1 indicates, the latter series exhibited much less pedal/rudder sensitivity, and exhibited values comparable to the B767. The A300-600 rudder/pedal sensitivity is over ten-times greater than the A300-600B2 and A300-600B4B4. An additional graphical comparison can be made showing the ratio of yaw acceleration induced per pound of pedal force above breakout for the A300-600 and A300-600-B2 and A300-600B4 series aircraft. This is shown in Fig. 6 below and is based upon a 40 lbf pedal input. The solid vertical line indicates the airspeed appropriate for the AA 587 accident. Note that at this airspeed, the A300-600 exhibits over six times the yaw acceleration per pound of pedal input of the A300-600B2 and A300-600B4 series.

The sensitive nature of the rudder/pedal system is a plausible candidate for a control system property conducive to a PIO and exposed by the triggering event defined in Section III.B.2. The muscles used by a pilot to move the pedals are among the most powerful in the human body, namely the *vastus lateralis*, a member of the *quadriceps* group [9]. It is estimated that a pilot can exert over 400 pounds of force to rudder pedals using these muscles [10]. The greater muscle size, however, comes at the expense of sensitivity, i.e. the ability of the human to accurately command relatively small forces. In addition, the rudder is probably the most powerful aerodynamic surface on the A300-600. It constitutes 30% of the area of the entire vertical stabilizer, itself nearly 490 ft<sup>2</sup> in area [11]. The rudder in the A300-600, as in any conventionally configured aircraft, can induce moments about two axes, roll and yaw. Thus, one has a very powerful aerodynamic surface with multi-axis control authority activated by one of the most powerful muscles in the human body commanding a pedal/rudder system that is considerably more sensitive than that of any comparable aircraft.

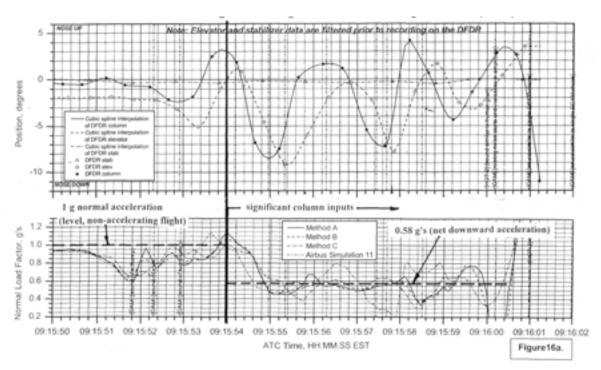
Figure 7 Comparison of column inputs and normal load factor in cockpit from Ref. 8

Thus, a second triggering event, a large change in normal load factor at the cockpit, likely induced a longitudinal PIO that involved oscillatory column inputs. It may have been the spoiler deflections caused by the PF's *lateral-directional PIO* that induced these "triggering" normal accelerations. Thus pedal/rudder sensitivity remains as the control system property conducive to a PIO.

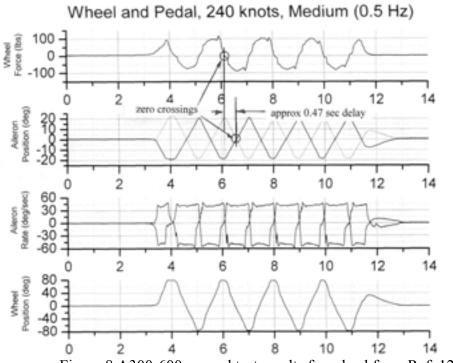
Figure 8 A300-600 ground test results for wheel from Ref. 12

Figure 8 shows the applied wheel force, resulting aileron deflection, and aileron rate when both the wheel and pedal are oscillated at a frequency of 0.5 Hz and full wheel and pedal throw is required (pedal data is not shown). The figure clearly shows that the aileron actuator is under nearly constant rate saturation. This means the actuator is moving the aileron at the maximum rate possible, here  $\pm$  45 deg/sec. Rate saturation can adversely effect aircraft stability, e.g. [3], [5] and [14]. The reason that actuator rate saturation can be destabilizing is also shown in Fig. 8. By comparing the time that elapsed between corresponding "zero crossings" of the *force* applied to the wheel and aileron motion, an effective time delay of over 450 milliseconds can be seen for this run.

Ideally, the aileron and applied wheel force would pass through their zero or null values simultaneously. This would indicate that the aileron is following wheel force inputs with no lag or time delay. In reality, of course, some lags do occur due to the dynamics of

both the cockpit force/feel system and the actuator itself. However values of over 450 milliseconds would be considered very large, even for an aircraft the size of the A300-600. When the command oscillation frequency was reduced to 0.25 Hz, with the full-throw requirement was still in effect, minimal aileron actuator rate limiting was noted and the apparent time delay between wheel force inputs and aileron deflection was reduced to a much smaller value. Similar, albeit smaller, delays occurred with pedal inputs as can be gleaned from Fig. 9.

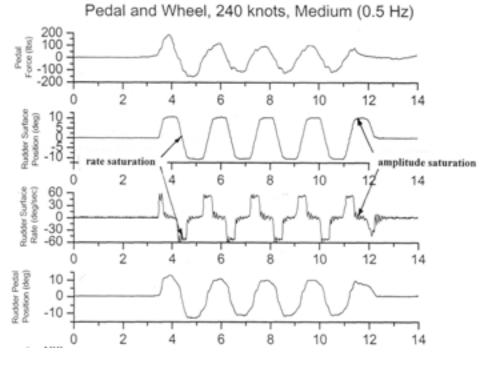
Figure 9 A300-600 ground test results for pedal from Ref. 12

The experiments of Ref. 13 also indicated that the maximum forces that the subjects applied to the wheel and pedals in the 240 kt, 0.5 Hz, full-displacement experiments significantly exceeded those required to move the controls to their full displacement in a quasi-static condition. Again, this can be seen from Figs. 8 and 9. The maximum pedal forces also significantly exceeded those for the wheel despite the fact that the forces required for both in a quasi-static condition are nearly equal. One plausible explanation for the increased forces in both cases is that the pilot valves in the actuators were hitting their travel limits during the periods that the actuators were rate saturated. Also note that the nature of the rate saturation is significantly different between Figs. 8 and 9. In Fig. 8 the aileron actuator remains in nearly constant rate saturation, but only briefly amplitude saturates (reaches the limits of its travel). In contrast, Fig. 9 shows the rudder actuator quickly amplitude saturating after brief periods of rate saturation. These characteristics could again be attributed to the sensitivity of the pedal/rudder system. That is, rather than the smooth, albeit rate-saturated movement of the aileron, the rudder quickly amplitude saturates and remains amplitude saturated for about 0.6 secs in each half cycle in an "onoff' type of movement.

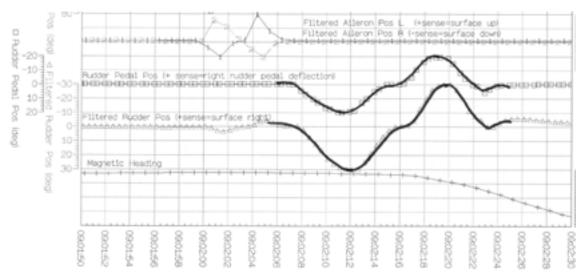
Figure 10 AA 587 preflight control checks showing slow rudder check

The only significant use of pedal inputs previous to the oscillation that began at 9:15:52 occurred while taxiing to takeoff position. At approximately 9:02:06 the PF initiated a very slow "rudder check" that lasted nearly 20 sec and involved full pedal motion (which in this condition was  $\pm$  30 deg, three times the maximum displacement available at 240 kts). This is shown in Fig. 10. The pedal and rudder displacements have been highlighted in this figure. The maximum force in this quasi-static movement was probably 65 lbf .
