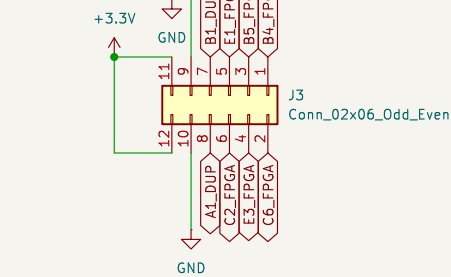
Problematic - 8 9 11 12
