ADA Curb Ramp New Construction Inspection Form (Perpendicular)

WASHINGTON COUNTY OREGON

North-South Road Name	Project No.	Sheet No.	Intersection No.	East-West Road Name
Nw 289th	24952.54			Nw union

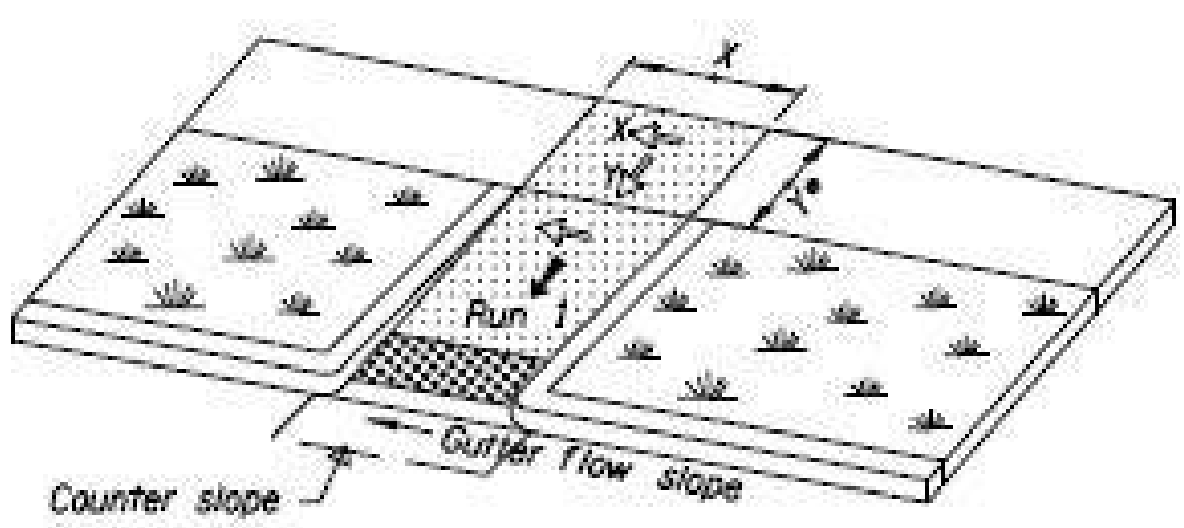
PERPENDICULAR RAMP (PR)

Item	Value	Pass		Fail	
Running Slope 1		≤ 8.3%	☐	>8.3%	☐
Length 1	4.5				
Cross Slope 1		≤ 2.0%	☐	>2.0%	☐
Detectable Warning (Y,N)		Y	☐	N	☐
Lip Height		1/4"	■	>1/4"	☐
Gutter Flow Slope	2	≤ *	■	>*	☐
Curb Running Slope (avg) (N/A ☐)	1.08	≤ 8.3%	☐	>8.3%	☐
Counter Slope (+/-) *2	5.5	≤|5.0%|	■	>|5.0%|	☐
Longest distance from corner to back of curb (see dwg on BT form)	0.55	< 5.0'	■	≥ 5.0'	☐
Detectable warning extends full width of ramp throat opening		Y	☐	N	■

Item	Value	Pass		Fail	
Width X	5.0	≥ 4.0'	■	< 4.0'	☐
Length Y	5.2	≥ 4.0'*1	■	< 4.0'*1	☐
Back of Ramp Obstruction (Y/N)		≥ 5.0'*1	■	< 5.0'*1	☐
Slope X	2.3	≤2.0%	☐	>2.0%	■
Slope Y		≤2.0%	☐	>2.0%	☐

IITD, RR 1 fail
