## Headlamp Aim Research Project

## **HGV and PSV Headlamp Aim Testing**

A report produced by Testing Standards Policy and Strategy

July 2004

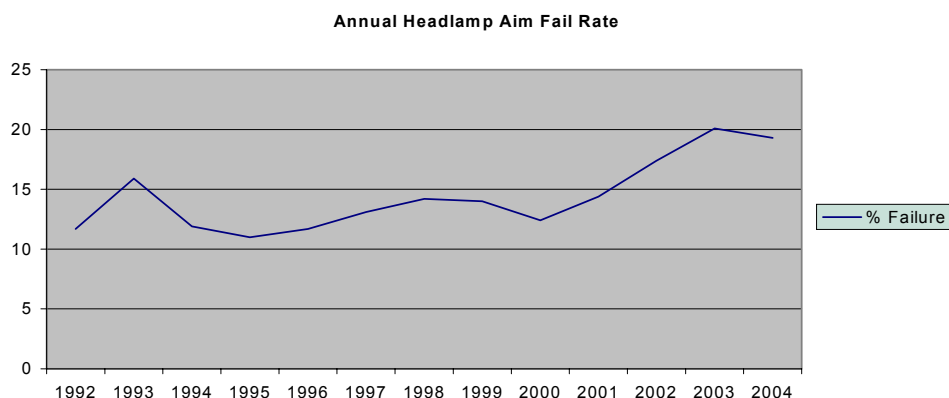
6. The table shows that the headlamp aim failure rate has effectively doubled in the last decade. The failure rate for PSV's over the same period shows a broadly similar trend.
7. In order to address the concern, VOSA has conducted project and survey work looking at vehicle construction features, vehicle loading, fitter & driver competence, tester training, equipment and the test standards.

4. In 1989 the Transport and Road Research Laboratory (TRRL) conducted a roadside survey of vehicle lighting (Research Report 290 – J.Cobb B.Sc.). TRRL concluded that as many as 1 in 5 truck drivers would not be able to stop in the distance they could see illuminated ahead. This was because headlamps were aimed too low and/or too far to the left. At that time headlamp aim would only fail at annual test for being high or too far to the right. Consequently, a new headlamp aim standard introduced additional lower and left limits.
5. From 1992 (the earliest headlamp aim data available in VOSA – see table below) the headlamp aim failure rate for trucks has ranged from 11% (1994/95) to 20.1% (2002/03). In 2002/03 and 2003/04 the truck headlamp aim failure rates were 20.1% and 19.3% respectively.
