**SOIL ENGINEERING INVESTIGATION
PROPOSED ADU
AT
510 E SANTA PAULA STREET
SANTA PAULA, CALIFORNIA
FOR
BIRD**

The report is for a soil engineering investigation for the proposed ADU. The project is located at 510 E Santa Paula Street, Santa Paula, California.

There is anticipated to build a 2 story ADU residence. The structure will be of wood frame construction. Concrete slabs on grade will be used. The building will be placed near existing grade. Some minor grading will be done. Light loads are anticipated. No basement is intended. Retaining walls are not anticipated. Public sewers will be used.

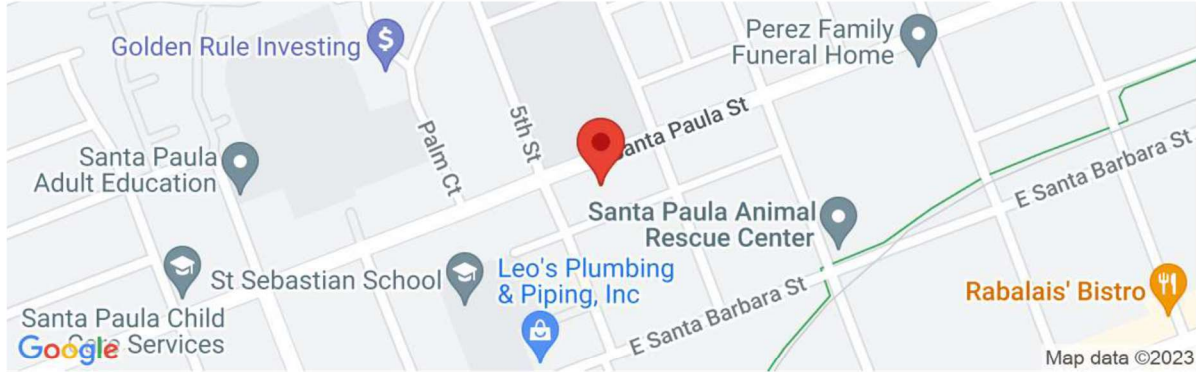
Date	8/16/2023, 11:11:01 AM
Design Code Reference Document	ASCE7-16
Risk Category	II
Site Class	D - Stiff Soil

Type	Value	Description
S_S	1.964	MCE_R ground motion. (for 0.2 second period)
S_1	0.75	MCE_R ground motion. (for 1.0s period)
S_{MS}	1.964	Site-modified spectral acceleration value
S_{M1}	null -See Section 11.4.8	Site-modified spectral acceleration value
S_{DS}	1.309	Numeric seismic design value at 0.2 second SA
S_{D1}	null -See Section 11.4.8	Numeric seismic design value at 1.0 second SA

Type	Value	Description
SDC	null -See Section 11.4.8	Seismic design category
F_a	1	Site amplification factor at 0.2 second
F_v	null -See Section 11.4.8	Site amplification factor at 1.0 second
PGA	0.87	MCE_G peak ground acceleration
F_{PGA}	1.1	Site amplification factor at PGA
PGA_M	0.957	Site modified peak ground acceleration
T_L	8	Long-period transition period in seconds
S_{sRT}	1.964	Probabilistic risk-targeted ground motion. (0.2 second)
S_{sUH}	2.225	Factored uniform-hazard (2% probability of exceedance in 50 years) spectral acceleration
S_{sD}	2.704	Factored deterministic acceleration value. (0.2 second)
S_{1RT}	0.75	Probabilistic risk-targeted ground motion. (1.0 second)
S_{1UH}	0.849	Factored uniform-hazard (2% probability of exceedance in 50 years) spectral acceleration.
S_{1D}	0.864	Factored deterministic acceleration value. (1.0 second)
PGA_d	1.092	Factored deterministic acceleration value. (Peak Ground Acceleration)

PGA_{UH}	0.87	Uniform-hazard (2% probability of exceedance in 50 years) Peak Ground Acceleration
C_{RS}	0.882	Mapped value of the risk coefficient at short periods
C_{R1}	0.884	Mapped value of the risk coefficient at a period of 1 s
C_v	1.493	Vertical coefficient

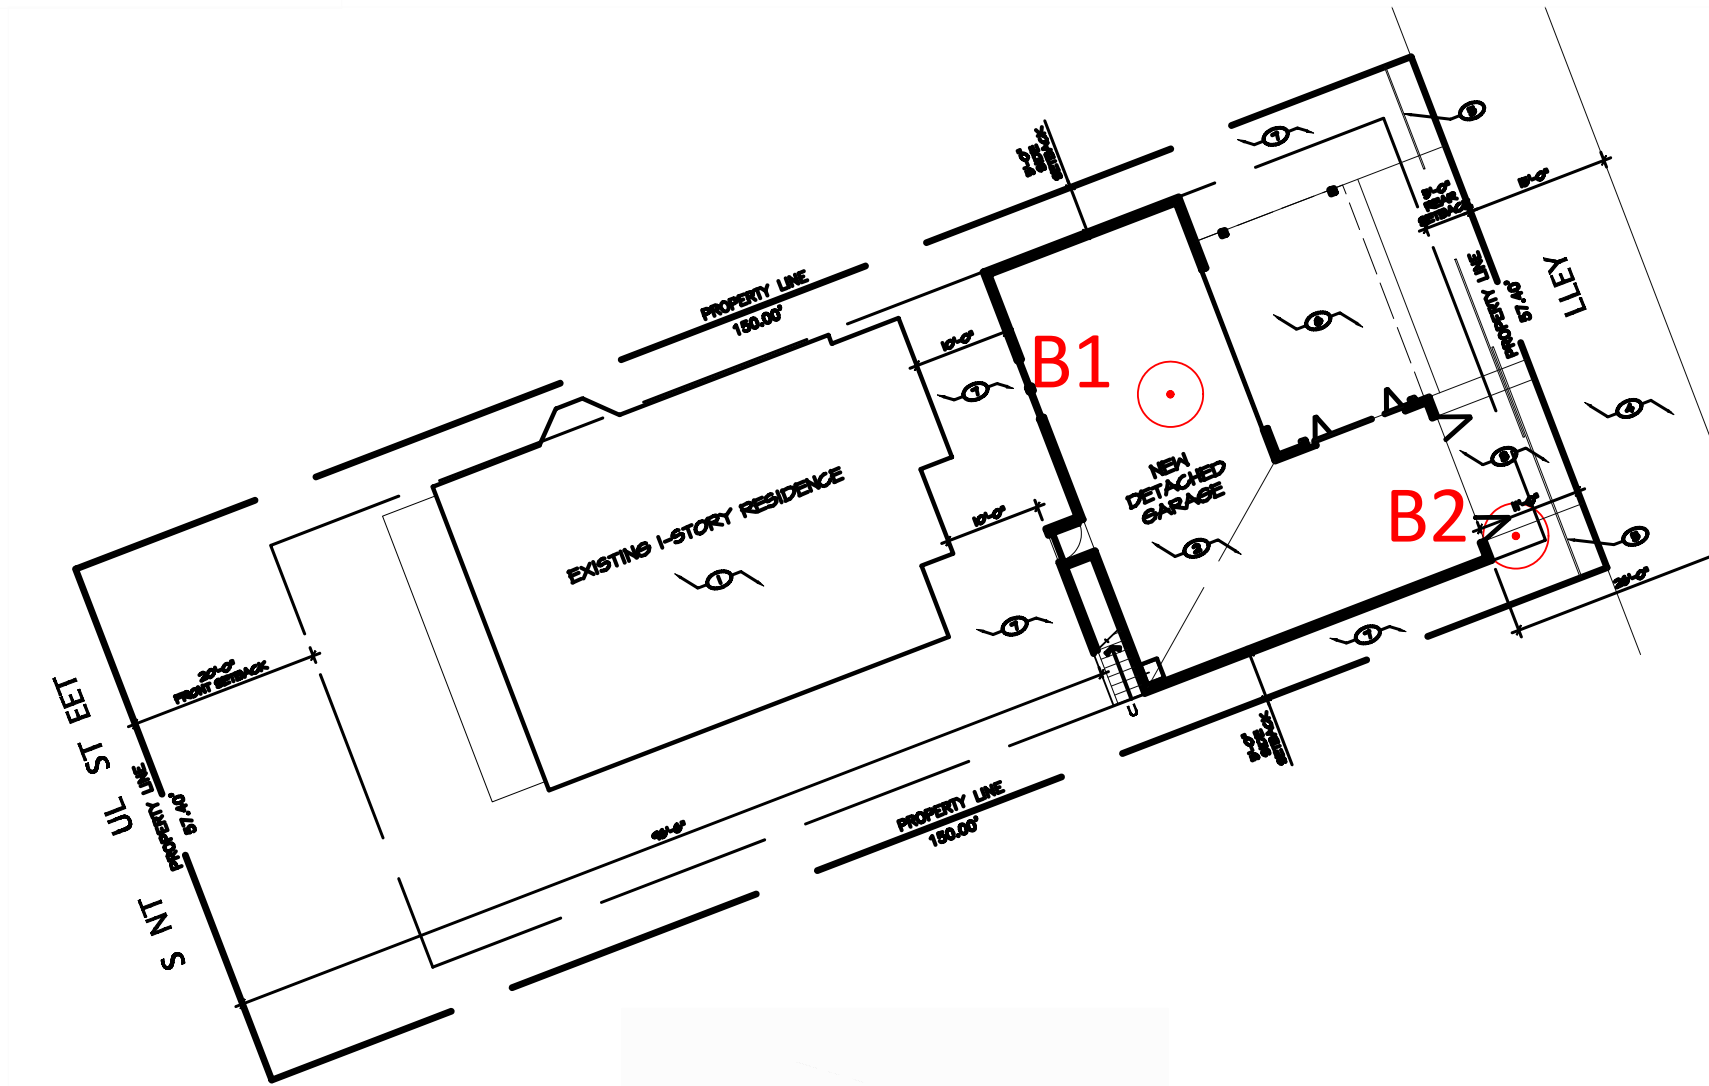
STANDARD PEN (blows per foot)	MOISTURE CONTENT (% of dry weight)	DRY DENSITY (lbs. per cubic foot)	DRIVE ENERGY (kip-feet)	ELEVATION (feet)	DEPTH (feet)	SAMPLE LOCATION	BORING 1	
	5.6	94	5				JOB: 23114	
	13.0	99	7				FIELD ENGINEER: FRED HEATHCOTE	
			18				DATES DRILLED: JULY 25, 2023	
							DRILLING EQUIPMENT: 8-INCH HOLLOW STEM AUGER	
							ML	CLAYEY SILT- mod compacted, brown, damp
								mod firm

The upper natural soils are clayey silts. The soils are moderately loose in the upper 4 feet. These soils are compressible and have a medium expansion potential.
