WASHINGTON COUNTY OREGON

ADA Curb Ramp New Construction Inspection Form (Perpendicular)

North-South Road Name	Project No.	Sheet No.	Intersection No.	East-West Road Name
317	24952.54			Timeric

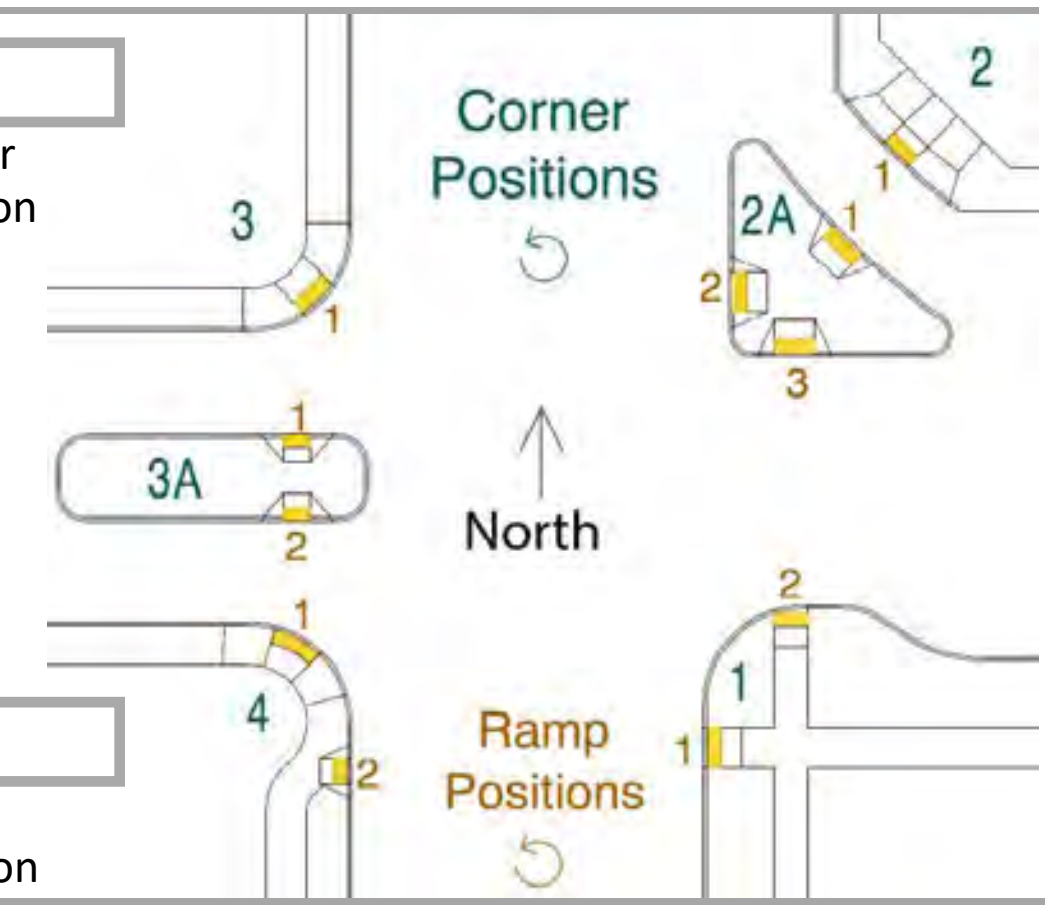
Corner Position: 2

RAMP RUN 1	Value		Pass		Fail	
Running Slope 1	7.4	≤ 8.3%	■	>8.3%	☐
Length 1	4.4					
Cross Slope 1	1.1	≤ 2.0%	■	>2.0%	☐
Detectable Warning (Y,N)	Y	Y	■	N	☐
Lip Height	0	1/4"	■	>1/4"	☐
Gutter Flow Slope (N/A ☐)	0.6	≤ *	☐	>*	☐
Curb Running Slope (avg)	0.64	≤ 8.3%	☐	>8.3%	☐
Counter Slope (+/-) *2	5.4	≤|5.0%|	☐	>|5.0%|	■
Longest distance from corner to back of curb (see dwg on BT form)		< 5.0'	■	≥ 5.0'	☐
Detectable warning extends full width of ramp throat opening	Y	Y	■	N	☐

CS fail in middle
