DTC	B11 <u>9</u> 8/76∏	Short[in[Rear[P/T[\$quib[(LH)[Circuit[(to B+)
		$\mathbf{D}^{T}$

# **CIRCUIT** DESCRIPTION

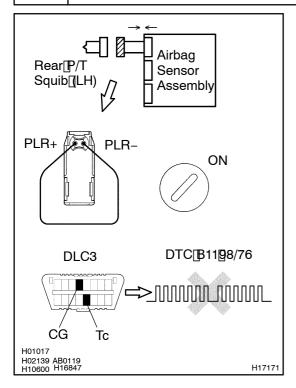
- (a) Turn the ignition switch to ON.
- (b) For the connector (on the rear seat belt pretensioner side) between the rear seat belt pretensioner (LH) and the airbag sensor assembly, measure the voltage between PLR+ and body ground.

Voltage: 0 V

Repair or replace harness or connector between rear seat belt pretensioner (LH) and airbag sensor assembly.

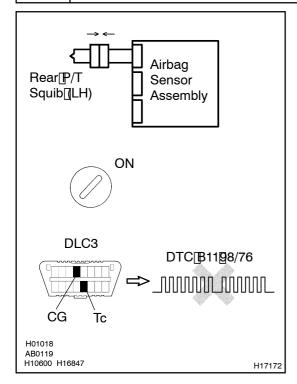
- (a) Turn[the[ignition]switch[to[ON]and[wait[at]]east[for[20]seconds.
- (b) Clear[the[DTC[stored[in[memory[(See[step[5]]pn[page DI-484).
- (c) Turn the ignition switch to LOCK, and wait at least for 20 seconds.
- (d) Turn the ignition switch to ON, and wait at least for 20 seconds.
- (e) Check[he[DTC[See[page[DI-484]].

# DTC B1198/76 is not output.

Replace airbag sensor assembly.
