# Release Notes

## Polycom® RealPresence® Group Series, Version 4.0.2

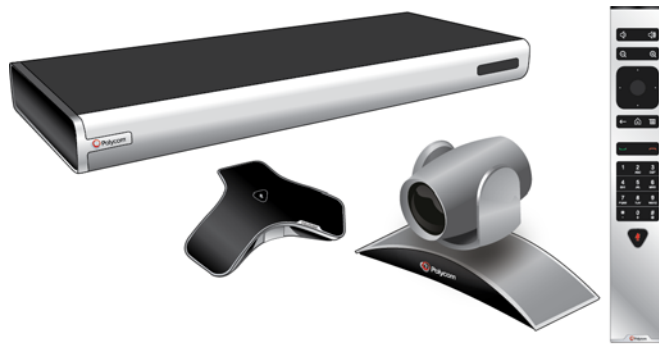
RealPresence Group 300 and 500 systems ship with a Polycom EagleEye III or EagleEye Acoustic camera and a Polycom RealPresence Group Remote Control. Bundles that contain the Polycom EagleEye III also include a RealPresence Group Microphone Array.

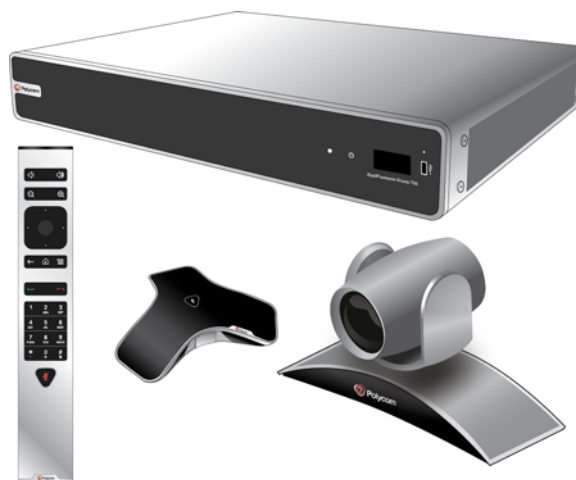
RealPresence Group 700 systems ship with a Polycom EagleEye III camera, a Polycom RealPresence Group Microphone Array, and a Polycom RealPresence Group Remote Control.
