RED BANNER ALERT

SHW Serious Incident (SI) – Preliminary Notice

Incident Short Description:	Asphalt Workers on Foot within 1.2m of Live Traffic
------------------------------------	---

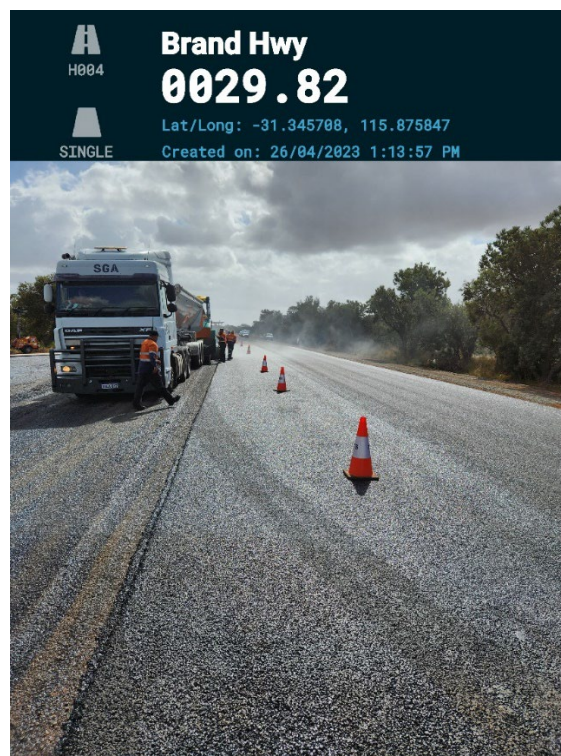
On Thursday 27/04/2023 at approximately 14:40, Main Roads representatives noticed that as asphalt works were proceeding, the buffer zone between the workers on foot and the live traffic lane had decreased to less than the required 1.2m.

Workers were directed to stop until cones delineating the worksite could be moved to provide the required buffer zone between the workers and live traffic lane.

Asphalt Workers working within 1.2m of Live Traffic

- *Ensure that work methodologies clearly communicate Traffic Management requirements for specific works.*
- *Ensure Traffic Controllers are briefed in what is actually required for the specific works - Discuss Critical Risks and the corresponding Critical Controls at Pre-start Meetings.*
- *Use tools such as Critical Risk Observation Checklists to verify that Critical Controls are in place and are effective at the start of a task and as required thereafter.*
