737
NON-DESTRUCTIVE TEST MANUAL

PART 2 - X-RAY

FORWARD FRAME MEMBER IN NOSE COWL

PART 2 54-10-01

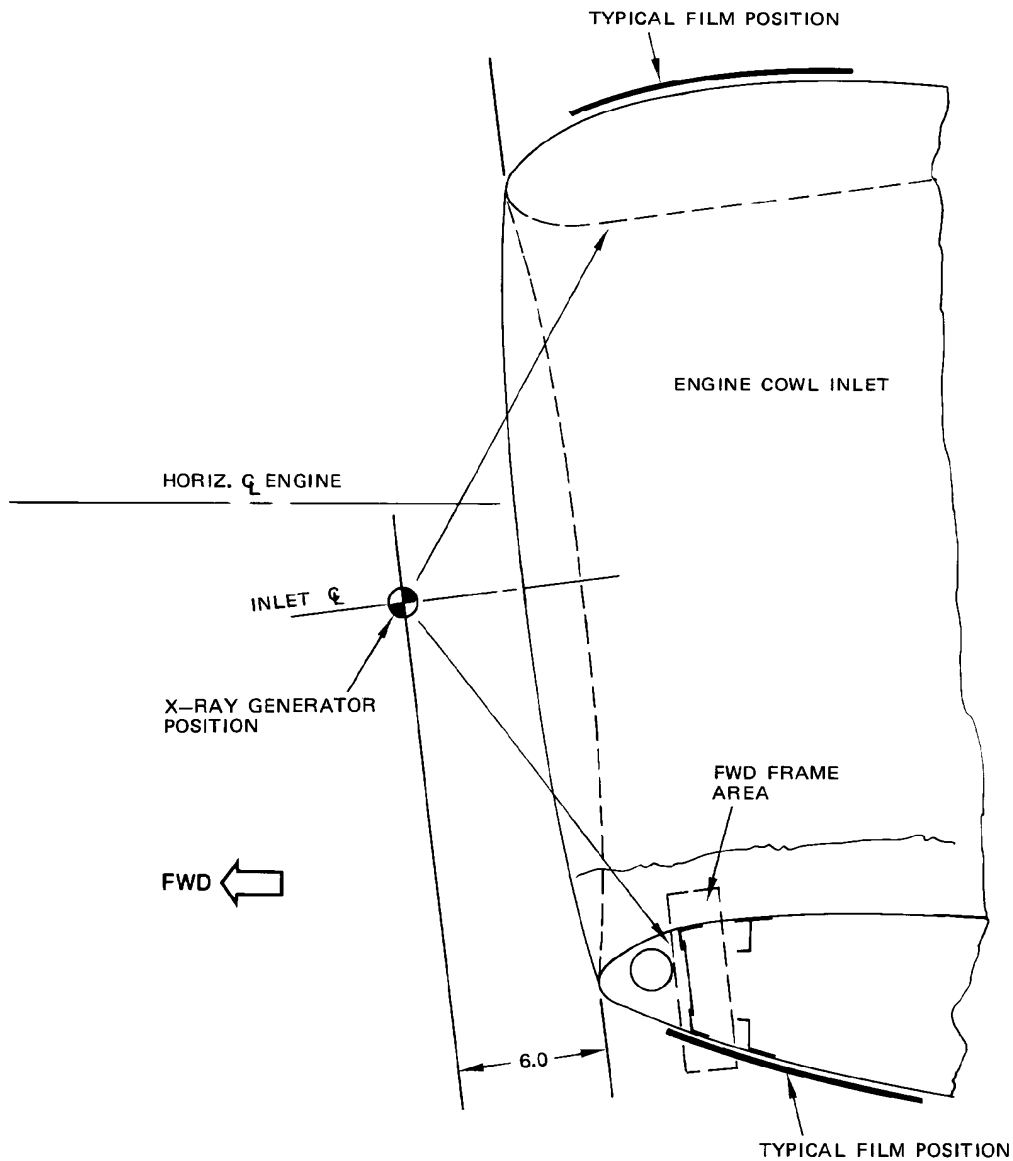
**X-Ray Generator and Film Positioning
Figure 1**

X-RAY PARAMETERS						
EXPOSURE NUMBER	FILM			SFD (INCHES)	GENERATOR SETTING	
	POSITION	ASTM CLASS	SIZE (INCHES)		KV	MAS
1	1	I	1	44	85	360

- ALL DIMENSIONS ARE IN INCHES
- ▷ 14 x 17-inch sheet or strip

- A. To detect fatigue cracking of the forward frame member in the engine nose cowl. See Figure 1.
- B. Cracks are large and may occur in the frame web and generally are located in the lower portion of the cowl. However, inspection should cover 360°.
- C. This procedure is suitable for use on the airplane with the part in place. No removals are required.

- A. Place identification tape on outer surface of cowl.
- B. Place film (either 14 x 17-inch sheet or strip) on the outside of the cowl in position to allow for projection of the X-ray image of the frame.
