## RED BANNER ALERT

# SHW Serious Incident (SI) – Preliminary Notice

| <b>Incident Short Description:</b> | Workers within 1.2m of traffic in unauthorised second work area |

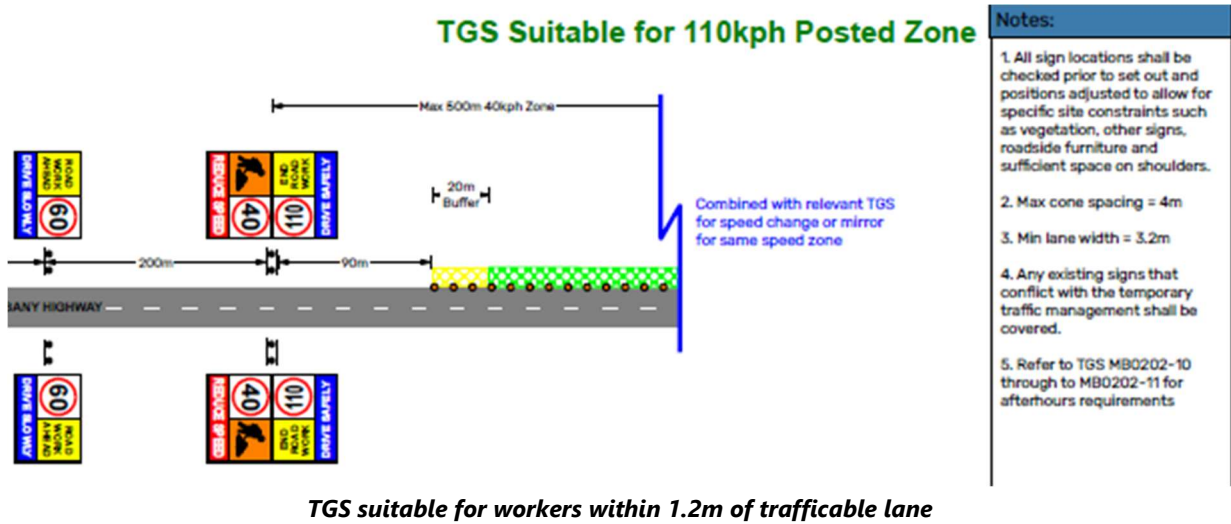
Work on shoulder widening was being undertaken in a 2km work area with posted speed of 110kph, speed was reduced to 60kph and a FOLLOW ME vehicle was in operation. A separate work crew were undertaking compaction testing on the shoulder of the live lane, opposite of the main work area.

An errant member of the public vehicle was travelling behind the FOLLOW ME vehicle close to the pavement edge. No workers were spotting as vehicles approached or moving back from pavement.

TGS contained statement that workers on foot to be greater than 1.2m from the trafficable lane. This is accordance with the code of practice with speed reduced to 60kph. For workers to be within 1.2m, speed must be 40kph and delineation (cones) at 4m spacings between workers and trafficable lane.

The workers undertaking task resulted in two work areas within the TC controlled area, this was not in accordance with the TGS.

- Reinforce Traffic controllers have the right to hold traffic if hazard exists
- Discuss at toolbox meetings requirement to follow the Traffic Guidance Schemes, and if work layout changes deviations must be approved
- Communicate event and review SWMS interaction with traffic controls with all workers to assist address Workers becoming complacent, hazard perception changes
