737 NON-DESTRUCTIVE TEST MANUAL

PART 6 - EDDY CURRENT

WING LOWER SURFACE BBL 70.85 SPLICE (HFEC)

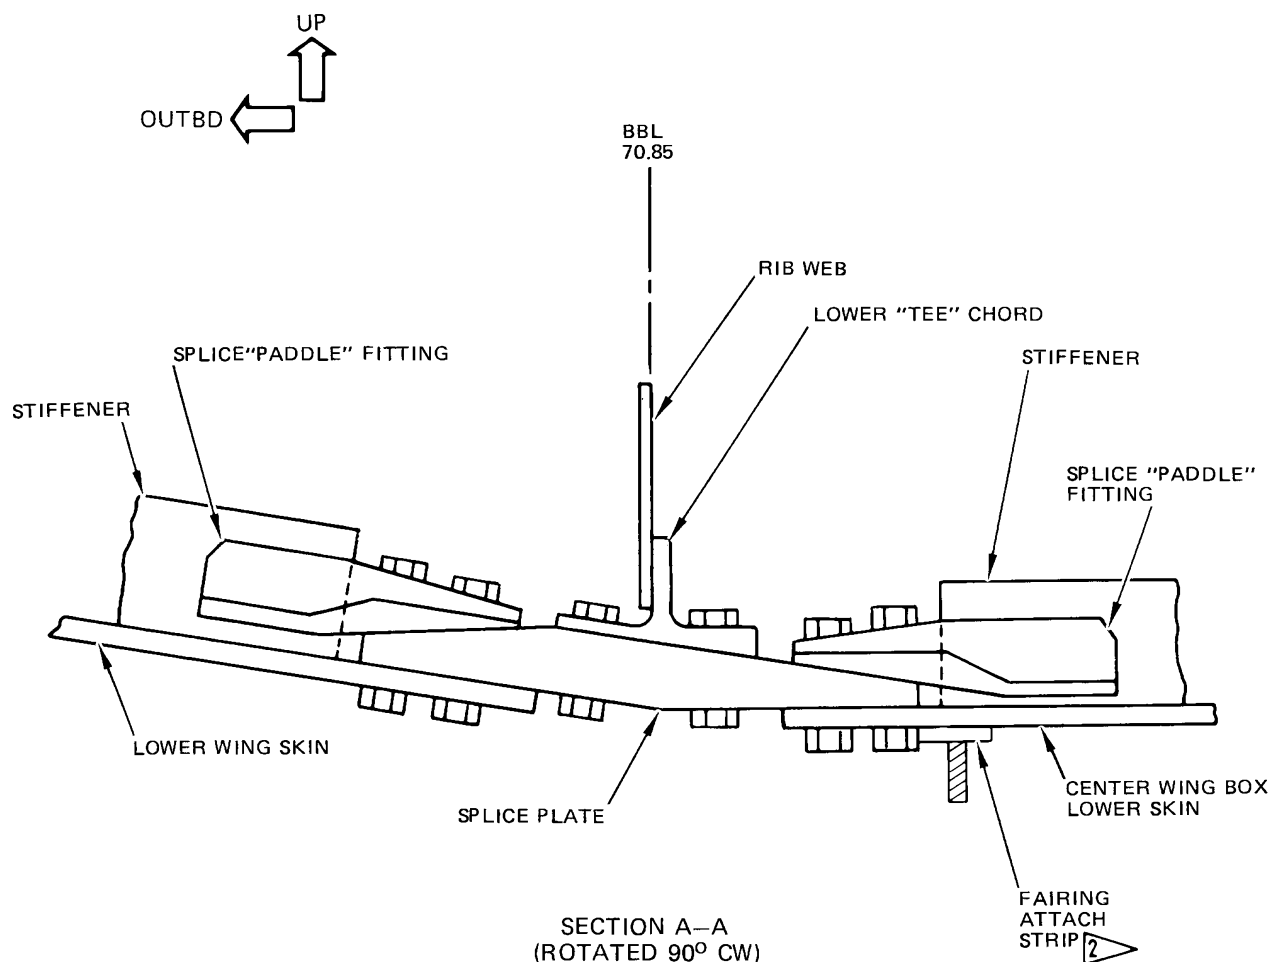
- THIS DETAIL SHOWS TYPICAL CONSTRUCTION OF SPLICE PLATE AND SPLICE FITTINGS

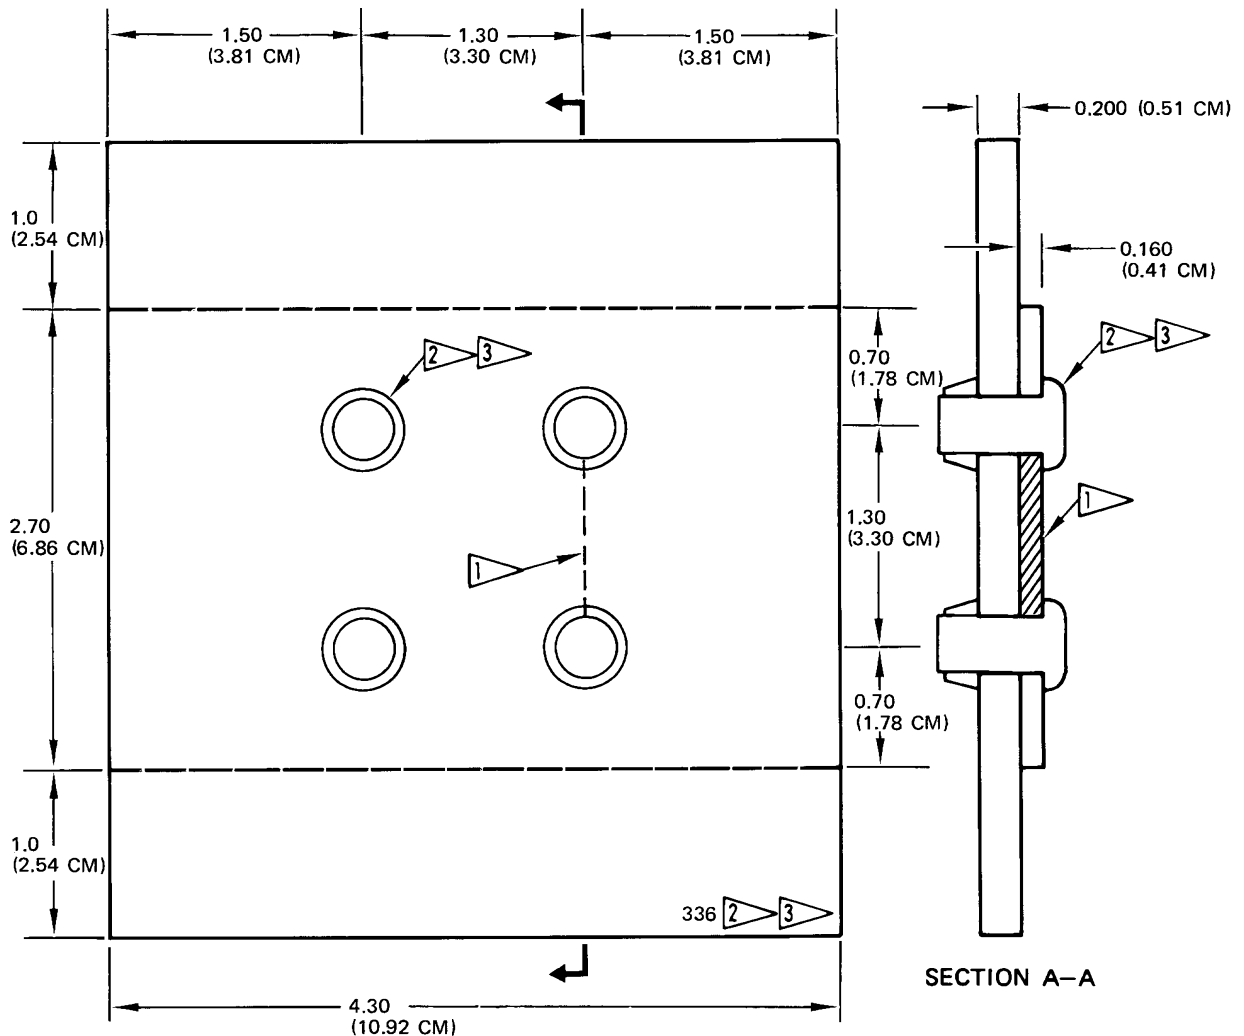
Reference Standard 336A and 336B
Figure 2

- ALL DIMENSIONS ARE IN INCHES (CENTIMETERS IN PARENTHESES)
- TOLERANCE: $X.X \pm 0.02$ (0.05 CM), $X.XX \pm 0.010$ (0.025 CM)
- MATERIAL: 7175-T6, 7075-T6, 2024-T3 ALUMINUM
- ETCH OR STEEL STAMP WITH 336A OR 336B
- P/N 6412-247 AVAILABLE FROM IDEAL SPECIALTY CO.

- A. Any eddy current instrument and probe combination that satisfies performance requirements of this procedure is suitable for this inspection. The following equipment was used in development of this procedure.
 - (1) Instrument - Eddy current instrument operable at 500 Hz.
 - (a) MIZ-10 or MIZ-10A; Zetec Inc.
 - (2) Probe - Spot probe, 0.6-inch (1.52 cm) maximum OD usable at 500 Hz.
 - (a) P/N SPO 565A; Nortec, Inc.
 - (3) Reference Standards - Manufacture Reference Standard 336A and 336B per Figure 2.

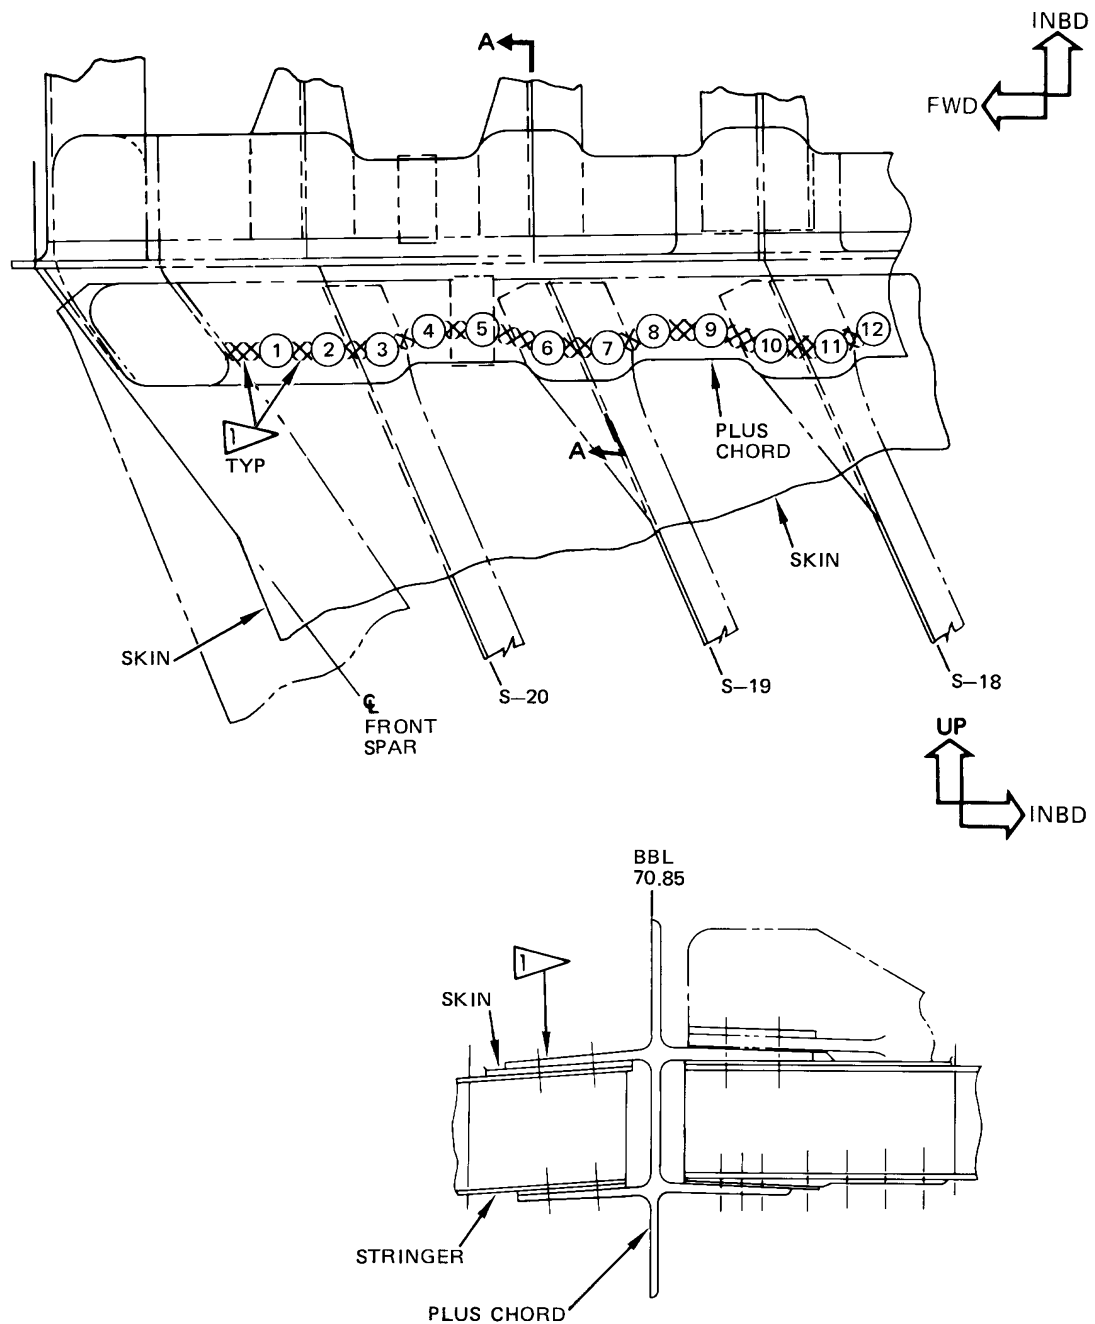
- ① FASTENERS TO BE INSPECTED
- ① PLACE PROBE AT LOCATIONS BETWEEN FASTENERS PER XXXX

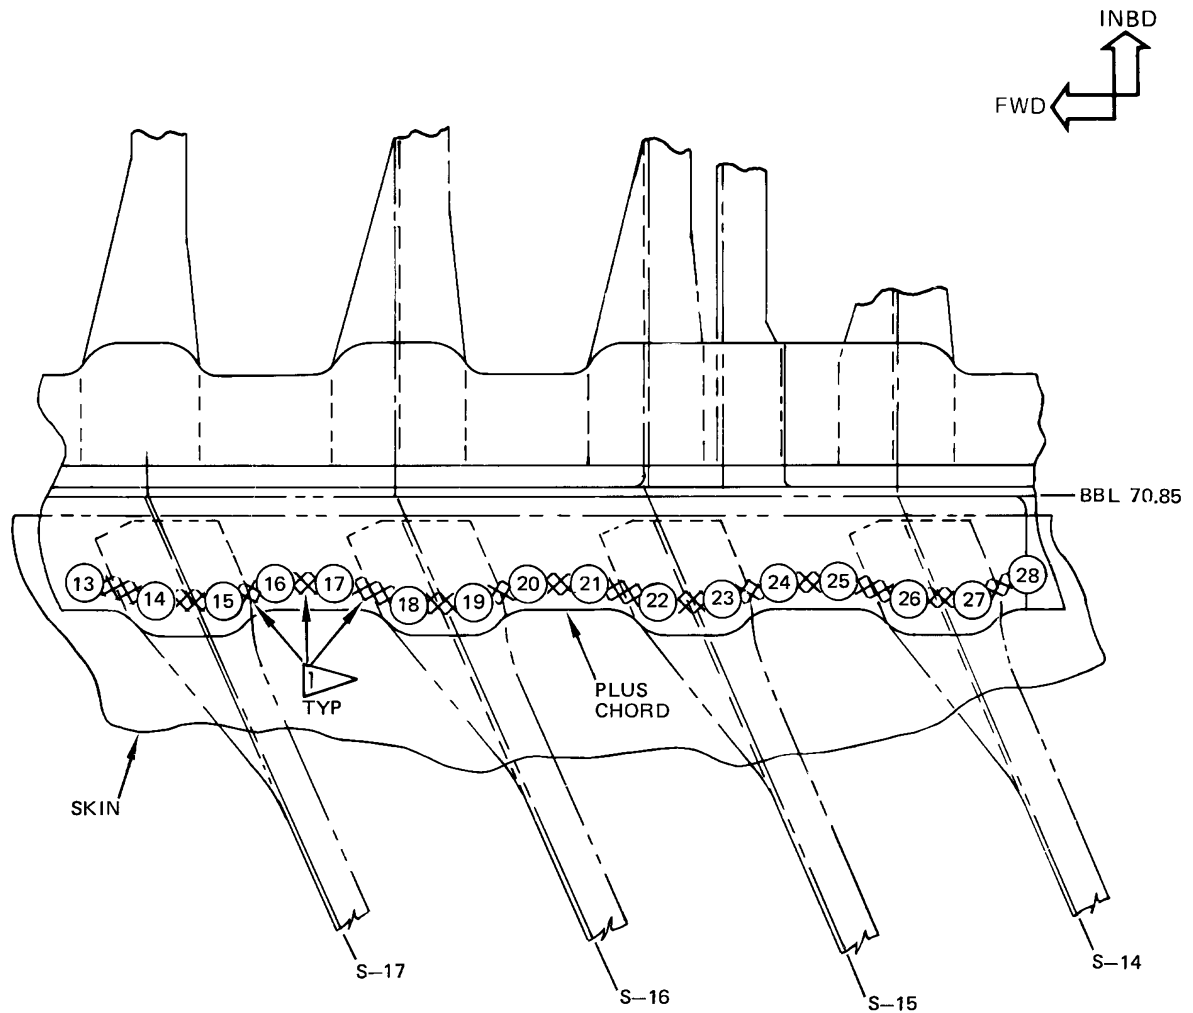
- ⑬ FASTENERS TO BE INSPECTED
- ① PLACE PROBE AT LOCATIONS BETWEEN FASTENERS PER XXXX

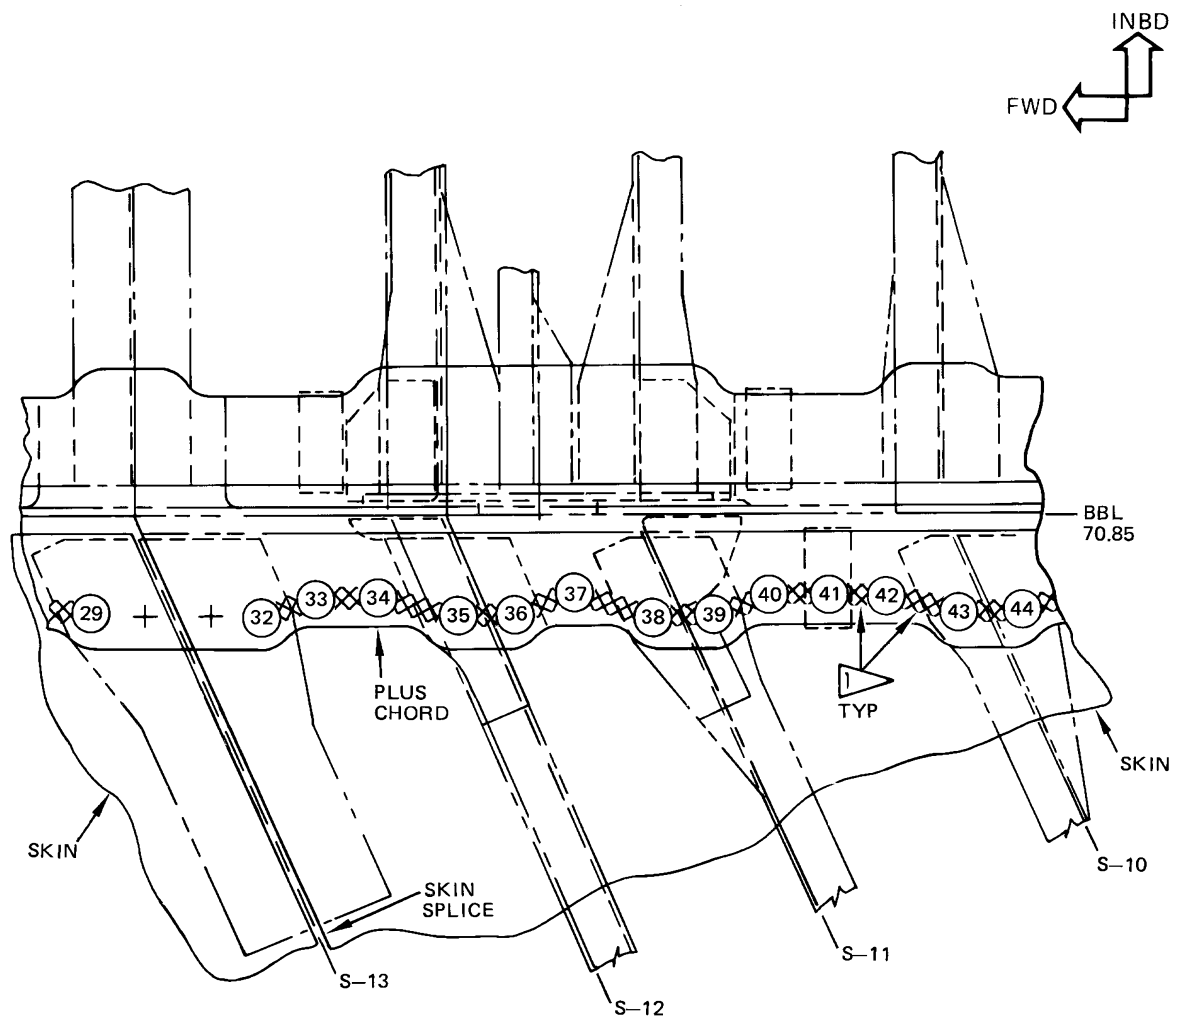
- ③ FASTENERS TO BE INSPECTED
- ① PLACE PROBE AT LOCATIONS BETWEEN FASTENERS PER XXXX

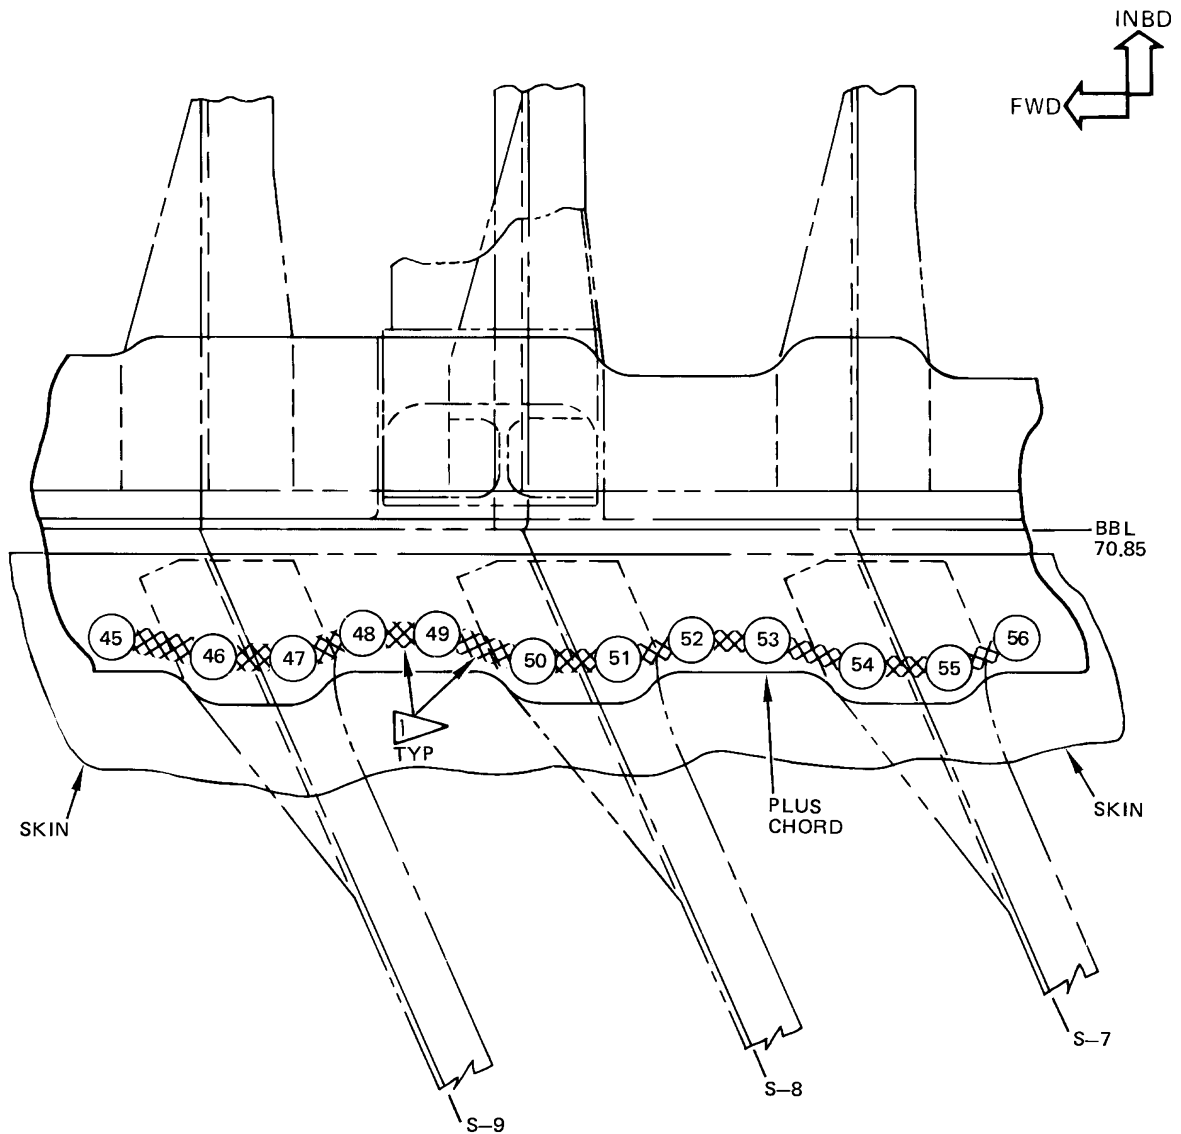
- ④ FASTENERS TO BE INSPECTED
- ▤ PLACE PROBE AT LOCATIONS BETWEEN FASTENERS PER

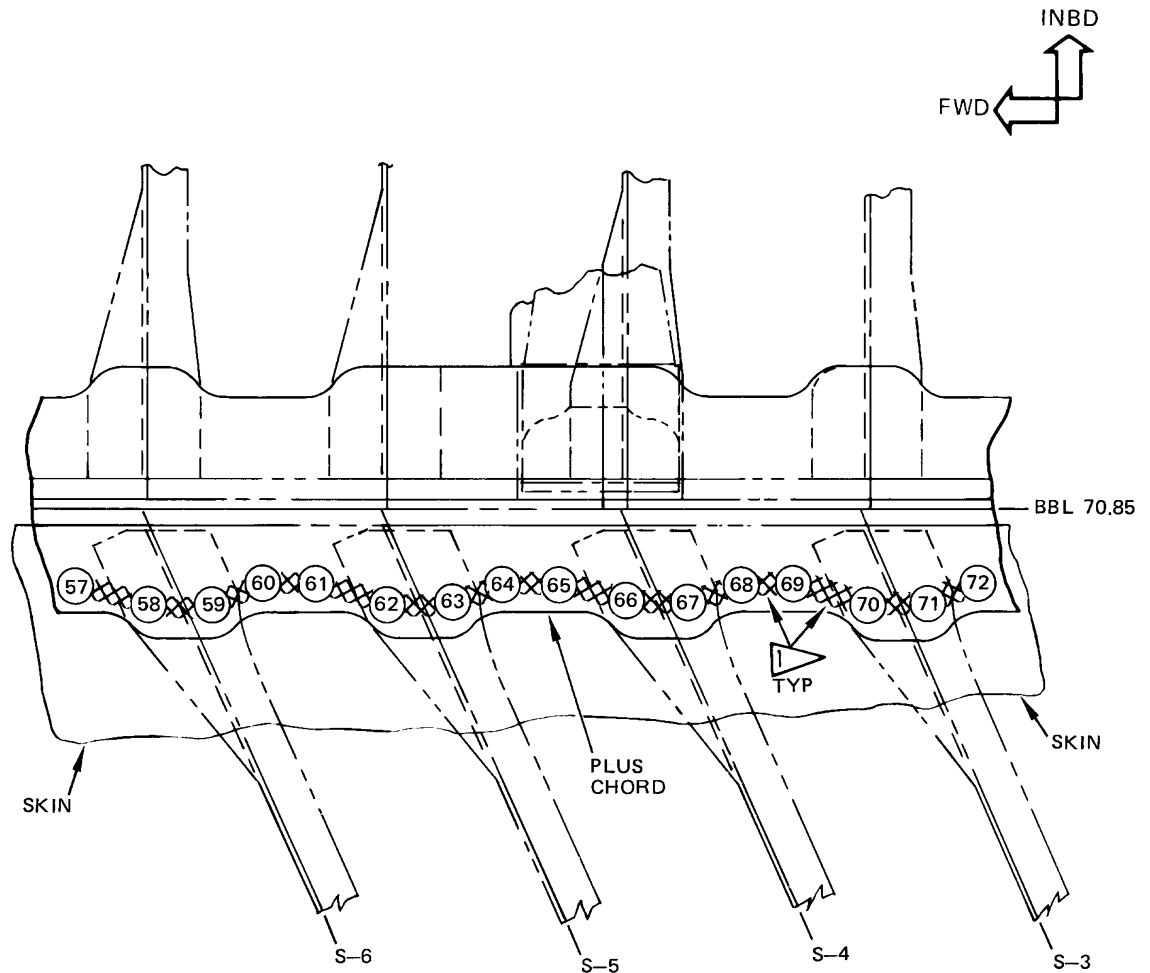
- ⑤7 FASTENERS TO BE INSPECTED
- ① PLACE PROBE AT LOCATIONS BETWEEN FASTENERS PER

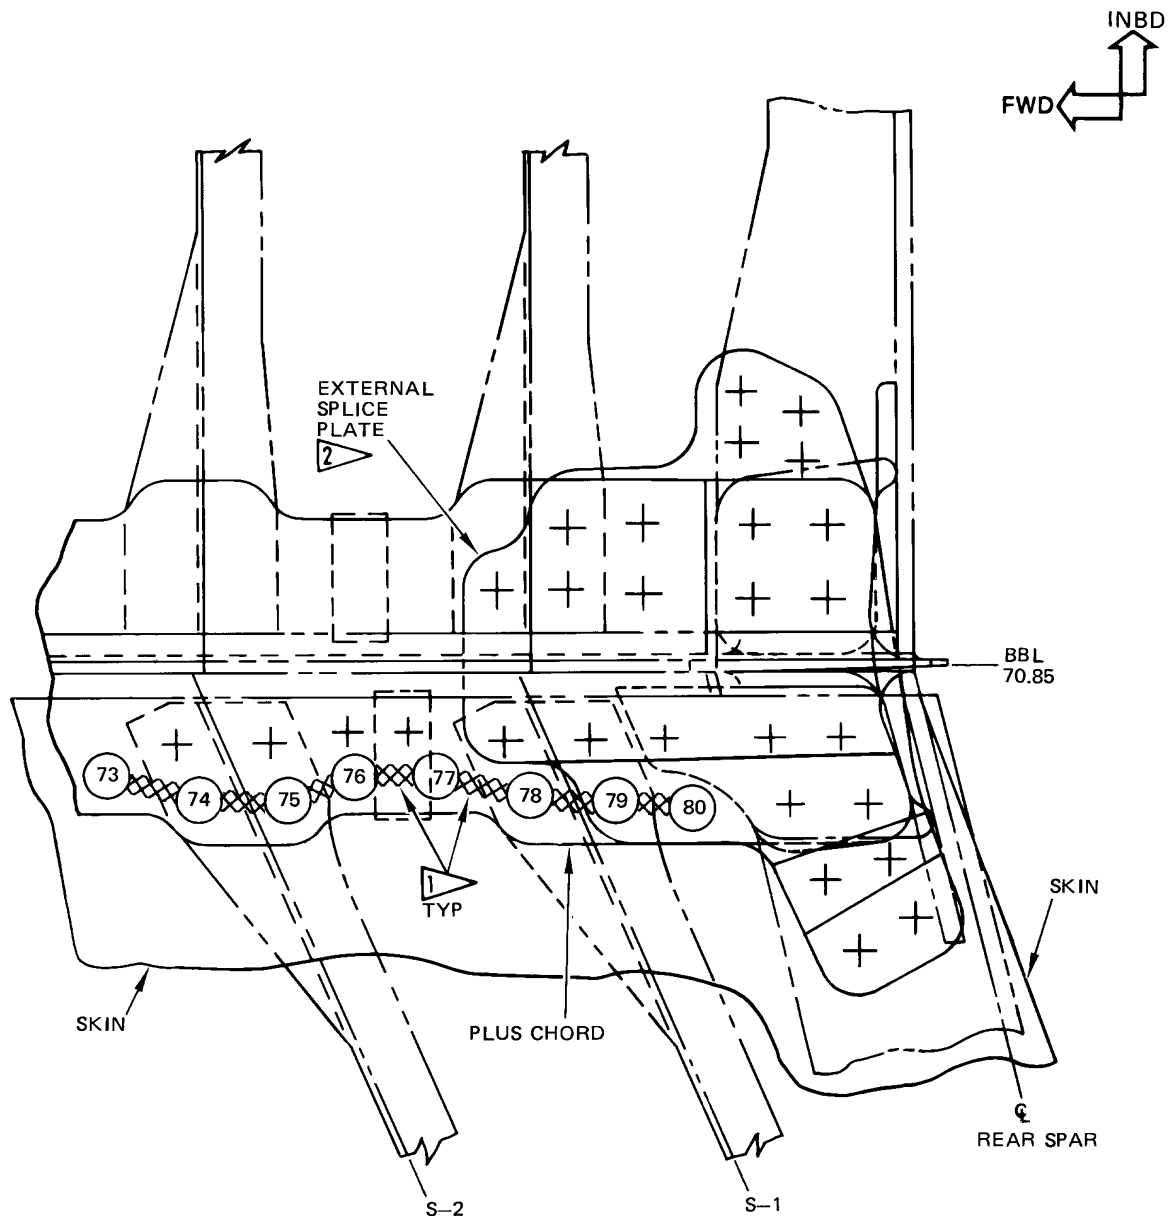
- ⑦③ FASTENER TO BE INSPECTED
- ① PLACE PROBE AT LOCATIONS BETWEEN FASTENERS PER
- ② EXTERNAL SPLICE PLATE FOR CUM LINE NO. 845 AND ON AND AIRPLANES INCORPORATING SERVICE BULLETIN 737-57-1087. IF SPLICE PLATE IS PRESENT, NO INSPECTION IS REQUIRED FOR FASTENERS NO. 79 AND 80

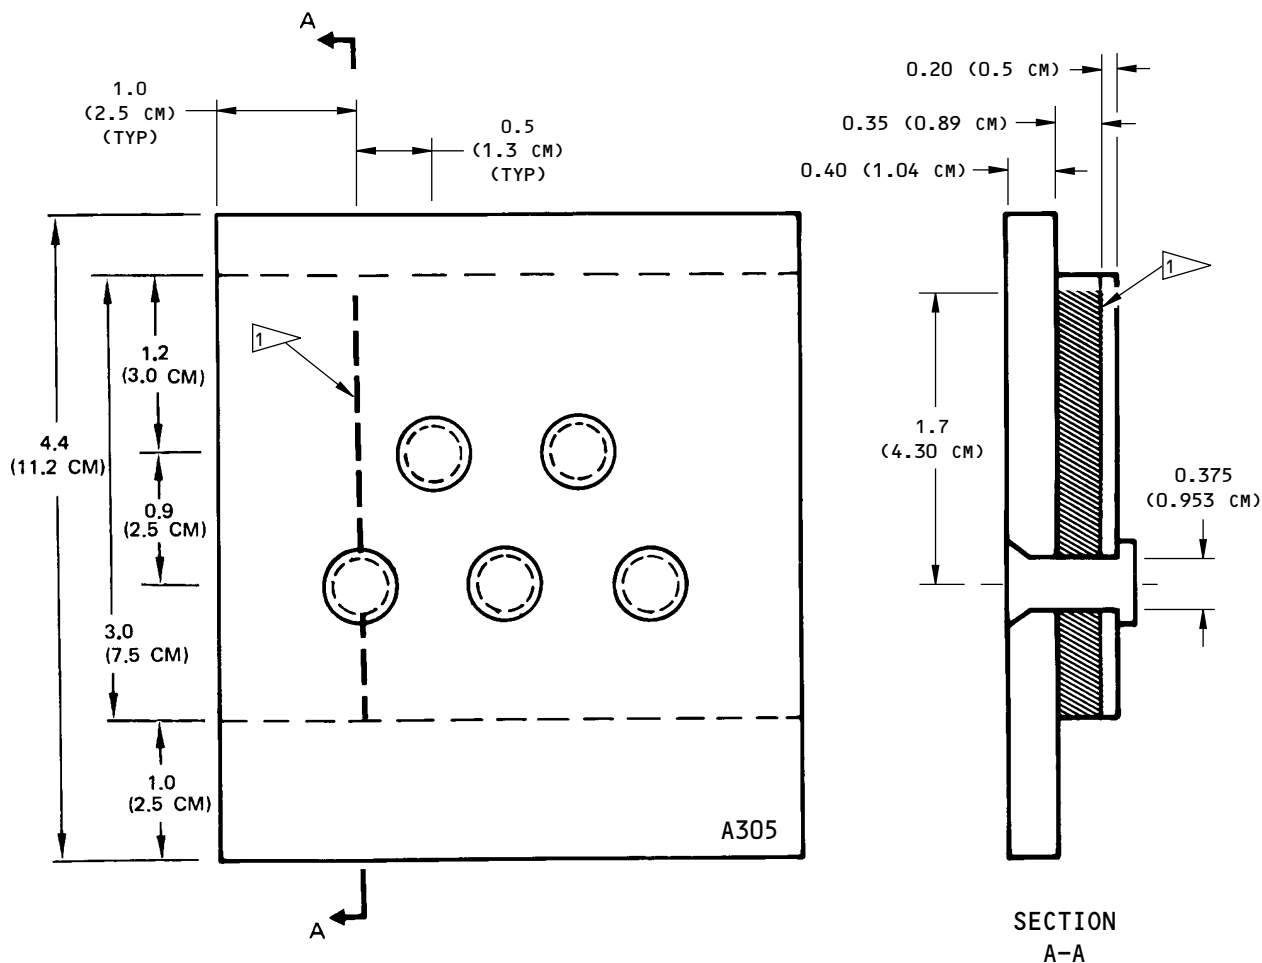
- ALL DIMENSIONS ARE IN INCHES (CENTIMETERS IN PARENTHESES)
- TOLERANCES: $X.X \pm 0.05$ (0.13 CM), $X.XX \pm 0.02$ (0.05 CM), $X.XXX \pm 0.005$ (0.013 CM)
- MATERIAL: 2024-T3 OR -T4 ALUMINUM
- FASTENERS: BACR15BA12B-20 RIVETS (5 LOCATIONS). THESE RIVETS MUST HAVE A CONVERSION COATED (ALODINED) FINISH. TO MAKE SURE THE FINISH IS ALODINE, REFER TO PART 1, 51-06-01. INSTALL THE RIVETS AS SPECIFIED IN PART 1, 51-01-04.
- ETCH OR STEEL STAMP WITH A305. PUT A LETTER "A" IN FRONT OF THE REFERENCE STANDARD NUMBER TO SHOW THAT IT HAS ALODINED RIVETS.

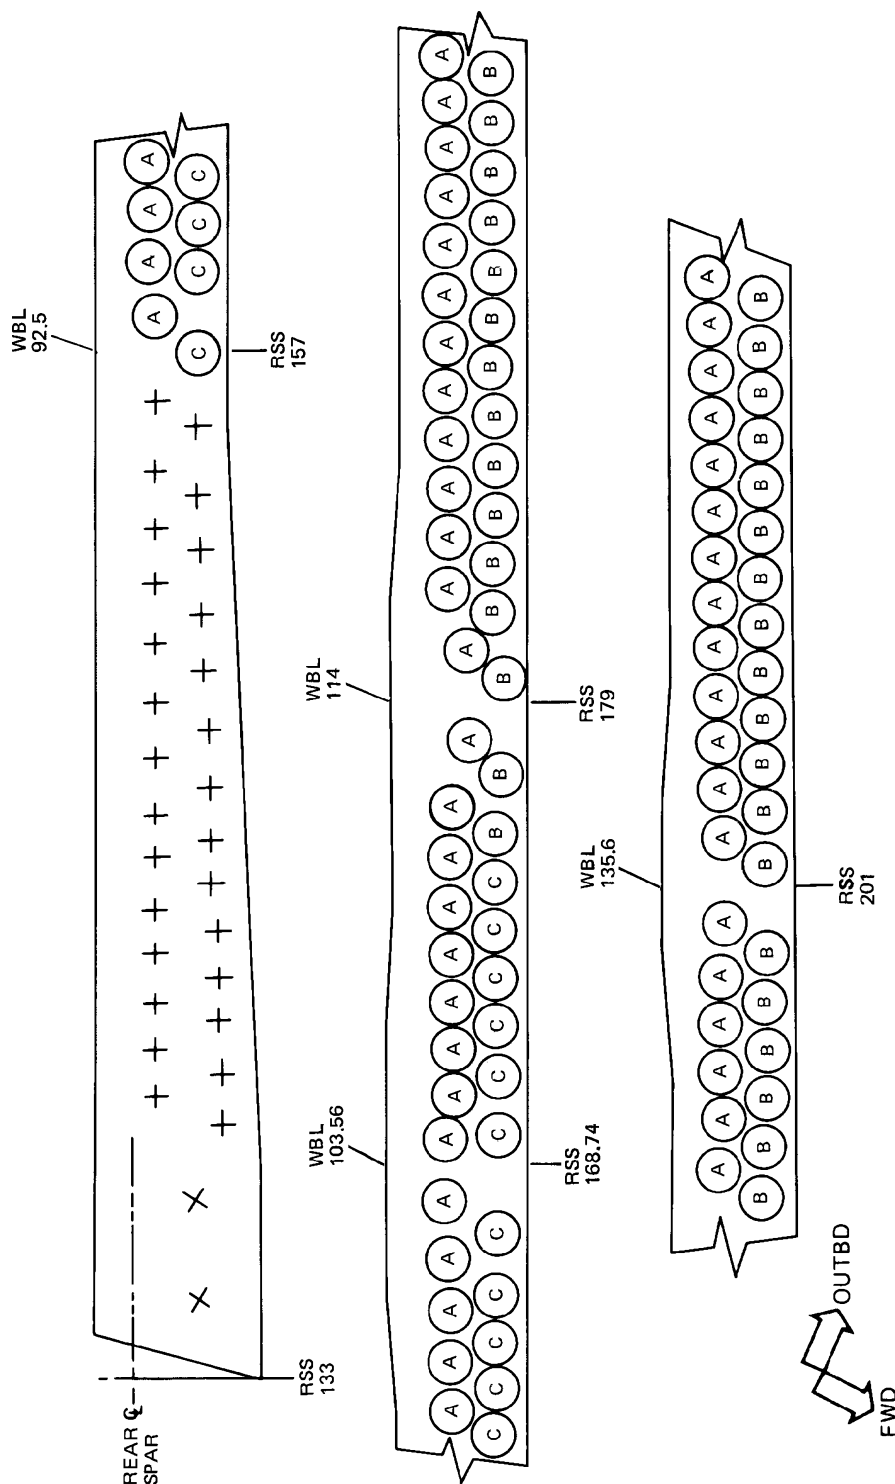
- NOTES
- VIEW LOOKING UP
 - RIGHT WING SHOWN, LEFT WING SIMILAR

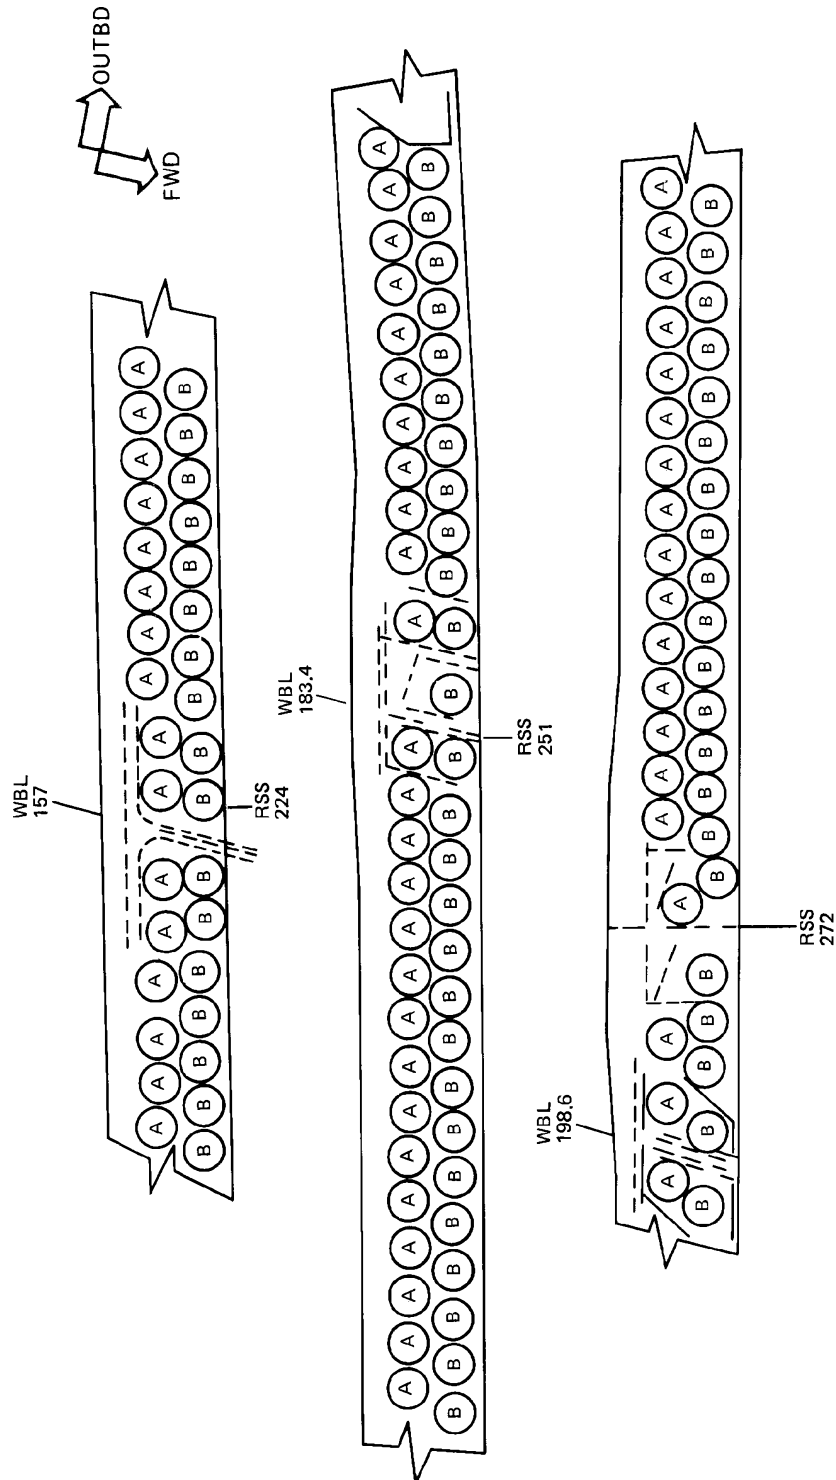
- NOTES
- VIEW LOOKING UP
 - RIGHT WING SHOWN, LEFT WING SIMILAR

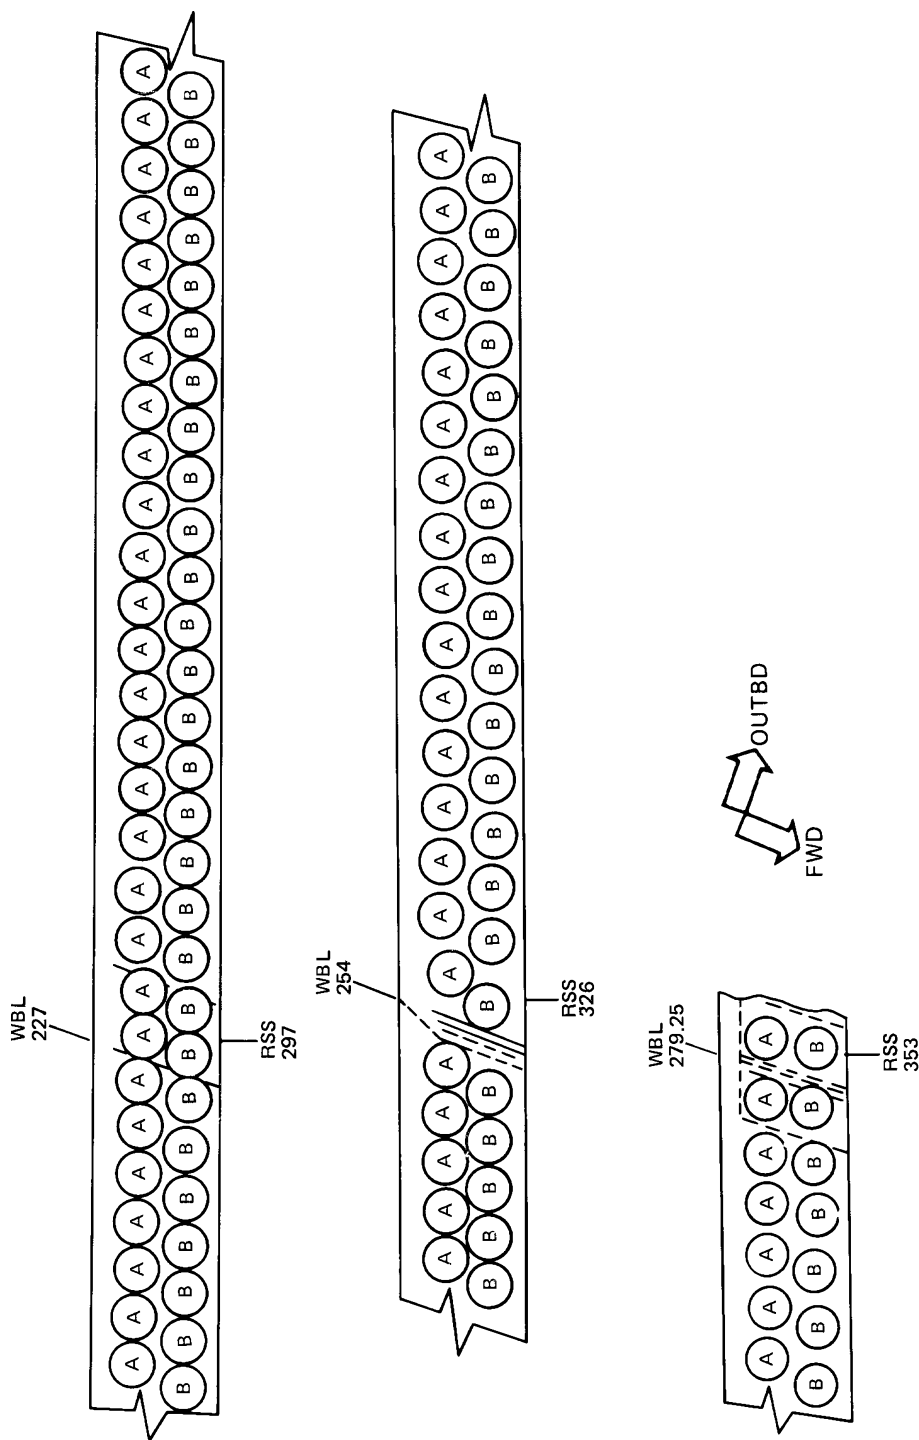
- VIEW LOOKING UP
- RIGHT WING SHOWN, LEFT WING SIMILAR

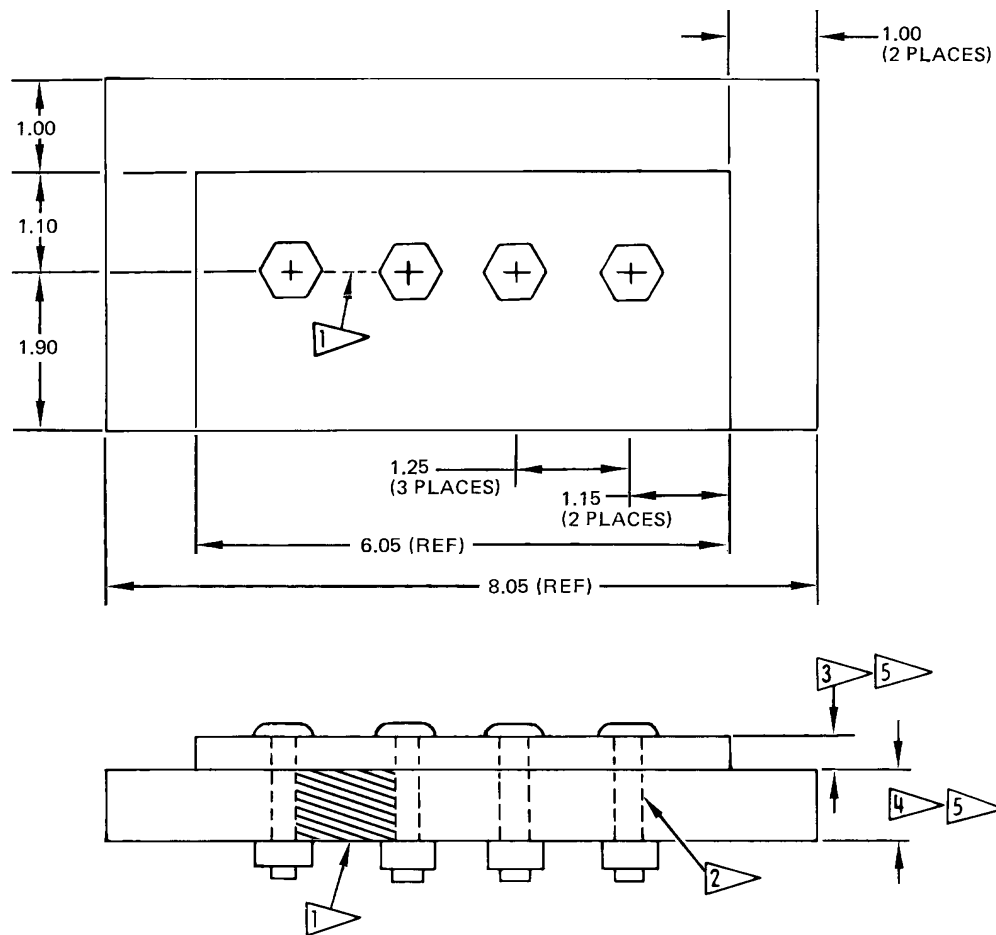
- ALL DIMENSIONS ARE IN INCHES
- TOLERANCE: $X.XX \pm 0.010$
 $X.XXX \pm 0.005$
- MATERIAL: 2024-T3, -T4 ALUMINUM
- TITANIUM OR STAINLESS STEEL FASTENERS MAY BE USED. IF THESE FASTENERS ARE NOT AVAILABLE, THE PARTS MAY BE CLAMPED TOGETHER WITH AN ALUMINUM, STAINLESS STEEL, OR NON-METALLIC CLAMP
- ETCH OR STEEL STAMP WITH 354X OR 355X PER TABLE I

- A. Any eddy current instrument and probe combination that satisfies the performance requirements of this procedure is suitable for this inspection. The following equipment was used to develop this procedure.
 - (1) Instrument -- MIZ-10B; Zetec Inc., Issaquah, WA
 - (2) Probe -- RR0115-3; NDT Product Engineering (Olympus). Low frequency driver-pickup encircling probe with 0.68 inch ID, 1.5 inch OD, useable at 100 Hz and capable of penetrating 0.43 inch of aluminum, to detect a 1.5 inch hole-to-hole crack in a 0.50-0.75 inch thick second layer.
 - (3) Reference Standard -- Manufacture reference standard per Figure 1.

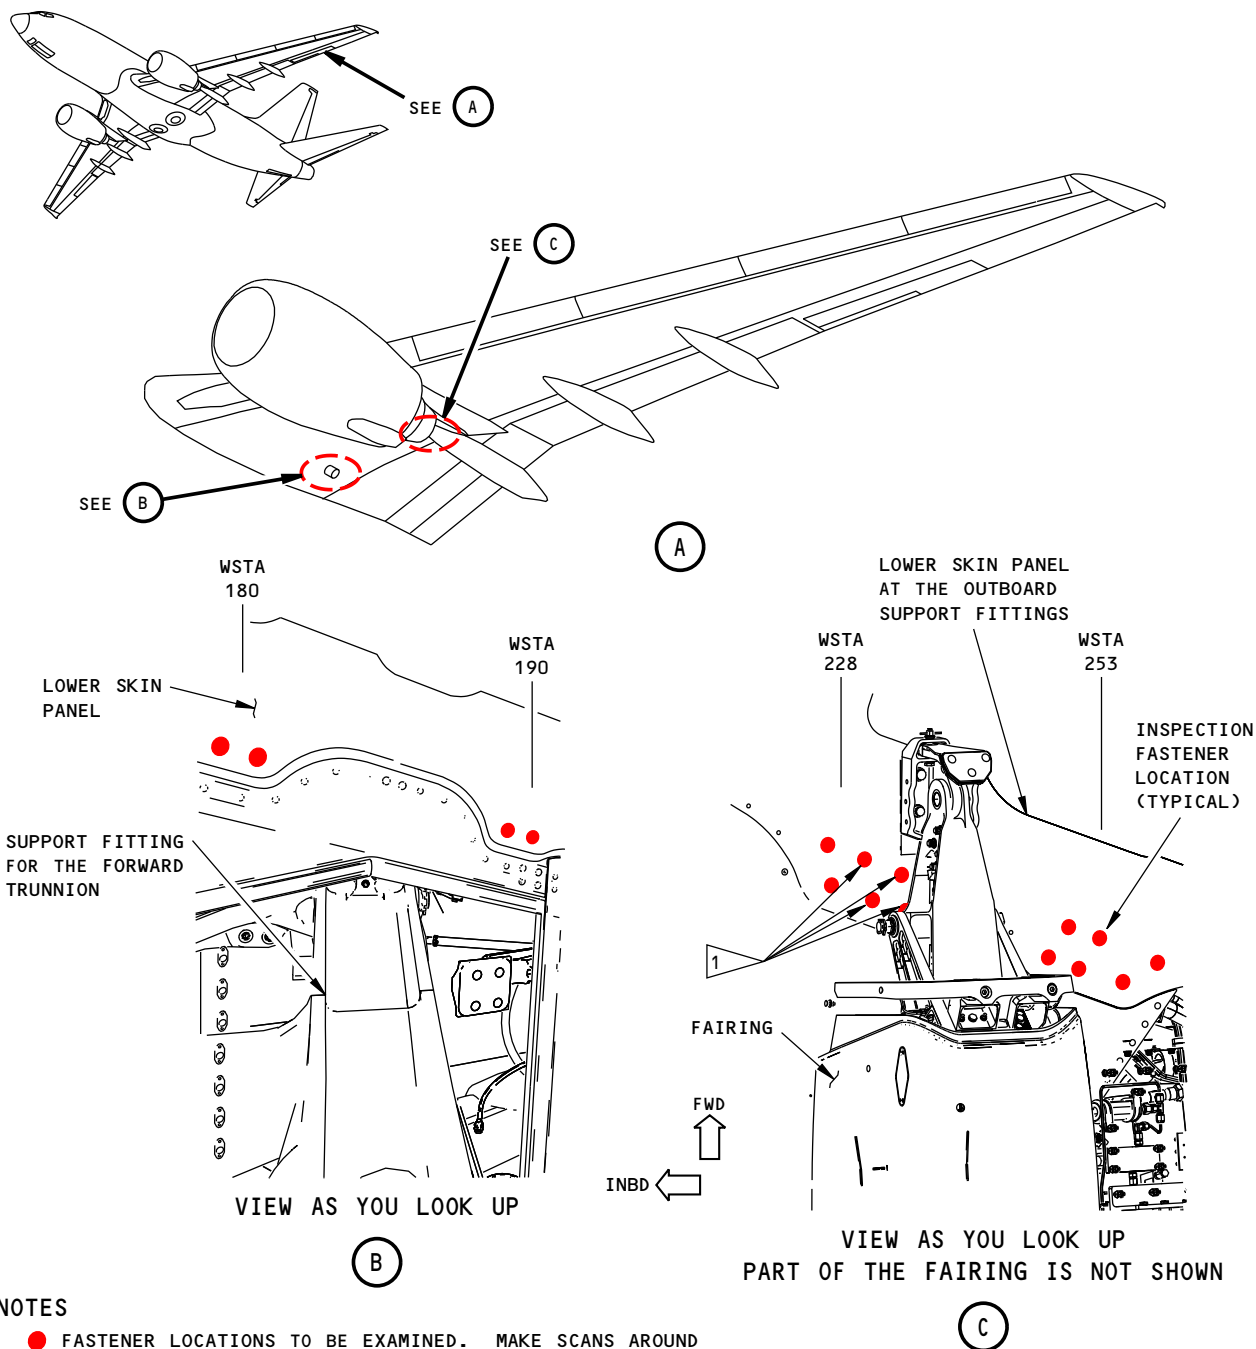
● FASTENER LOCATIONS TO BE EXAMINED. MAKE SCANS AROUND THESE FASTENERS TO IDENTIFY CRACKS IN THE LOWER SKIN PANELS
