737 NON-DESTRUCTIVE TEST MANUAL

PART 4 - ULTRASONIC

AUXILIARY FUEL TANK BOND INSPECTION

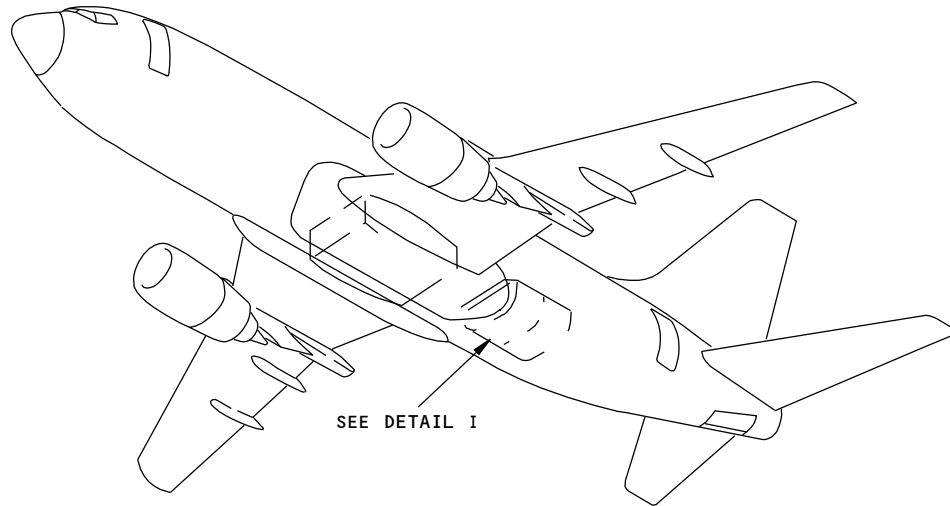
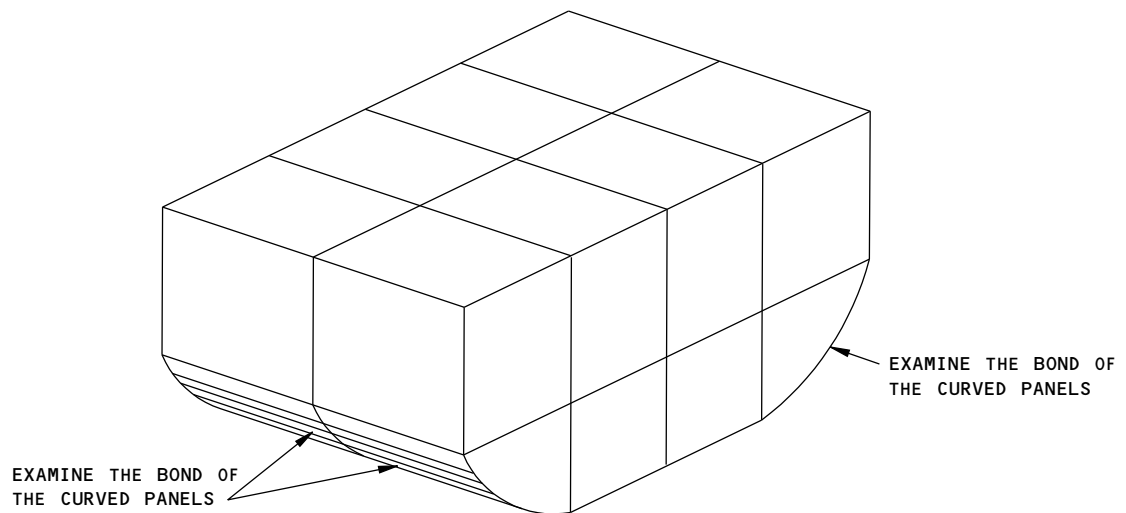
Areas of Inspection for Curved Panels
Figure 1

DETAIL I

- A. Drain the auxiliary fuel tanks.
- B. Remove the cargo lining panels to get access to the aft end of the auxiliary tank (see Figure 1).
- C. Clean the surfaces of the inspection area. Visually examine the external surfaces of the panels to be examined for signs of cracks or stress.
- D. Make sure that the probe can reach all of the areas of the inspection within the tank.

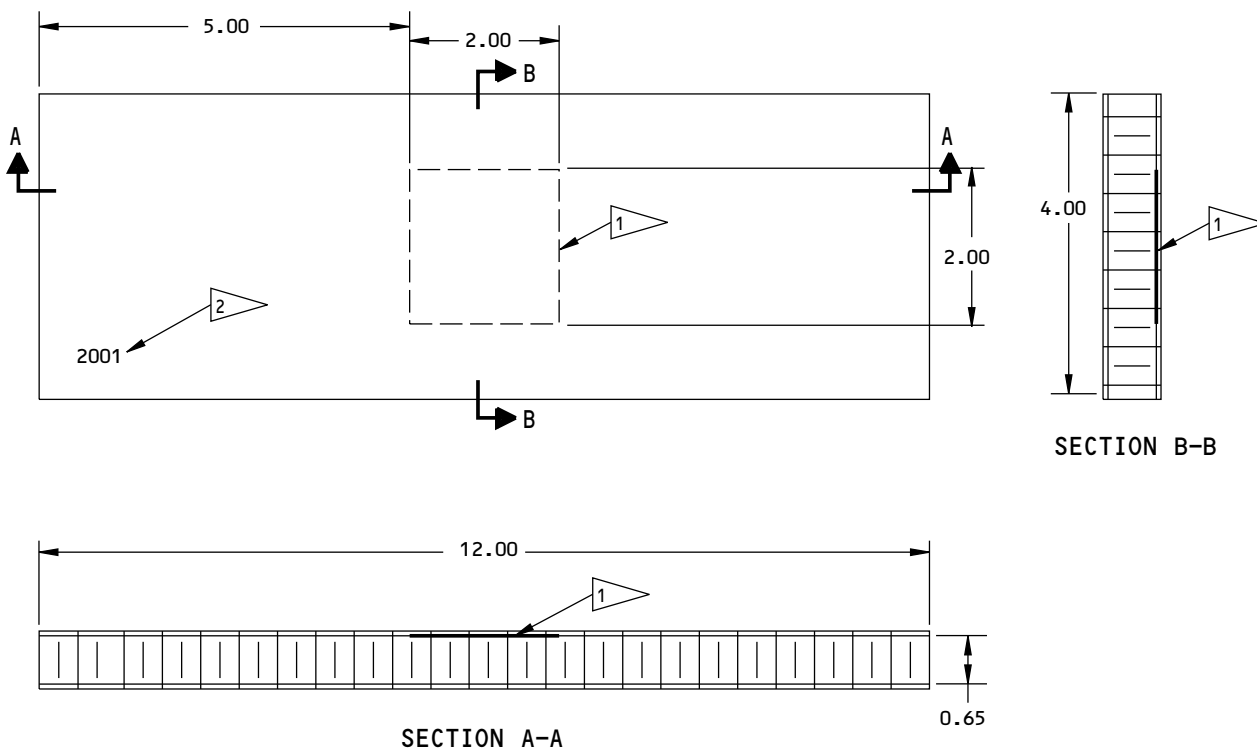
Reference Standard 2001
Figure 2

- 1 SIMULATED DISBOND CREATED BY 2 PLIES OF FEP 2 X 2 X 0.002 PER PLY.
- 2 ETCH 2001 AT THIS LOCATION

- (2) Reference Standard 2001 (see Figure 2). This part is available from The Boeing Company.

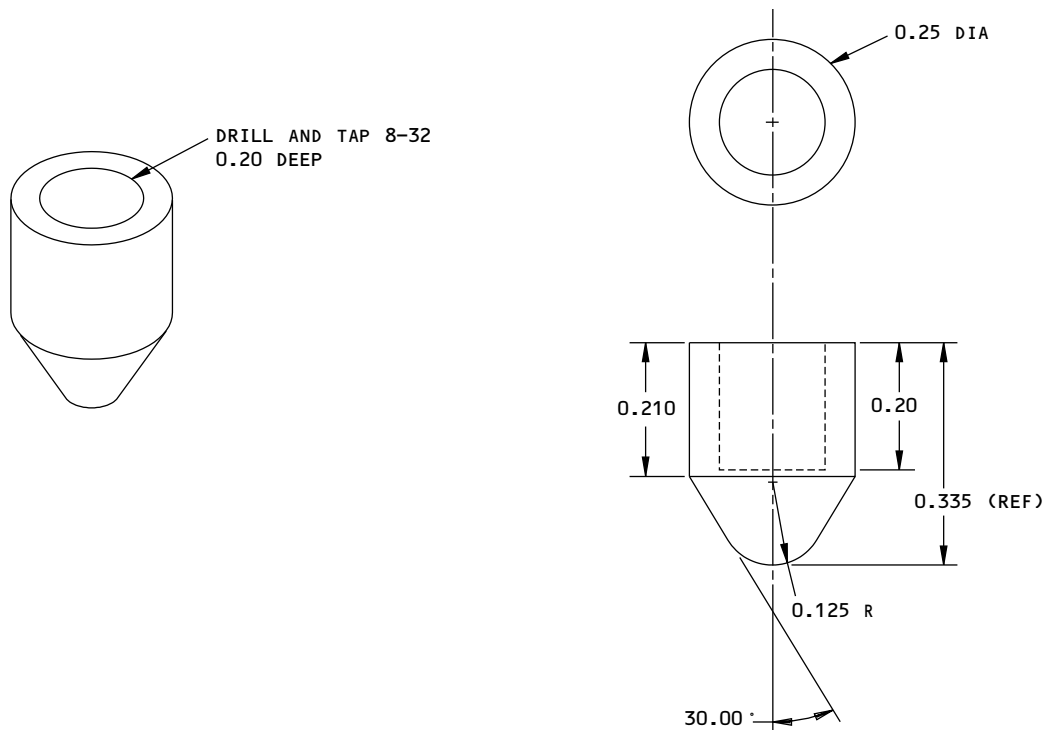
Sondicator Probe Tip
Figure 4

- ALL DIMENSIONS ARE IN INCHES
- MATERIAL: 0.25 DIA PHENOLIC
LUCITE (OPT)
2024-TXX (ANY HEAT TREAT) (OPT)
- TOLERANCE: XXX ± 0.005
XX ± 0.010
X ± 0.020

- (a) Sondicator S-5 with probe Part No. S-P-3 with aluminum, lucite, or phenolic tips (see Figure 4); Zetec, Inc.
 - (b) Sondicator S-1A with probe Part No. S-P-3 with aluminum, lucite, or phenolic tips (see Figure 4); Zetec, Inc.
 - (c) Sondicator S-3 with probe Part No. S-P-3 with aluminum, lucite, or phenolic tips (see Figure 4); Zetec, Inc.

NOTE: It is necessary to use aluminum, lucite or phenolic probe tips with this procedure (see Figure 4).

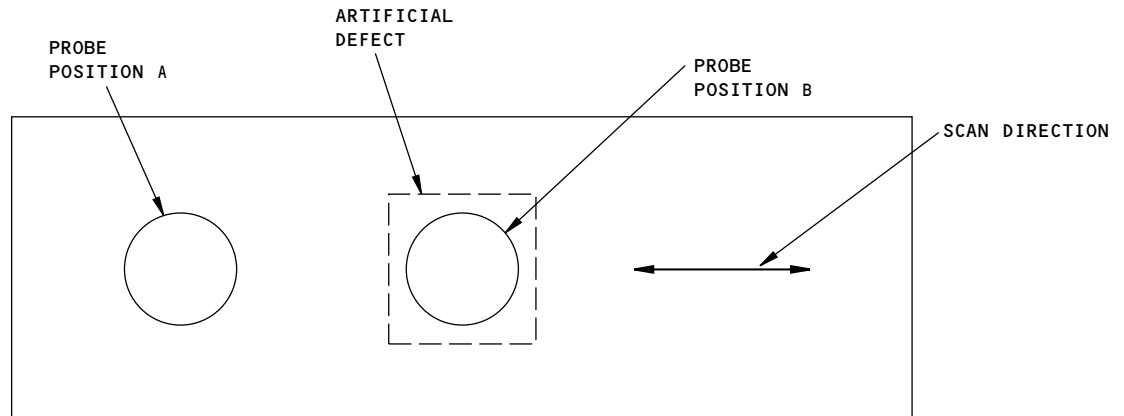
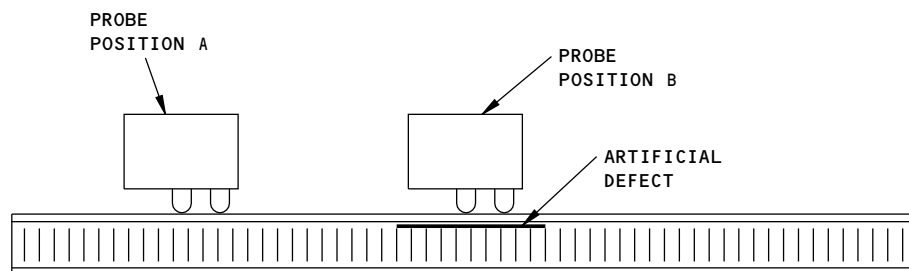
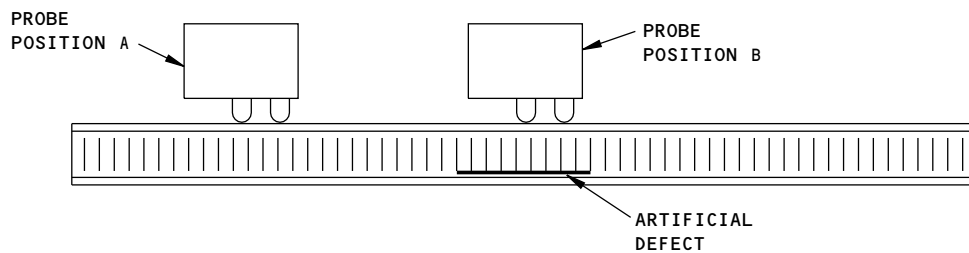
CALIBRATE FOR NEARSIDE DEFECT

CALIBRATE FOR FAR SIDE DEFECT

- (f) Put the probe on the opposite side of the reference standard in an area away from the artificial defect.
 - (g) Move the probe over the artificial defect. The instrument response must be a fast movement of the phase meter in an upscale direction. (On some reference standards, the phase meter can go in a downscale direction, with an upscale amplitude meter indication that occurs at the same time.)

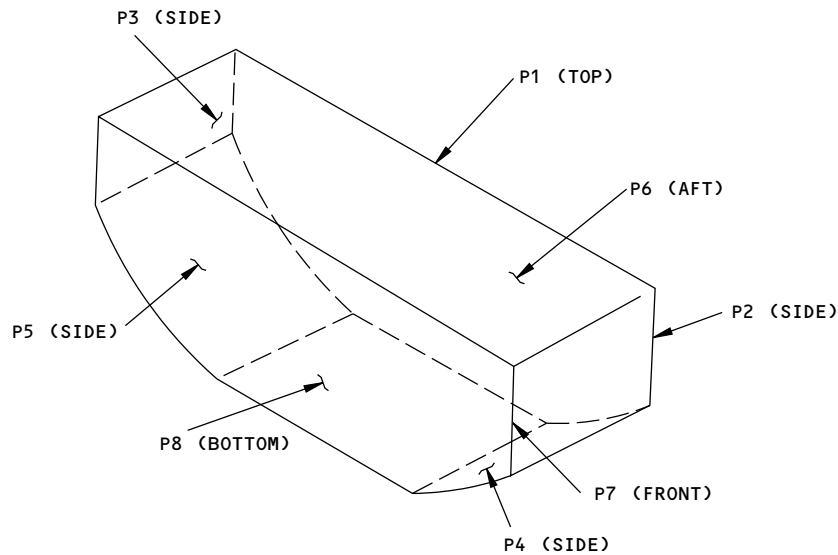
- DO AN INSPECTION ON ALL HONEYCOMB PANELS ON BOTH THE INTERNAL AND EXTERNAL SURFACES OF THE TANK FOR SIGNS OF DISBONDING.
- YOU DO NOT NEED TO DO AN INSPECTION ON CURVED PANELS P4 AND P5 IF AN INSPECTION WAS DONE BEFORE WITH THE USE OF PART 4, 28-10-01.
- IT IS NOT NECESSARY TO DISASSEMBLE THE TANKS TO DO THE INSPECTION. BLADDER CELL REMOVAL IS NECESSARY.

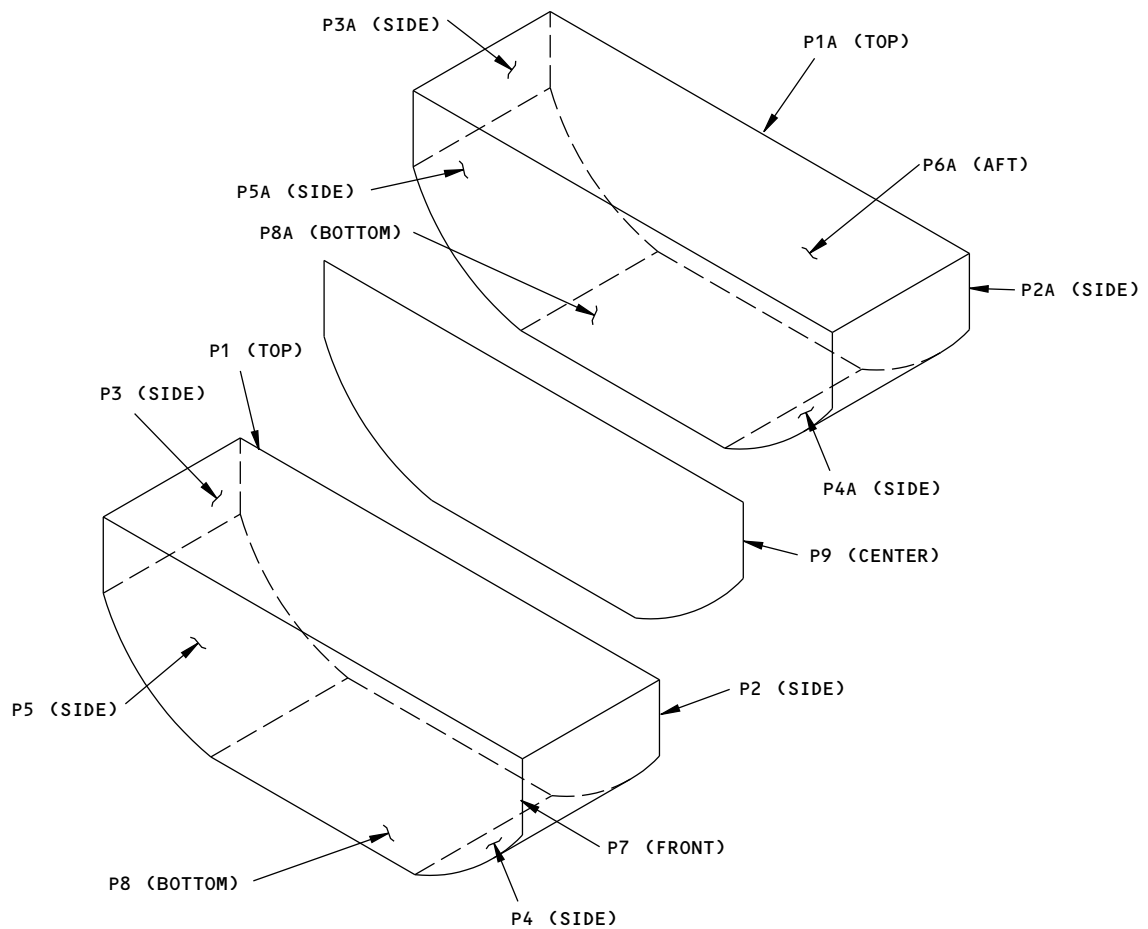
- DO AN INSPECTION ON ALL HONEYCOMB PANELS ON BOTH THE INTERNAL AND EXTERNAL SURFACES OF THE TANK FOR SIGNS OF DISBONDING. DO NOT DO AN INSPECTION ON PARTITION PANEL P9.
- YOU DO NOT NEED TO DO AN INSPECTION ON CURVED PANELS P4, P4A, P5, AND P5A IF AN INSPECTION WAS DONE BEFORE WITH THE USE OF PART 4, 28-10-01.
- IT IS NOT NECESSARY TO DISASSEMBLE THE TANKS TO DO THE INSPECTION. BLADDER CELL REMOVAL IS NECESSARY.

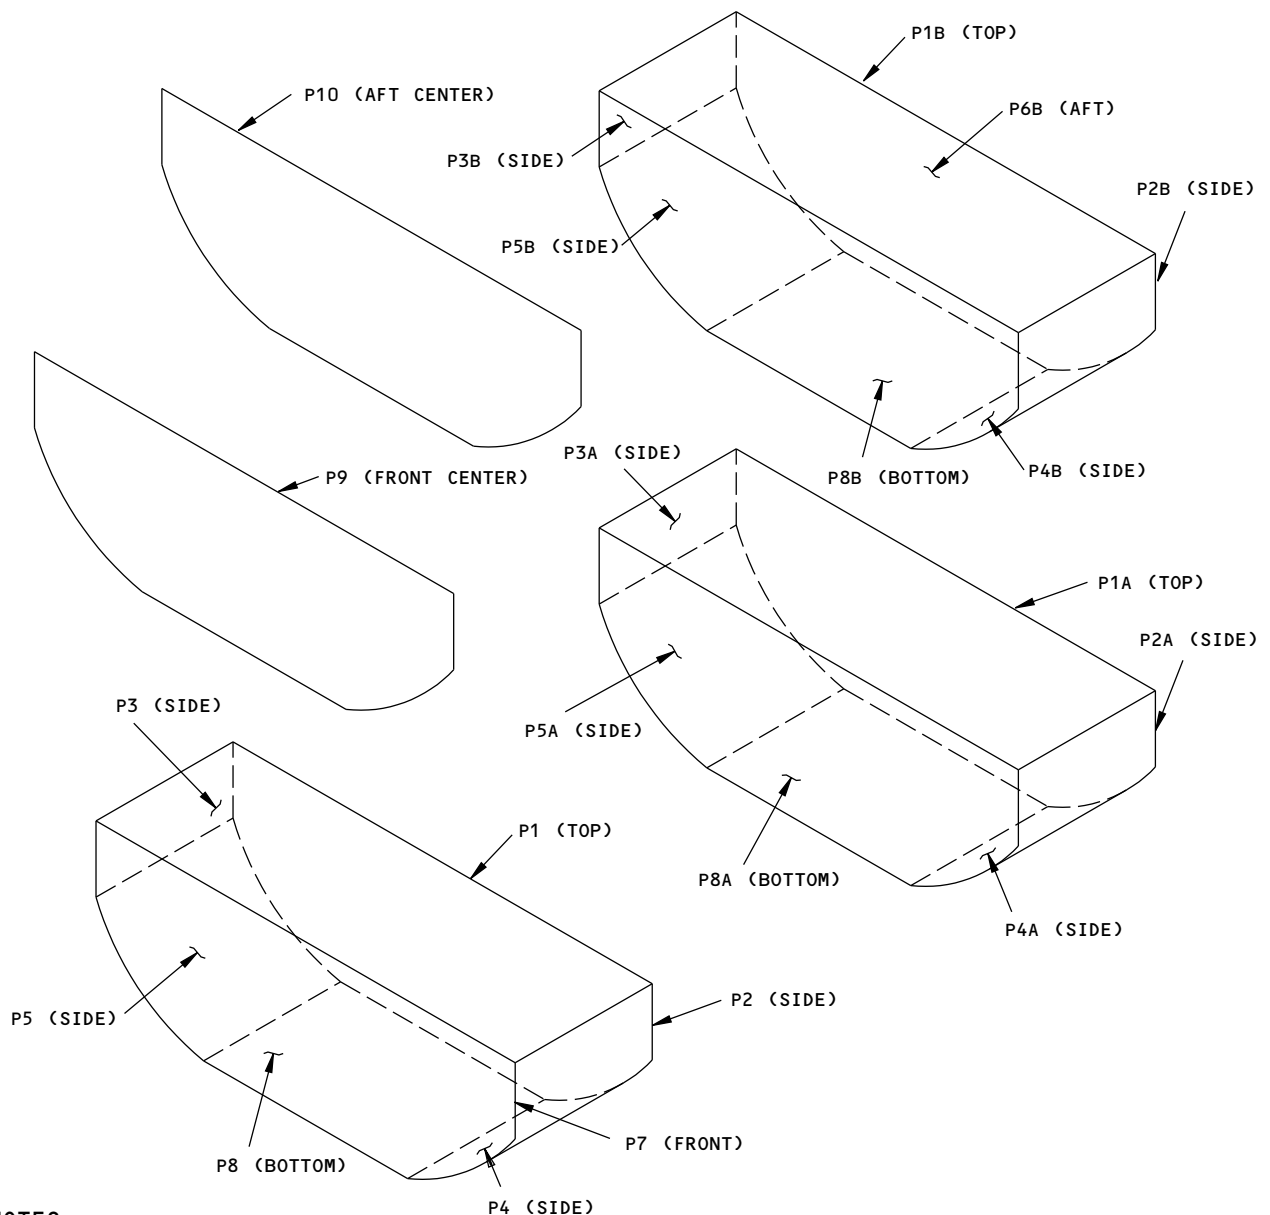
- DO AN INSPECTION ON ALL HONEYCOMB PANELS ON BOTH THE INTERNAL AND EXTERNAL SURFACES OF THE TANK FOR SIGNS OF DISBONDING. DO NOT DO AN INSPECTION ON PARTITION PANELS P9 AND P10.
- YOU DO NOT NEED TO DO AN INSPECTION ON CURVED PANELS P4, P4A, P4B, P5, P5A AND P5B IF AN INSPECTION WAS DONE BEFORE WITH THE USE OF PART 4, 28-10-01.
- IT IS NOT NECESSARY TO DISASSEMBLE THE TANKS TO DO THE INSPECTION. BLADDER CELL REMOVAL IS NECESSARY.

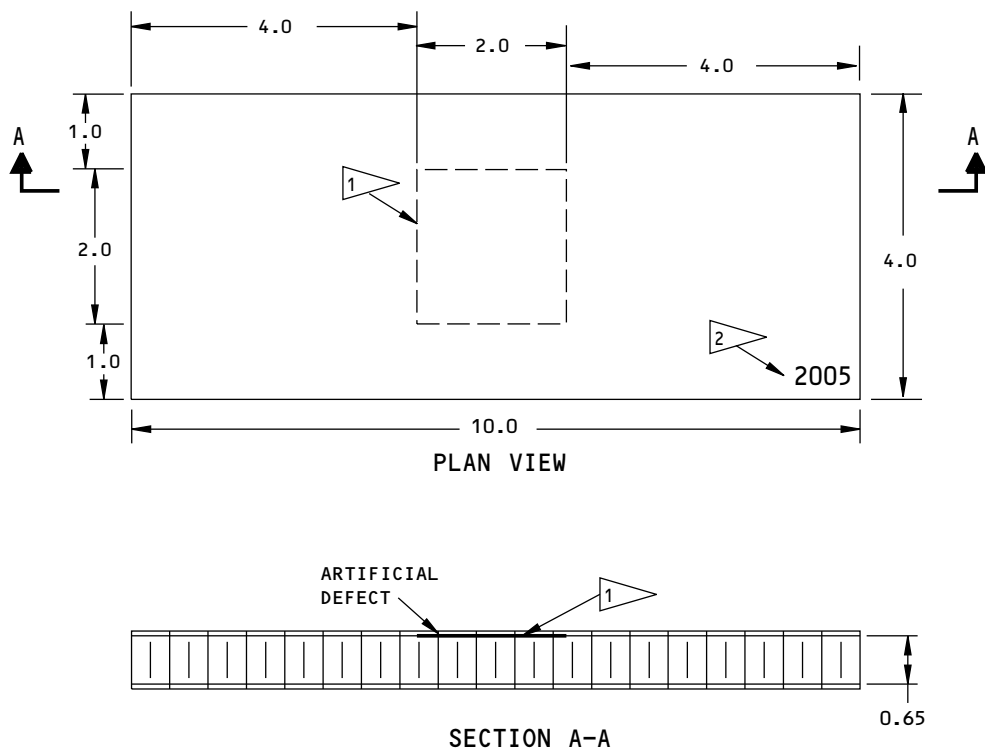
- ALL DIMENSIONS ARE IN INCHES
- MATERIAL: FACE SHEETS ARE 0.071 \pm 0.003 INCH THICK, 2024-T3 OR 7075-T6 ALUMINUM. 0.065 ALUMINUM CORE, BMS 4-4, TYPE 3-30N. ADHESIVE - BMS 5-51, TYPE II, CLASS 2, GRADE 15. ADHESIVE PRIMER - BMS 5-89
- BOND PER BAC5514-551
- TOLERANCE: X.XXX \pm 0.001
X.XX \pm 0.015
X.X \pm 0.1

NOTE: Do not use aluminum, lucite or phenolic tips with this inspection because they can give irregular results.
 - (2) Reference Standard 2005
 - (a) See Figure 2. This part is available from The Boeing Company.
 - (3) Long-Reach Probe Positioner Part No. 2001P; Ideal Specialty, Inc.
 - (a) See Figure 4. This positioner is made to fit the Sondicator probe, Part No. S-P-3 or S-3. It is possible to make a change to the probe positioner if other probes are used.

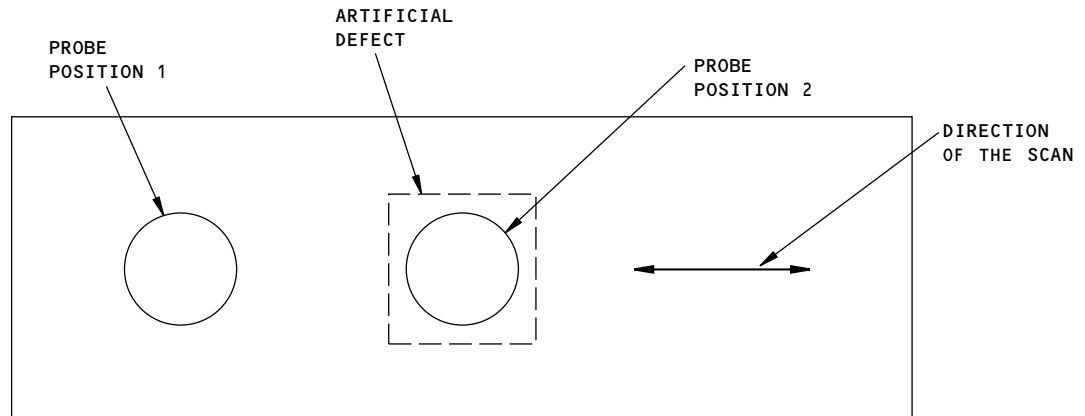
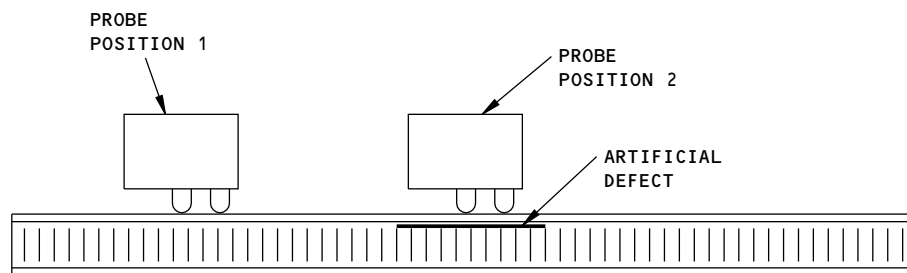
Instrument Calibration - Probe Locations
Figure 3

CALIBRATE FOR NEAR SIDE DEFECT

- (3) Put the probe on a bonded (good) area on the reference standard. See Figure 3, Position 1.
- (4) Slowly turn the phase dial clockwise and look for an upscale needle movement on the phase meter.

- (7) Quickly move the probe rearward and forward within a two-inch area on a good area of the reference standard. See Figure 3, Position 1.
NOTE: The fast probe movement is not to be done during the inspection. It is done during the calibration only to help remove disbond indications that show in a good area.

- (9) When the phase needle movement is less than 10 percent full scale, then stop the dial turns and the movement of the probe.
- (10) Slowly do a scan with the probe over the disbond area on the standard. See Figure 3, Position 2.

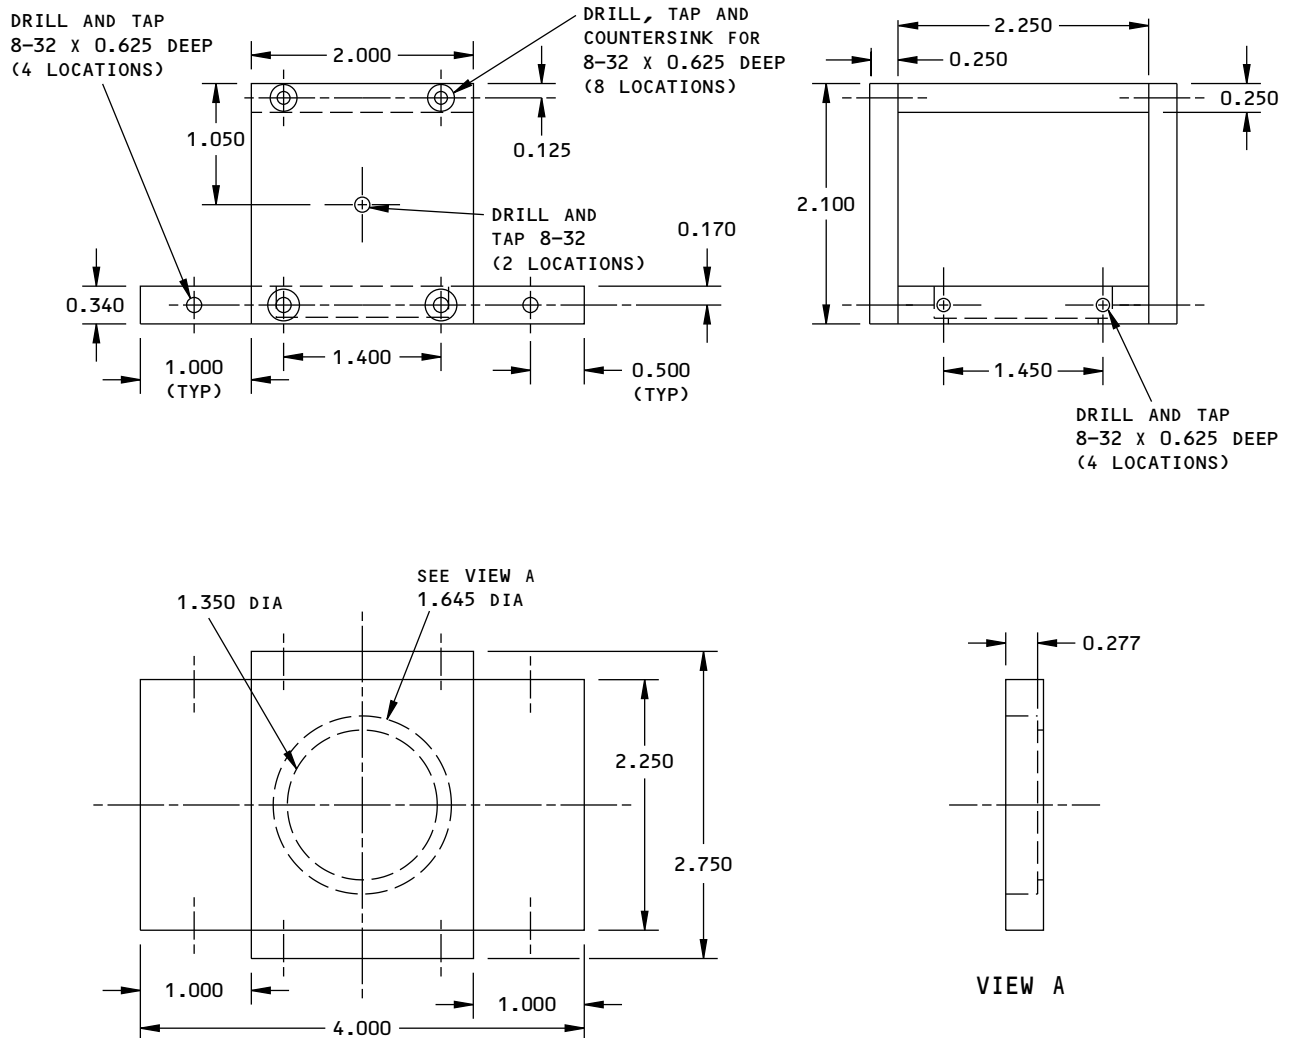
**Sondicator Probe Positioner Assembly
Figure 4 (Sheet 3 of 5)**

- ALL DIMENSIONS ARE IN INCHES
- MATERIAL: MICARTA
- TOLERANCE: XXX ± 0.005
XX ± 0.010
X ± 0.020

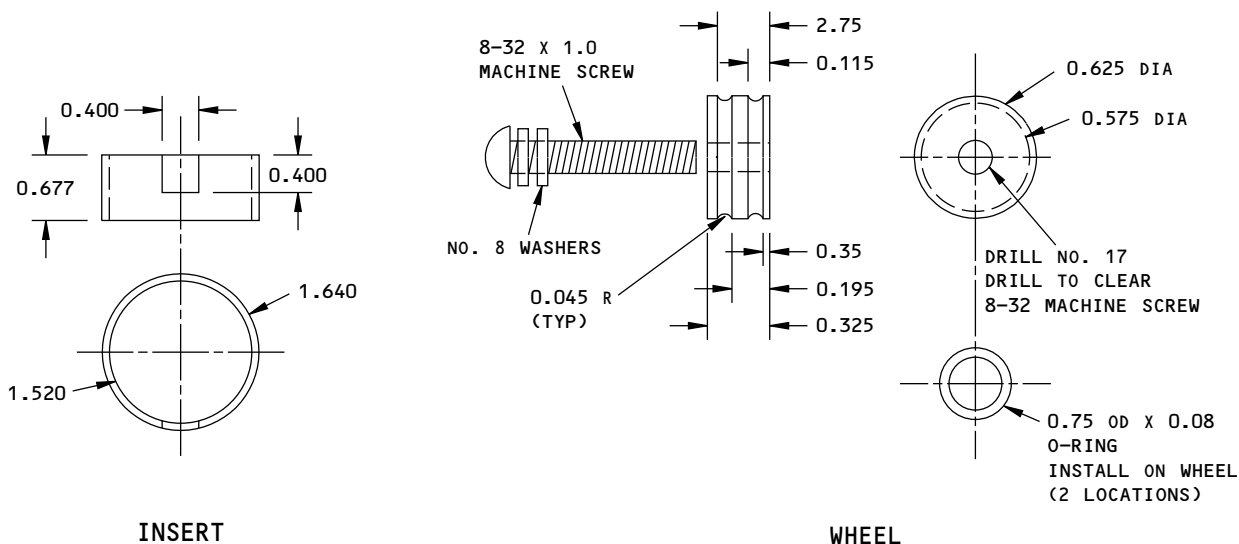
Sondicator Probe Positioner Assembly
Figure 4 (Sheet 4 of 5)

- ALL DIMENSIONS ARE IN INCHES
- MATERIAL: MICARTA
- TOLERANCE: XXX ± 0.005
XX ± 0.010
X ± 0.020

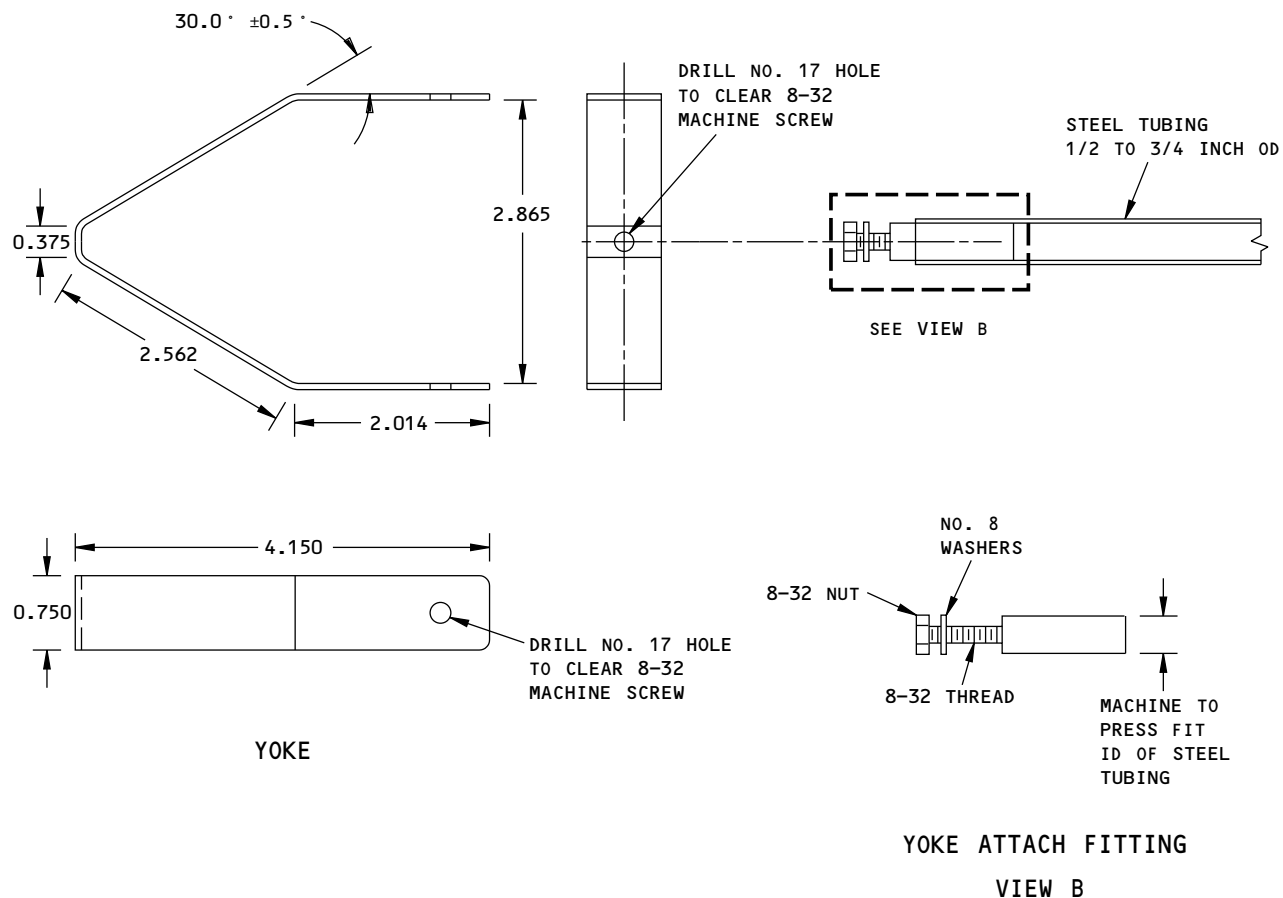
Sondicator Probe Positioner Assembly
Figure 4 (Sheet 5 of 5)

- ALL DIMENSIONS ARE IN INCHES
- MATERIAL: 2024-TXX
- TOLERANCE: XXX ±0.005
XX ±0.010
X ±0.020

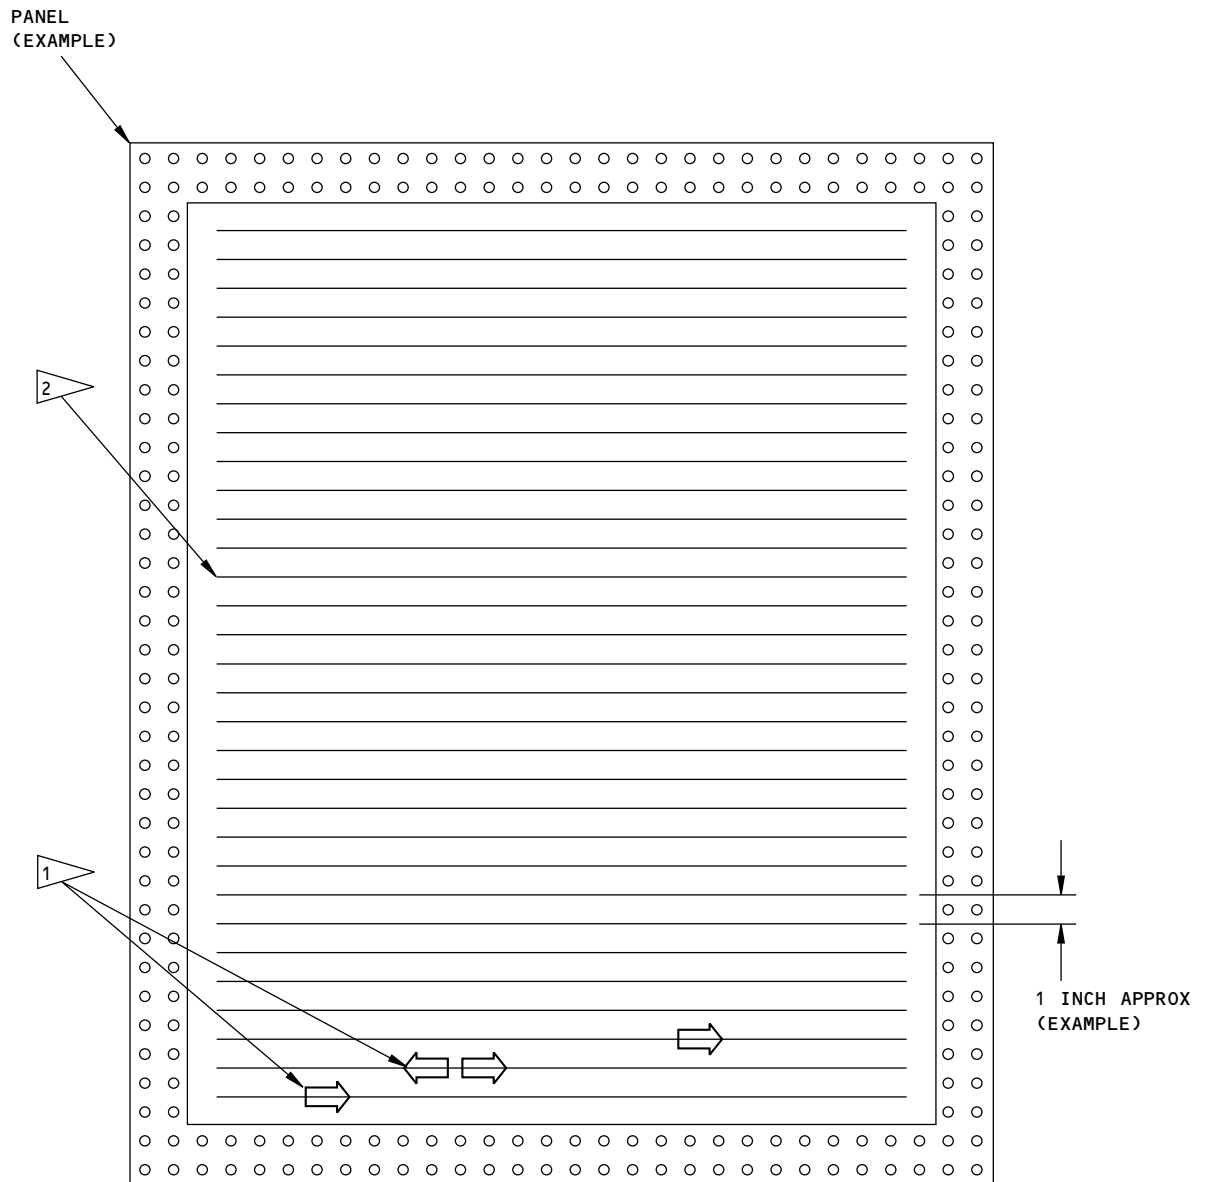
AREA OF FASTENERS;
 AREA OF FASTENERS IS NOT EXAMINED
 DURING THIS PROCEDURE.
