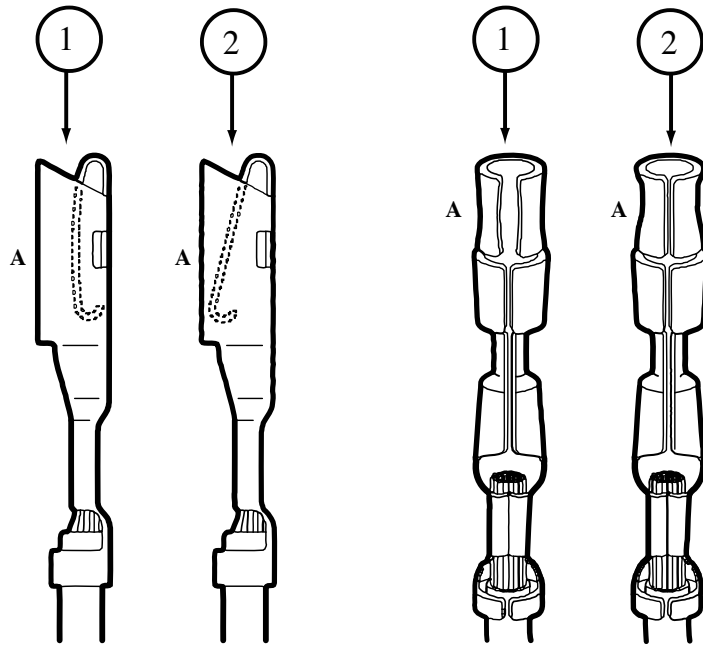
Deformed (enlarged) female terminals

1 = Enlarged

2 = Normal

Any probe entering the terminal may enlarge the contact spring opening creating an intermittent signal.

Insert the correct mating terminal (Location A) from the service kit and feel for a loose fit.
