## 737 NON-DESTRUCTIVE TEST MANUAL

### PART 4 - ULTRASONIC

#### FORWARD FLANGE OF THE OUTBOARD CHORD AT THE INTERSECTION OF STATION 727 AND STRINGER S-18A

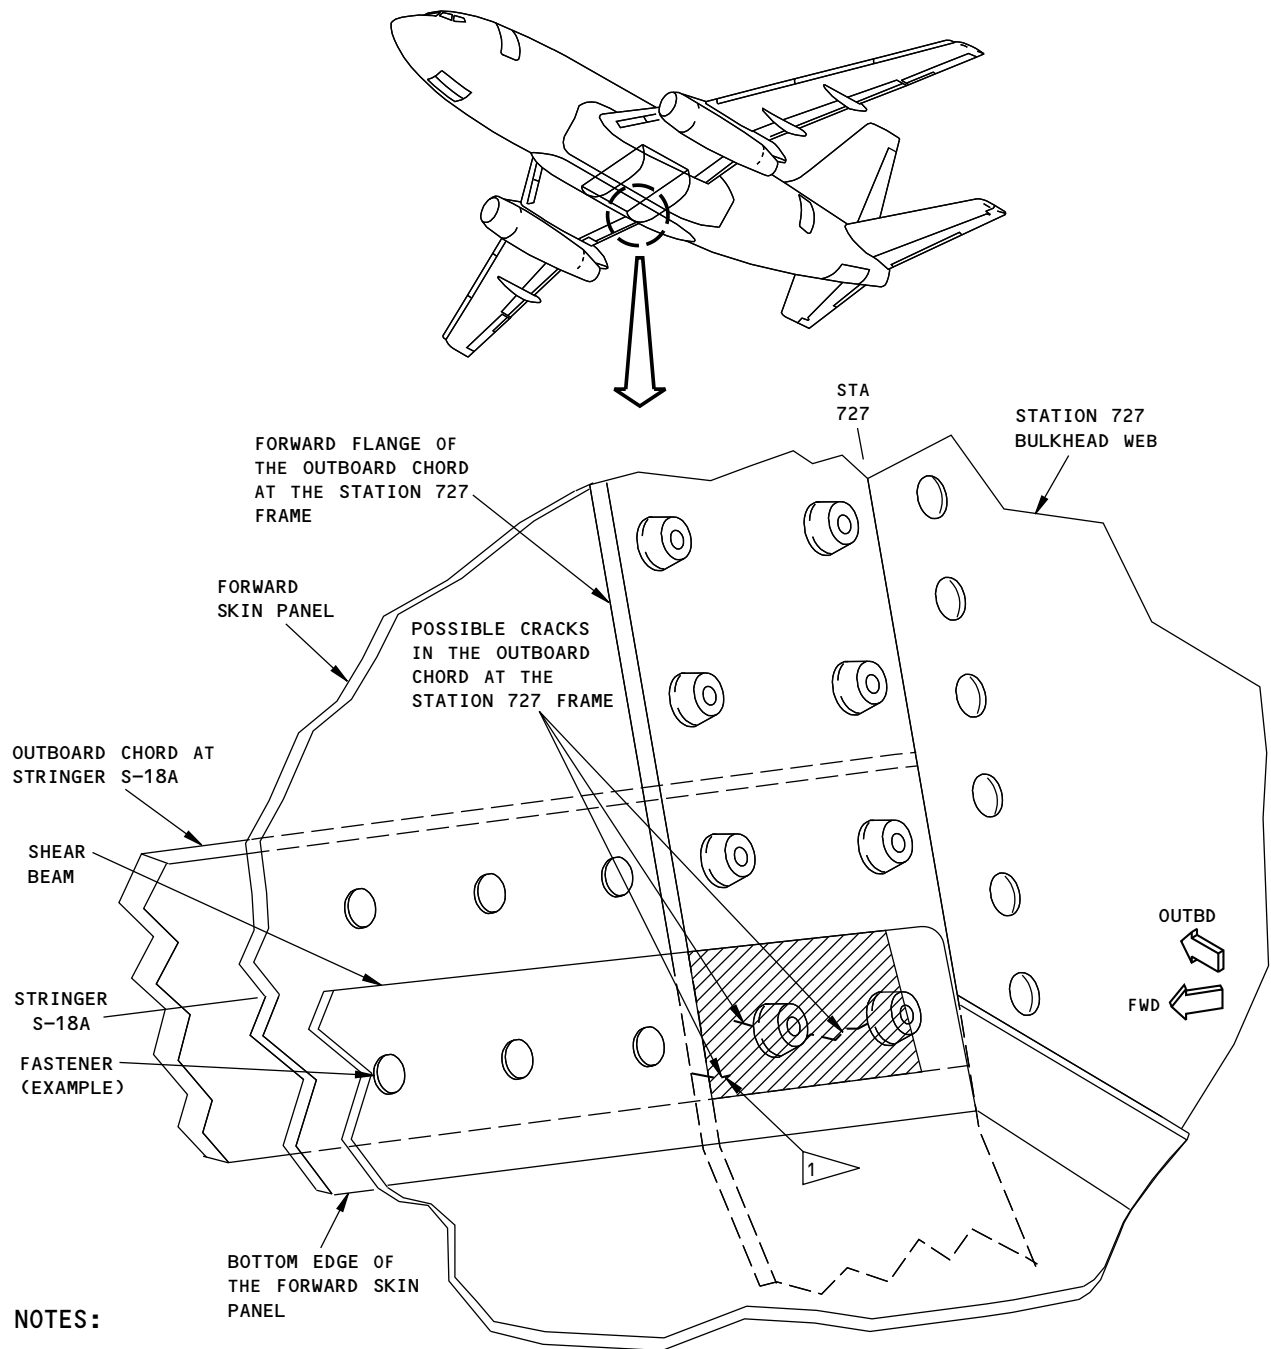
//// INSPECTION AREA

1 IT IS POSSIBLE FOR CRACKS TO BE AWAY FROM THE FASTENER HOLES AS SHOWN.

- A. Use this ultrasonic inspection procedure to examine the forward flange of the outboard chord for cracks at the intersection of the Station 727 frame and Stringer S-18A. Cracks can occur in the outboard chord at the fastener holes or away from the fastener holes as shown in the inspection area identified in Figure 1. The type of cracks this procedure can find are those that travel in a forward and aft direction as shown in Figure 1.
- B. The inspection is done while in the main landing gear wheel well and again on the outboard side of the wheel well.
- C. Service Bulletin Reference: 737-53A1166

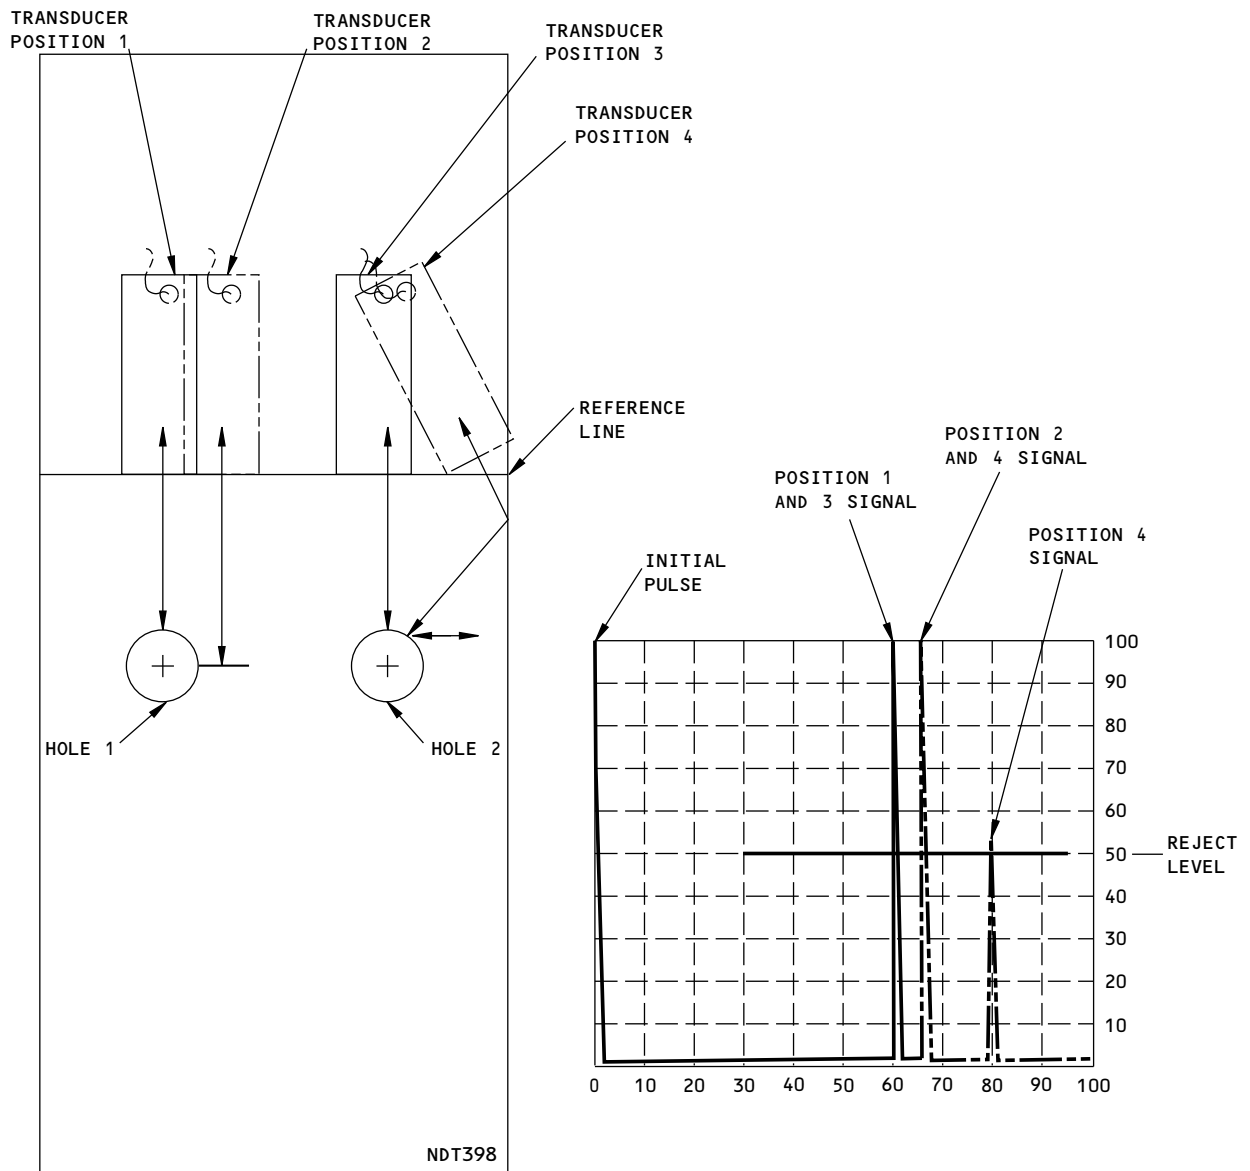
- THE DOUBLE ARROWS SHOWN ABOVE ON THE REFERENCE STANDARD SHOW THE DIRECTION OF SOUND TRAVEL.
- THE SIGNAL AT 60 PERCENT OF FULL SCREEN WIDTH IS FROM POSITION 1 TO HOLE 1 AND FROM POSITION 3 TO HOLE 2.

- THE SIGNAL AT 65 OF FULL SCREEN WIDTH IS FROM POSITION 2 TO THE NOTCH. ALSO IT IS ONE OF THE SIGNALS FROM POSITION 4 FROM THE EDGE TO HOLE 2.
- THE SIGNAL AT 80 PERCENT OF FULL SCREEN WIDTH IS THE SECOND SIGNAL FROM POSITION 4. THE SOUND AT POSITION 4 TRAVELS FROM POSITION 4, TO THE EDGE, TO HOLE 2 AND BACK TO THE EDGE. THE HEIGHT OF THIS SIGNAL AT 80 PERCENT OF FULL SCREEN WIDTH CAN BE DIFFERENT. THE LARGE TURN OF THE TRANSDUCER AT POSITION 4 IS DONE ONLY DURING CALIBRATION TO SHOW HOW A FALSE CRACK INDICATION COULD SHOW ON THE SCREEN IF THE LARGE TURN IS DONE DURING THE INSPECTION. DO NOT TURN THE TRANSDUCER THIS MUCH WHEN THE SCAN IS DONE AT THE FORWARD EDGE OF THE FRAME CHORD DURING THE INSPECTION.

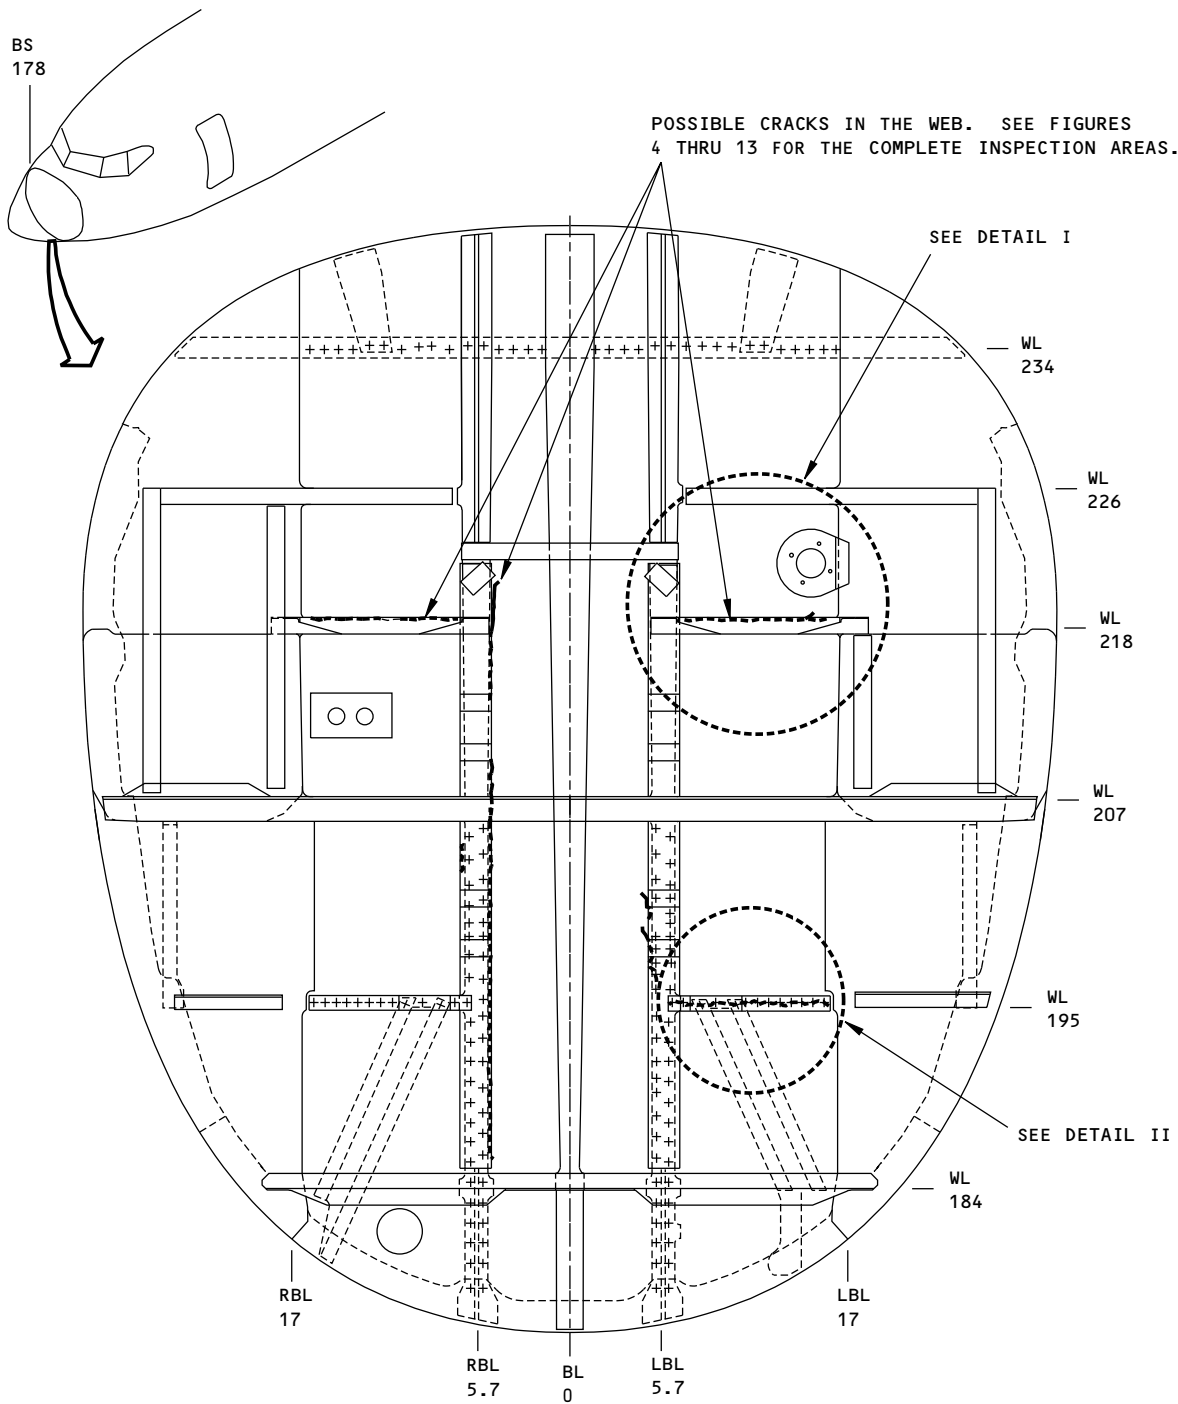
- THE FORWARD SIDE OF THE BULKHEAD IS SHOWN

- A. Use this procedure to examine areas of the pressure web that are behind the straps and stiffeners at body station 178.
- B. See Figure 1 for the location of the inspection areas.
- C. This procedure uses an ultrasonic instrument set for pulse echo.
- D. This procedure was made to find cracks that are 0.2 inches (5 mm) or more in length.
- E. Service Bulletin Reference: 737-53-1173

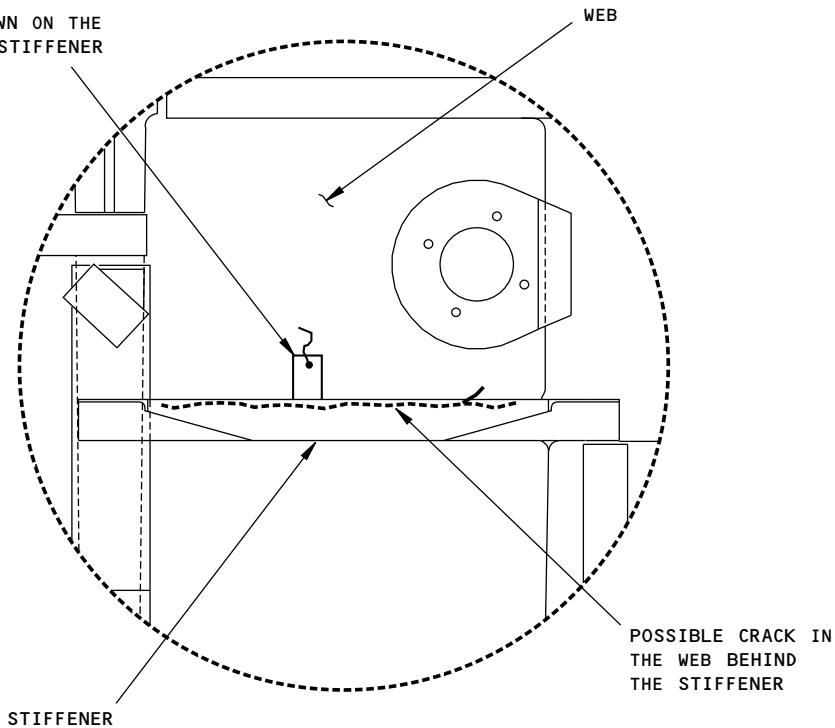
DETAIL I

TRANSDUCER SHOWN ON THE  
WEB ALONG THE STIFFENER

- (1) Make sure the front of the transducer is against the edge of the stiffeners or straps.
  - (2) Slowly turn the transducer a short distance (approximately 30 degrees) left and right to find possible cracks that are not parallel to the edge of the stiffeners or straps. See Figure 1 (sheet 2).

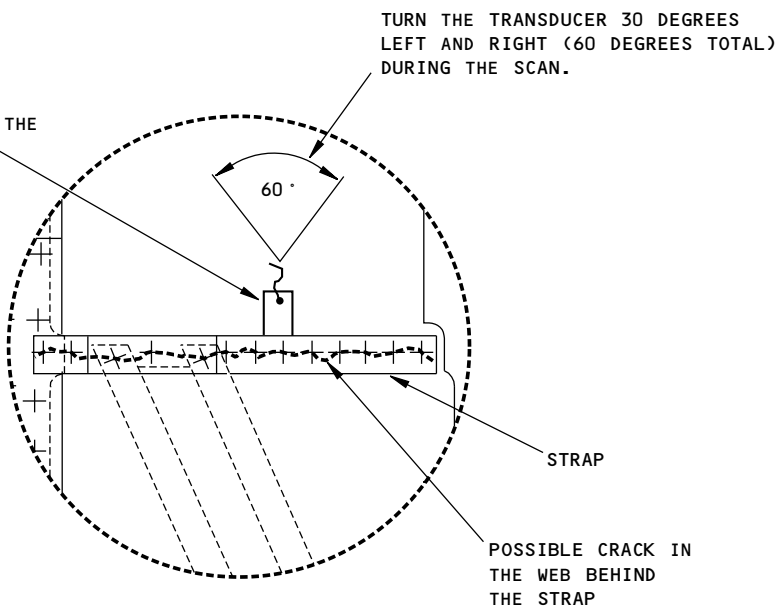
DETAIL II

TRANSDUCER SHOWN ON THE  
WEB ALONG THE STRAP

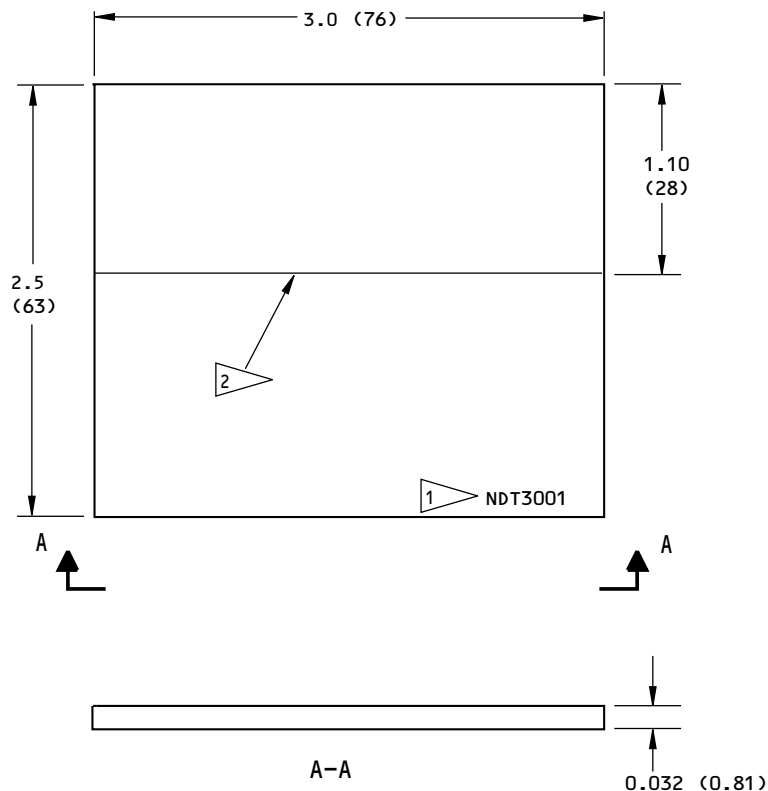
ALL DIMENSIONS ARE IN INCHES  
(MILLIMETERS ARE IN PARENTHESES)

- D. Reference Standards
  - (1) Use reference standard NDT3001. See Figure 2 for data about the reference standard.
- E. Couplant
  - (1) Use an ultrasonic couplant that will not cause corrosion or other damage to the airplane.

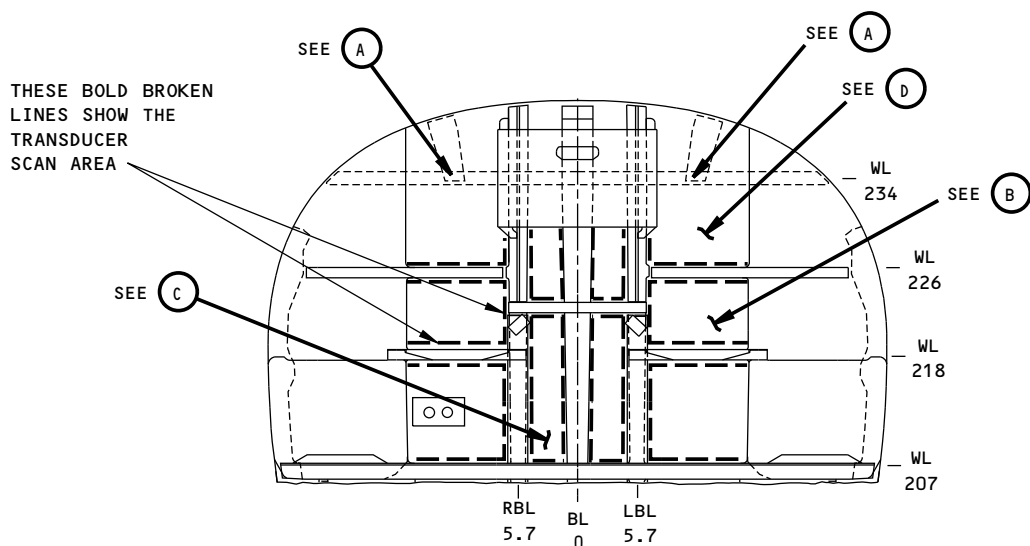
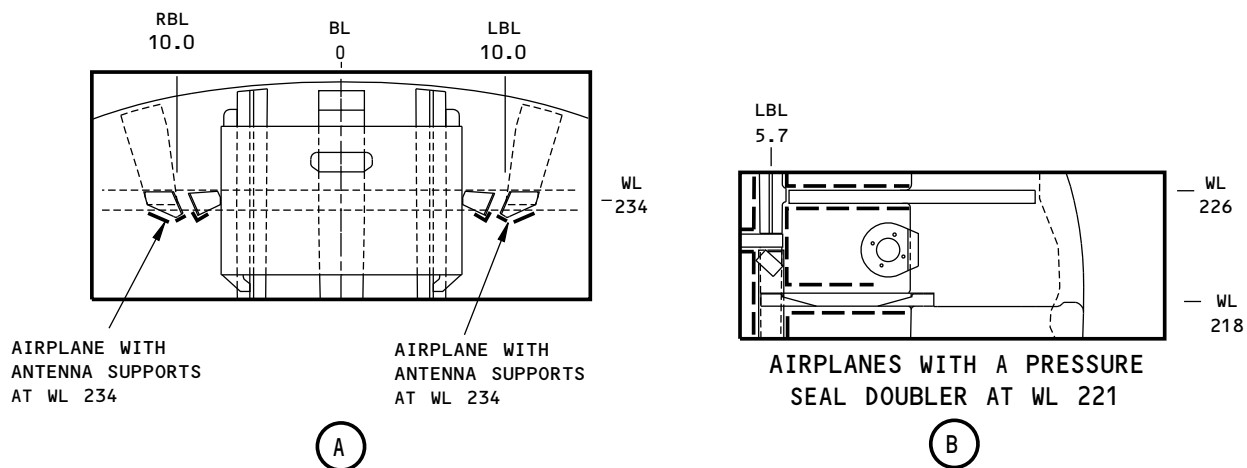
BS 178 Pressure Web Inspection Area - Groups 1, 8, 9, 11 thru 14, 17, 19, 21 thru 31, 35, 36, 37, 42 and 44

GROUPS 1,8,9,11 THRU 14,17,19,21 THRU 31,35,36,37,42 AND 44 -  
FORWARD SIDE SHOWN

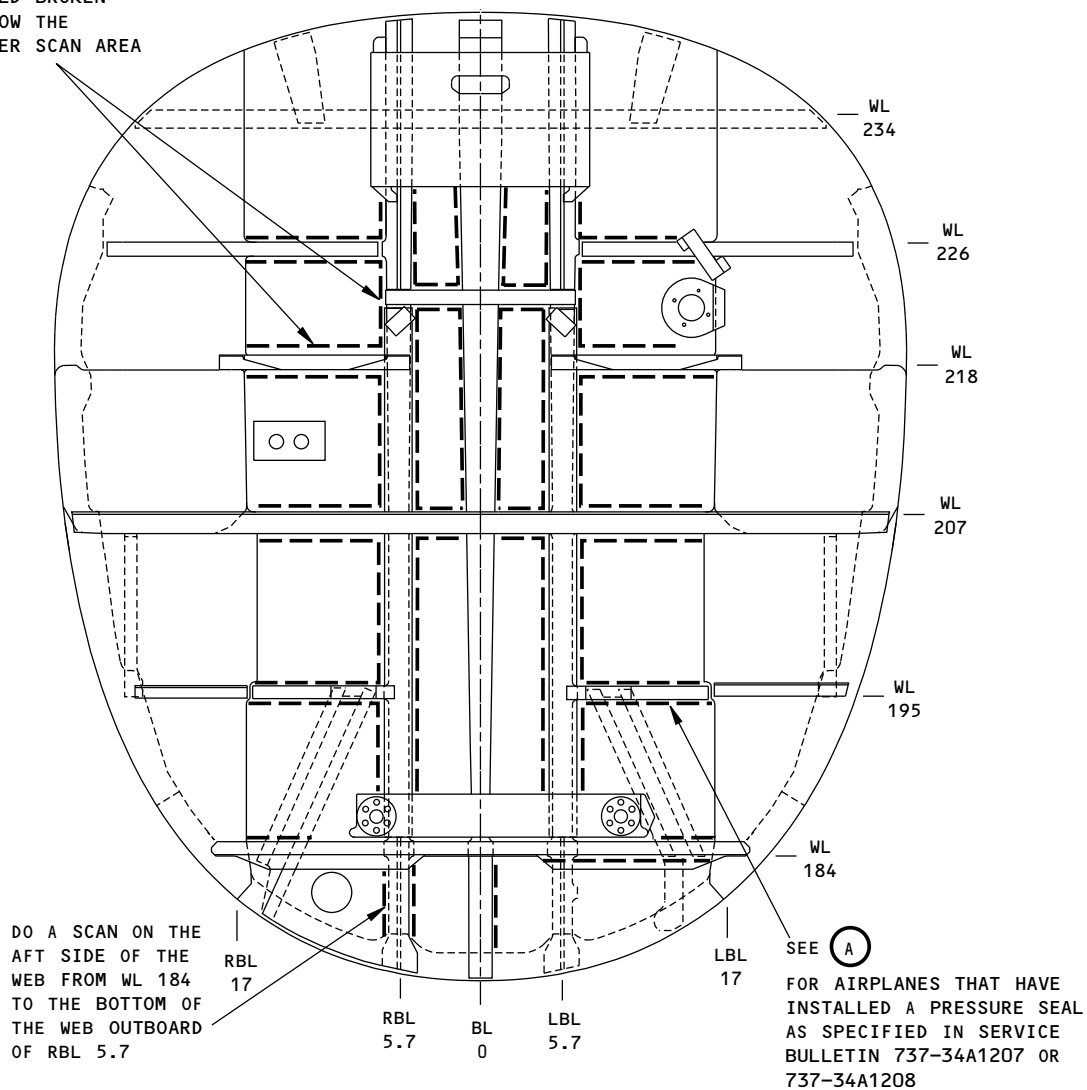
BS 178 Pressure Web Inspection Area - Groups 2 and 38  
Figure 6 (Sheet 1 of 2)

THESE BOLD BROKEN  
LINES SHOW THE  
TRANSDUCER SCAN AREA

GROUPS 2 AND 38 - FORWARD SIDE SHOWN

- DO A SCAN WITH THE TRANSDUCER ON THE WEB ALONG THE STIFFENERS AND STRAPS. THE SCAN AREA IS WHERE THE BOLD BROKEN LINES ARE SHOWN.
- REFER TO SERVICE BULLETIN 737-53-1173 TO IDENTIFY THE AIRPLANES IN THE GROUP(S) SPECIFIED IN THE TITLE OF THIS FIGURE.

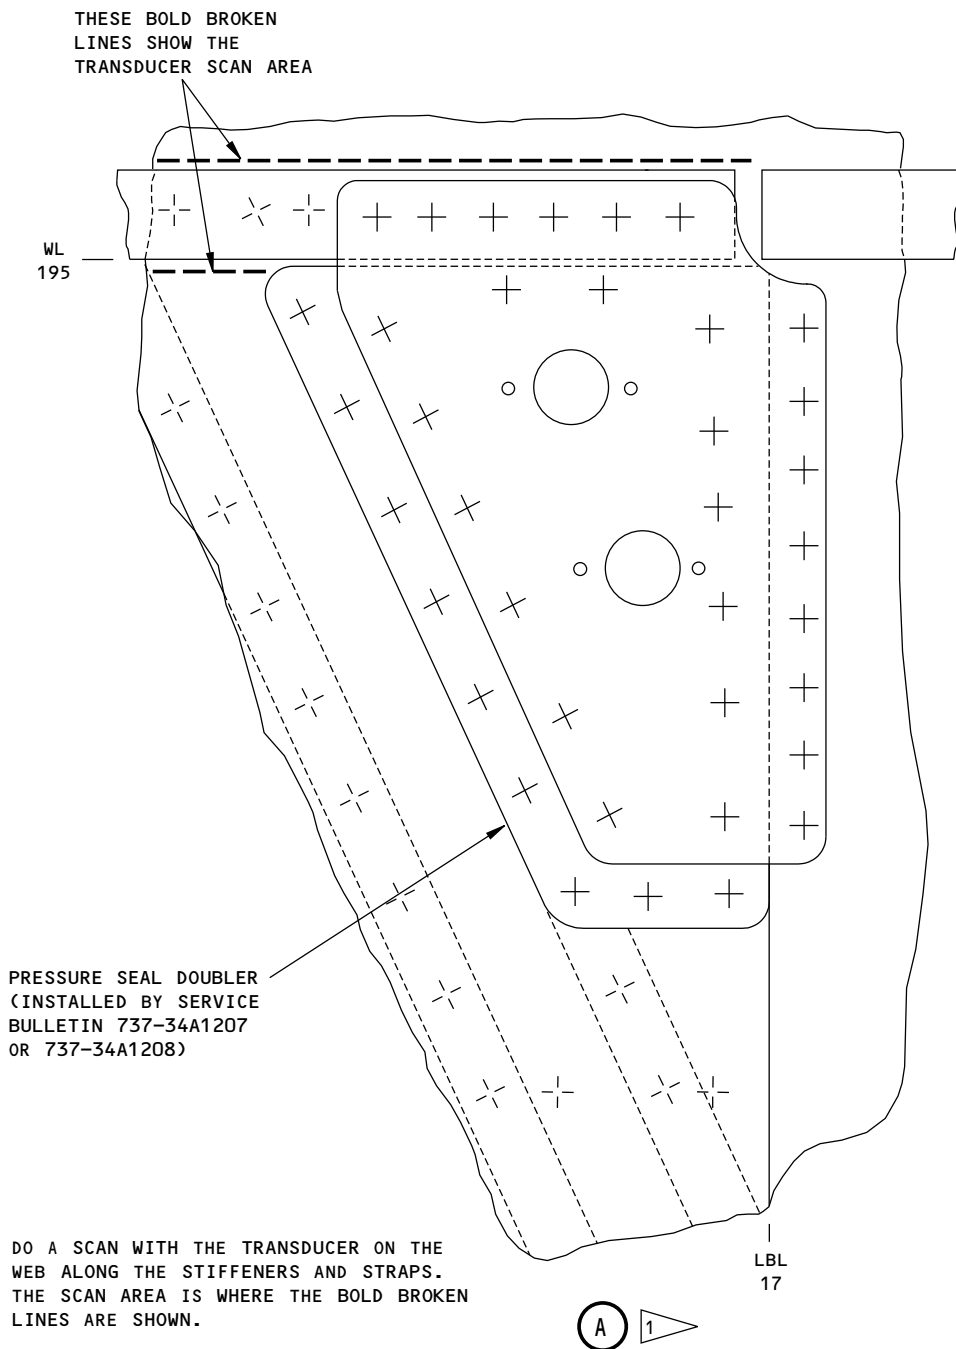
**BS 178 Pressure Web Inspection Area - Groups 2 and 38**  
**Figure 6 (Sheet 2 of 2)**

- DO A SCAN WITH THE TRANSDUCER ON THE WEB ALONG THE STIFFENERS AND STRAPS. THE SCAN AREA IS WHERE THE BOLD BROKEN LINES ARE SHOWN.
- REFER TO SERVICE BULLETIN 737-53-1173 TO IDENTIFY THE AIRPLANES IN THE GROUP(S) SPECIFIED IN THE TITLE OF THIS FIGURE.

FIGURE 6, SHEET 2  
FOR AIRPLANES WITH A  
PRESSURE SEAL DOUBLER  
INSTALLED AS SPECIFIED  
IN SERVICE BULLETIN  
737-34A1207 OR  
737-34A1208

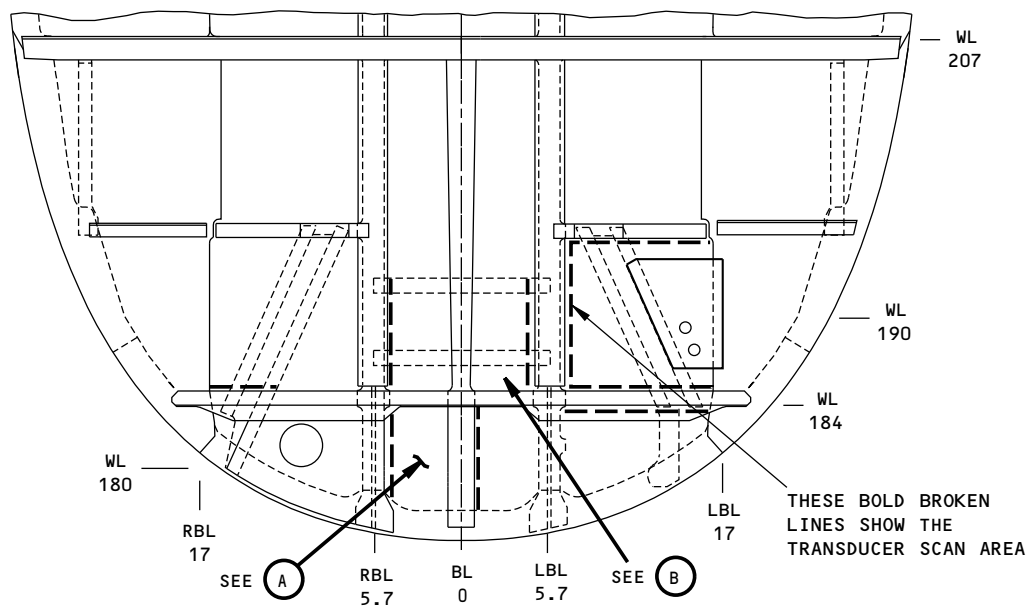
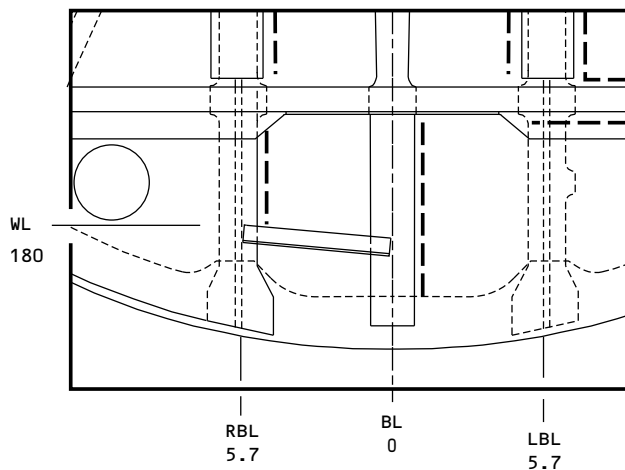
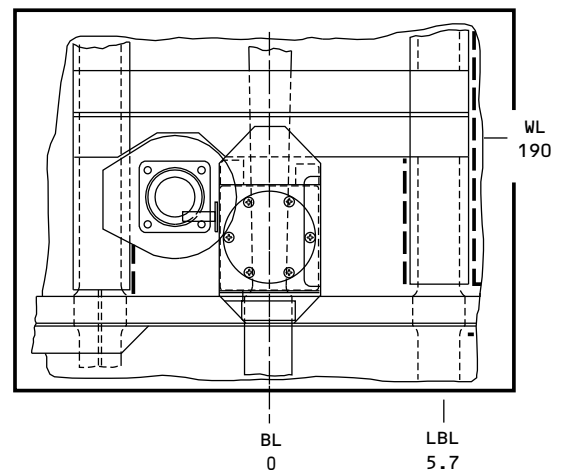
BS 178 Pressure Web Inspection Area - Groups 11 thru 15, 17, 19 and 42  
Figure 12 (Sheet 1 of 2)

GROUPS 11 THRU 15,17,19,42 - FORWARD SIDE SHOWN

AIRPLANES WITH A  
SUPPORT AT WL 180

AIRPLANES WITH AN  
ANTENNA SUPPORT AT WL 190

- DO A SCAN WITH THE TRANSDUCER ON THE WEB ALONG THE STIFFENERS AND STRAPS. THE SCAN AREA IS WHERE THE BOLD BROKEN LINES ARE SHOWN.
- REFER TO SERVICE BULLETIN 737-53-1173 TO IDENTIFY THE AIRPLANES IN THE GROUP(S) SPECIFIED IN THE TITLE OF THIS FIGURE.
- FOR GROUPS 11 THRU 15,17,19,42 SEE FIGURE 12 FOR AN ALTERNATIVE INSPECTION CONFIGURATION.

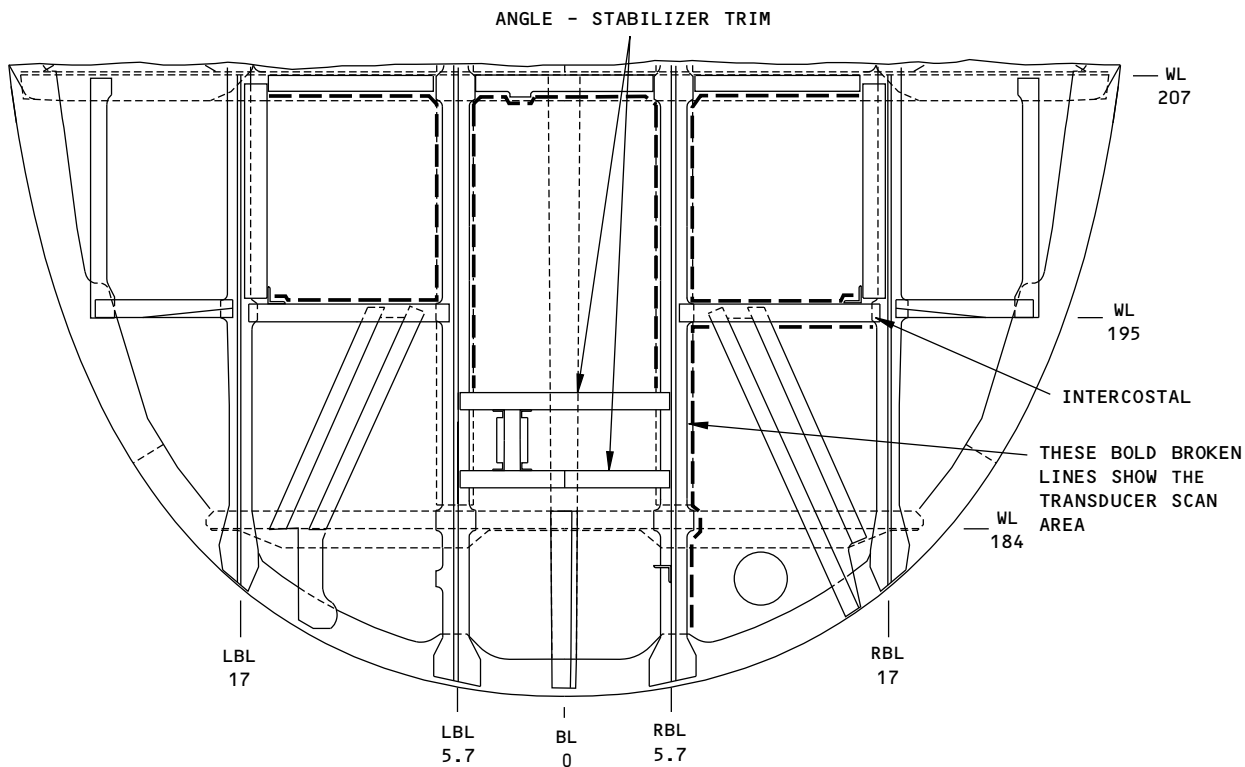
### BS 178 Pressure Web Inspection Area - Groups 11 thru 15, 17, 19 and 42 Figure 12 (Sheet 2 of 2)

## ALTERNATIVE ULTRASONIC INSPECTION GROUPS 11 THRU 15,17,19,42 - AFT SIDE SHOWN

- DO A SCAN WITH THE TRANSDUCER ON THE WEB ALONG THE STIFFENERS AND STRAPS. THE SCAN AREA IS WHERE THE BOLD BROKEN LINES ARE SHOWN.
- REFER TO SERVICE BULLETIN 737-53-1173 TO IDENTIFY THE AIRPLANES IN THE GROUP(S) SPECIFIED IN THE TITLE OF THIS FIGURE.
- THE INSPECTION AREA SHOWN ABOVE IS ON THE AFT SIDE OF THE WEB
- SEE FIGURE 5 FOR AN ALTERNATIVE INSPECTION CONFIGURATION

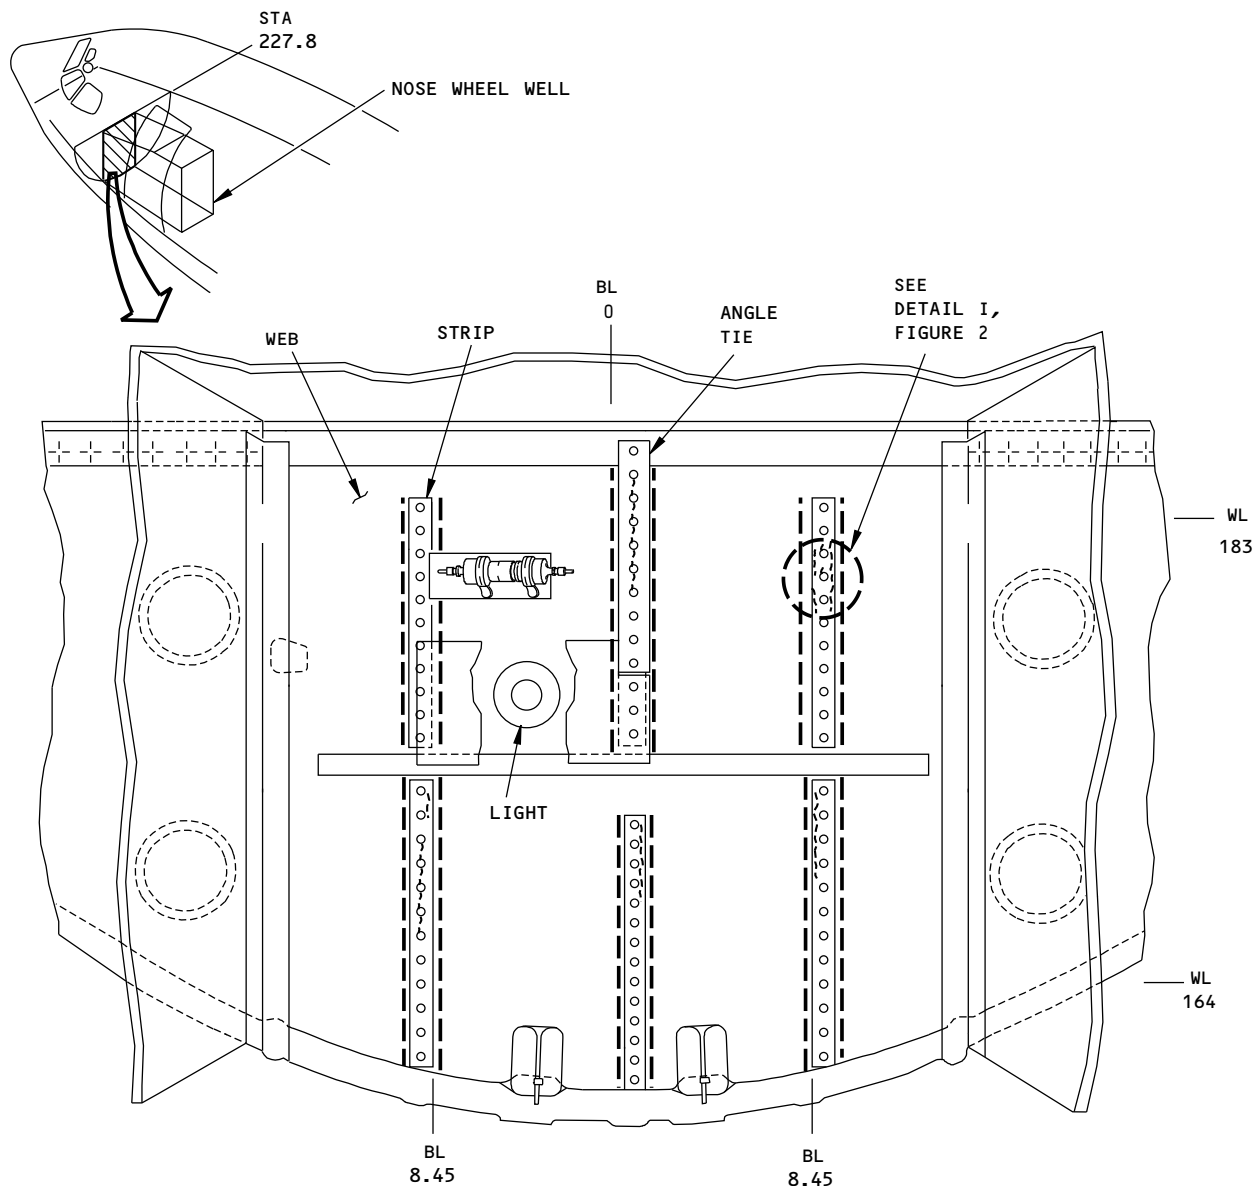
- DO A SCAN WITH THE TRANSDUCER ON THE WEB ALONG THE STRIPS AND ANGLE TIE.
- THE TRANSDUCER SCAN AREA IS WHERE THE BOLD BROKEN LINES ARE SHOWN. →
- THE AFT SIDE OF THE WEB IS SHOWN

- A. Use this procedure to examine areas of the pressure web of the nose wheel well at body station 227.8. This inspection procedure can be used to find cracks that are behind the strips and angle tie at buttock lines 0, 8.45 left, and 8.45 right. This inspection is done on the aft side of the pressure web.
- B. See Figure 1 and Figure 2 for the location of the inspection areas.
- C. This procedure uses an ultrasonic instrument set for pulse echo.
- D. This procedure was made to find cracks that are 0.2 inch (5 mm) or more in length.

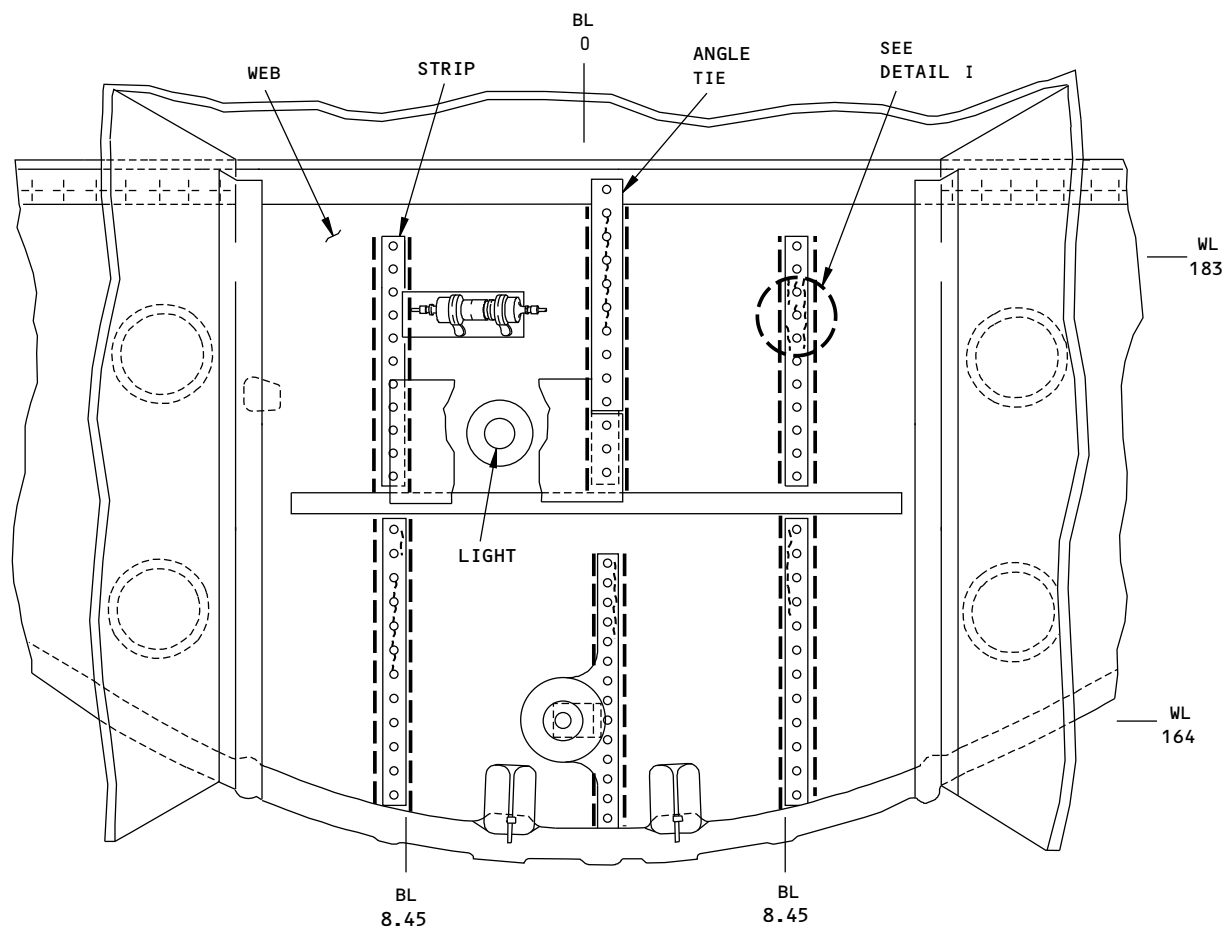
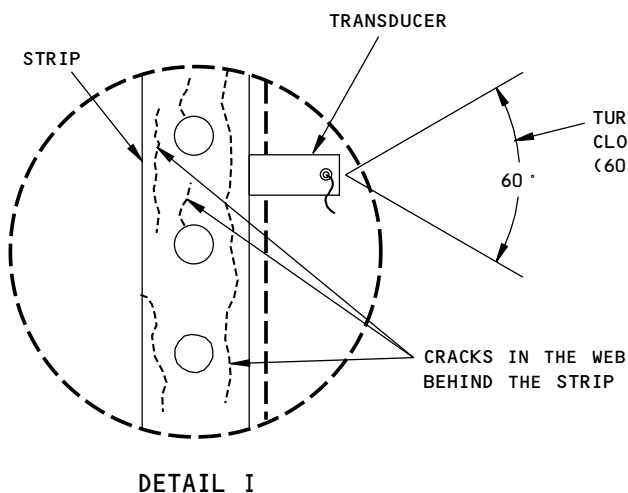
TURN THE TRANSDUCER 30 DEGREES  
CLOCKWISE AND COUNTERCLOCKWISE  
(60 DEGREES TOTAL) DURING THE SCAN.

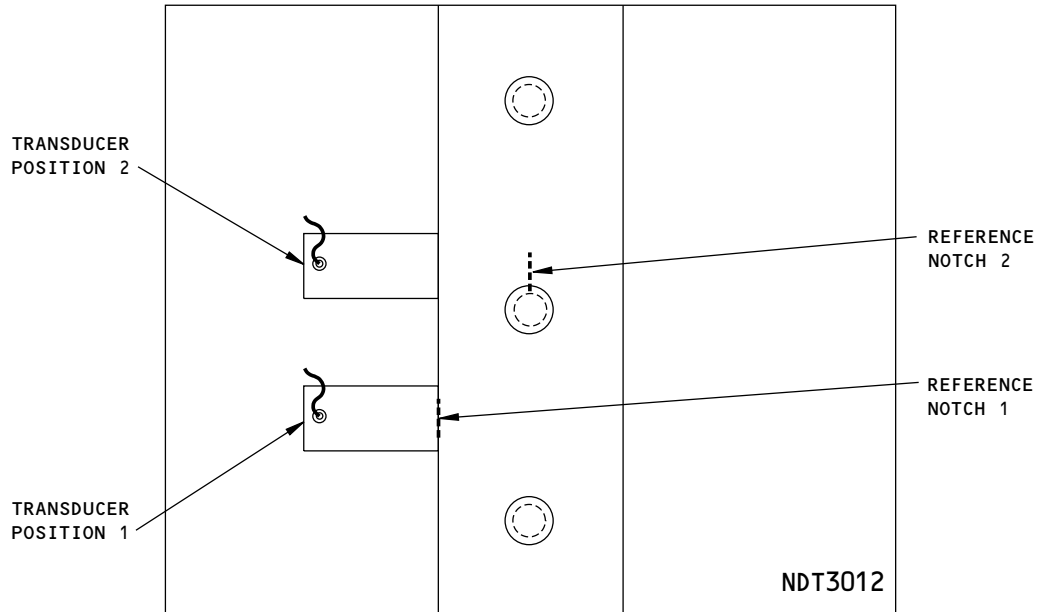
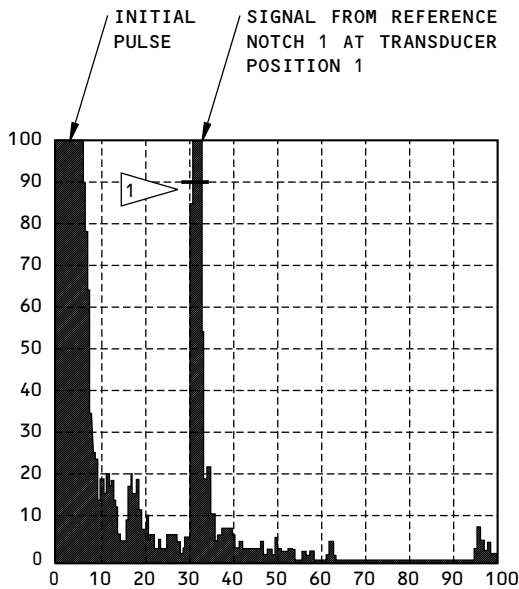
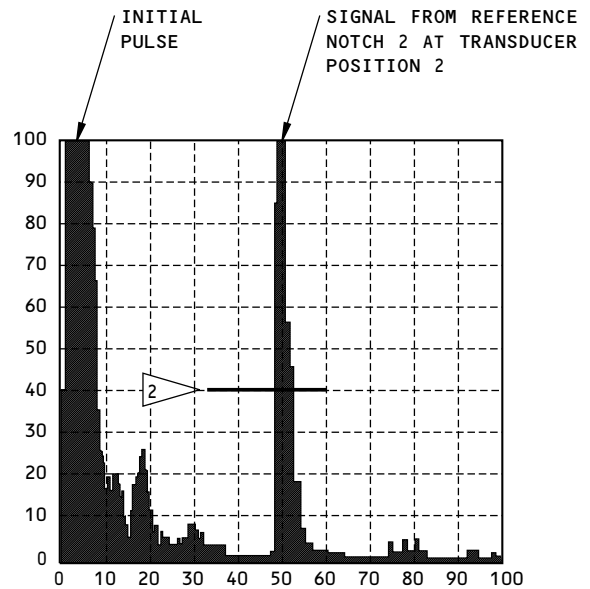
- 1 THIS REJECT LEVEL IS AT 90 PERCENT OF FULL SCREEN HEIGHT AND BETWEEN 29 PERCENT AND 33 PERCENT OF FULL SCREEN WIDTH.
- 2 THIS REJECT LEVEL IS AT 40 PERCENT OF FULL SCREEN HEIGHT AND BETWEEN 34 PERCENT AND 60 PERCENT OF FULL SCREEN WIDTH.

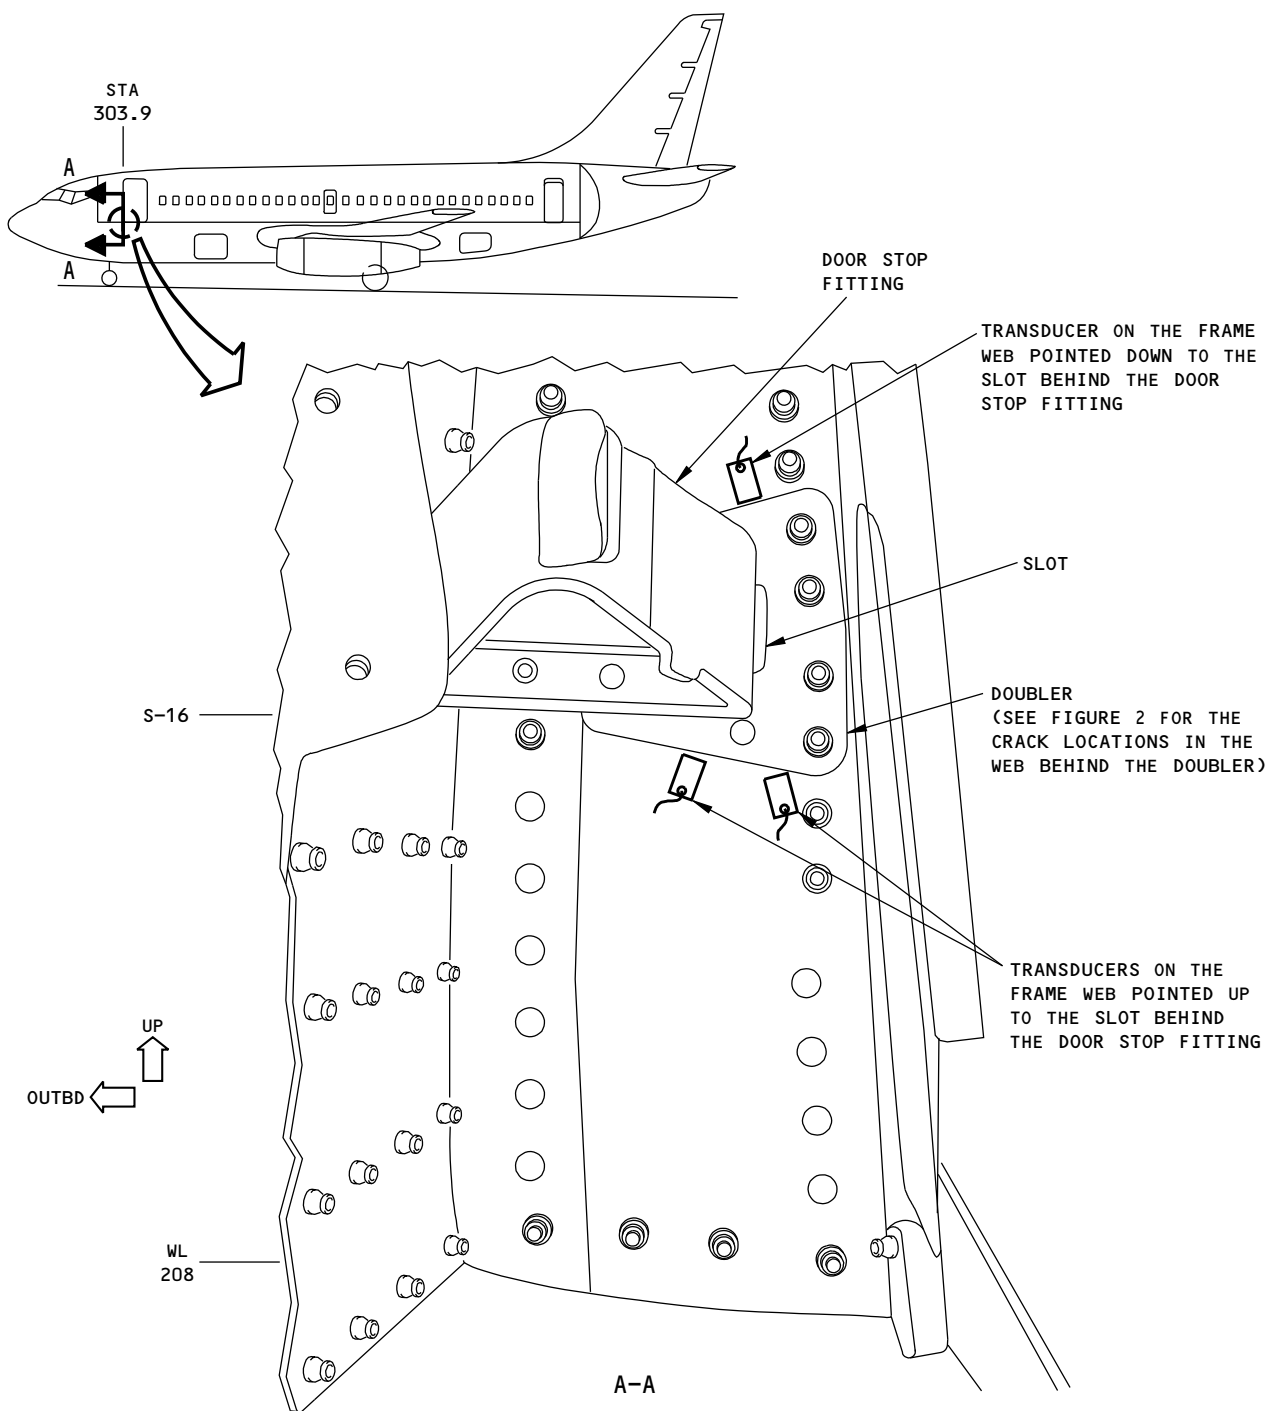
THIS IS THE VIEW OF THE FRAME WEB AT STATION 303.9 AS YOU LOOK FORWARD.  
IT IS SHOWN WITH THE FORWARD SCUFF PLATE AND THE DOOR REVEAL REMOVED

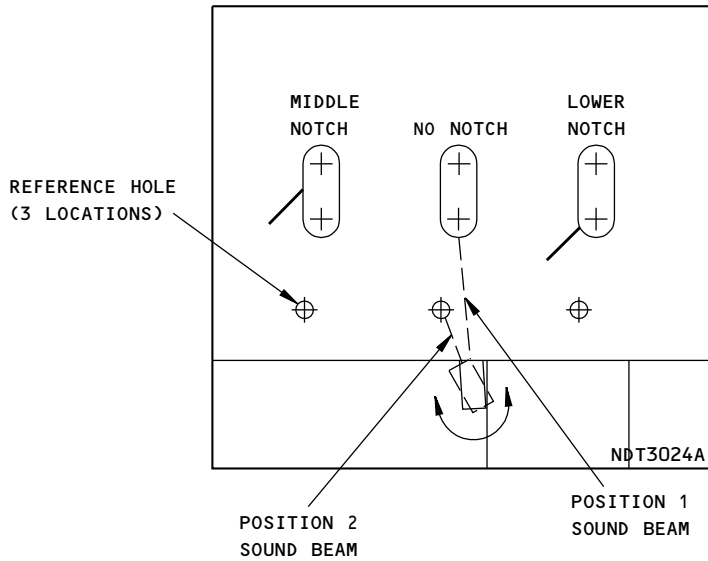
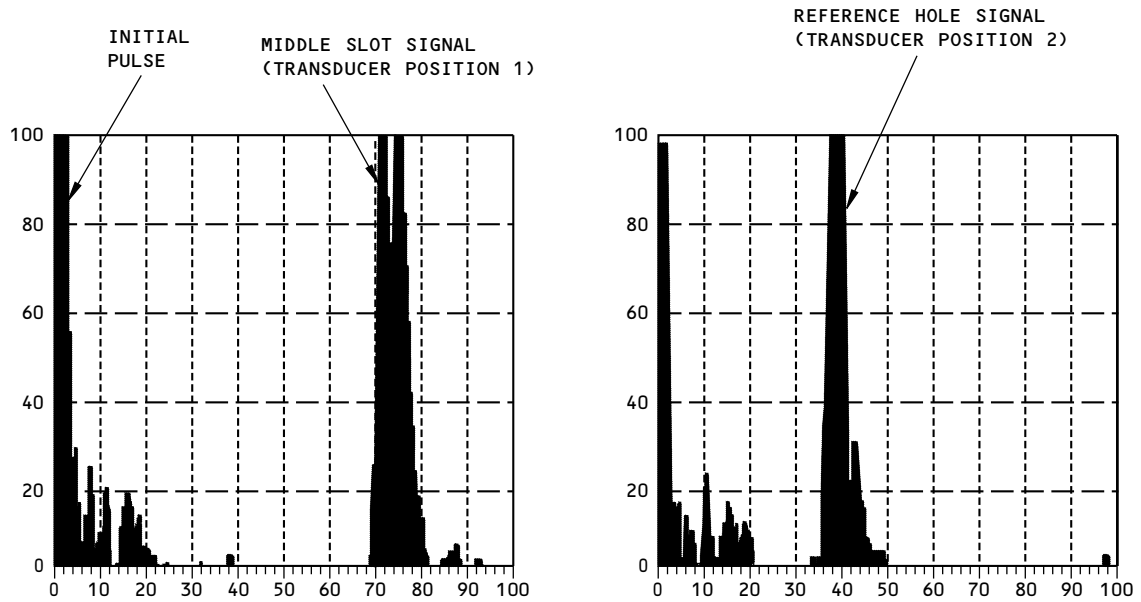
TURN THE TRANSDUCER TO THE LEFT TO SEE THE SLOT SIGNAL DECREASE AND THE REFERENCE HOLE SIGNAL SHOW ON THE SCREEN. THIS REFERENCE HOLE IS AT THE APPROXIMATE LOCATION WHERE A FASTENER IS INSTALLED ON THE FRAME WEB.

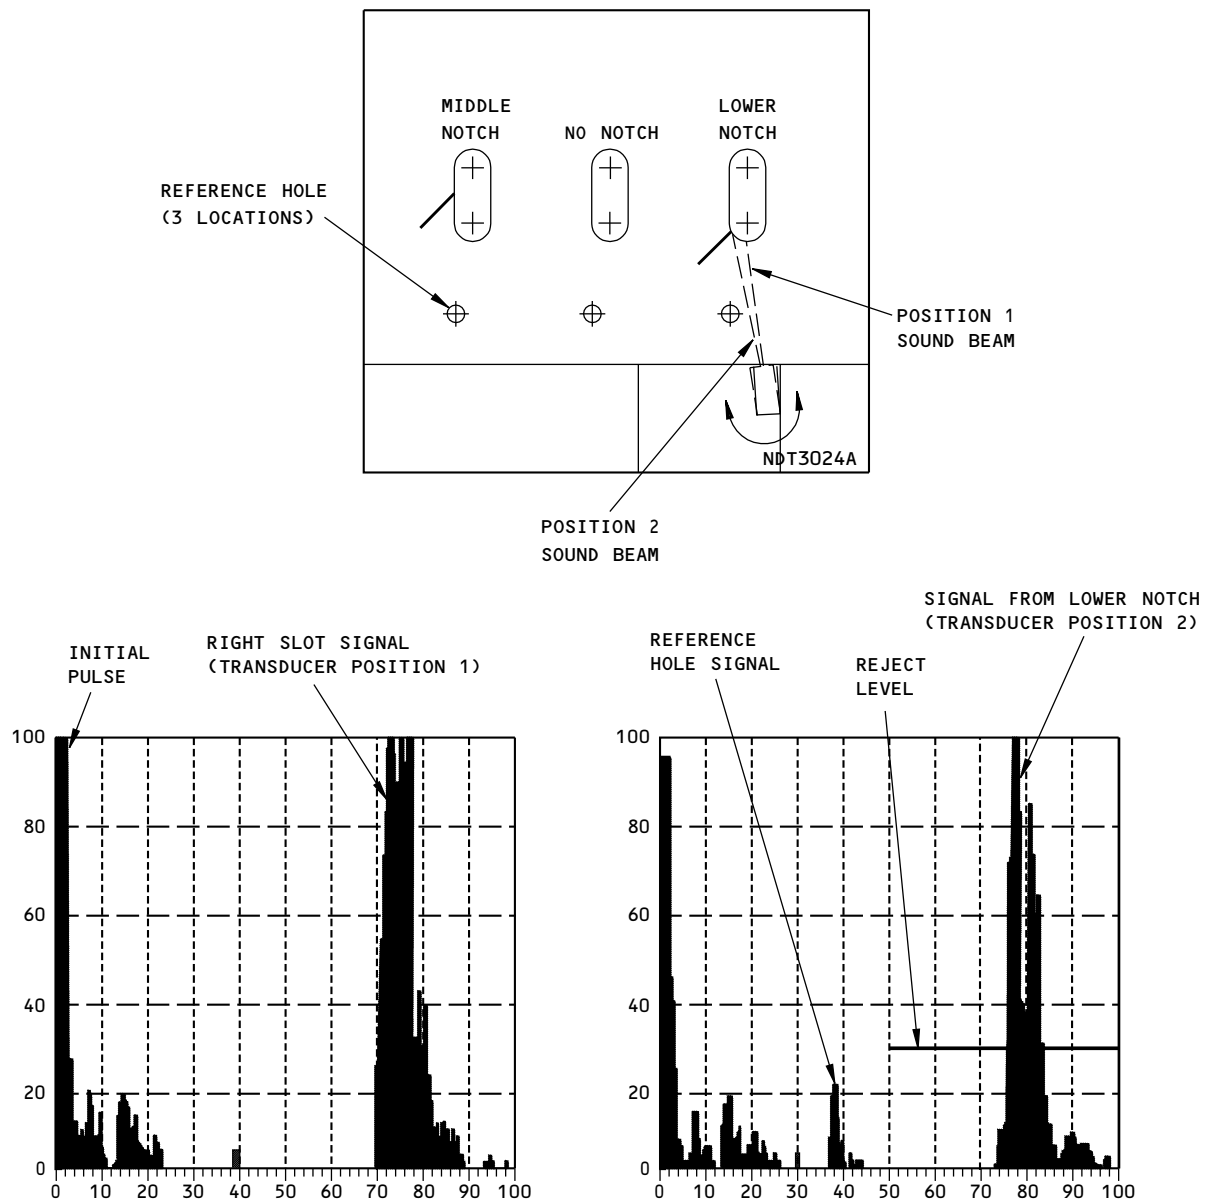
B

TURN THE TRANSDUCER TO THE LEFT TO SEE THE SLOT SIGNAL DECREASE AND THE NOTCH SIGNAL SHOW AT APPROXIMATELY 75 PERCENT OF FULL SCREEN WIDTH.
