## 737 NON-DESTRUCTIVE TEST MANUAL

### PART 4 - ULTRASONIC

#### FORWARD FLANGE OF THE OUTBOARD CHORD AT THE INTERSECTION OF STATION 727 AND STRINGER S-18A

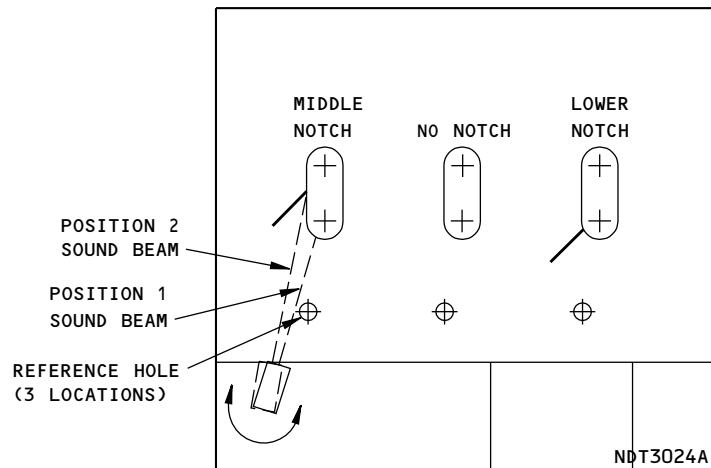
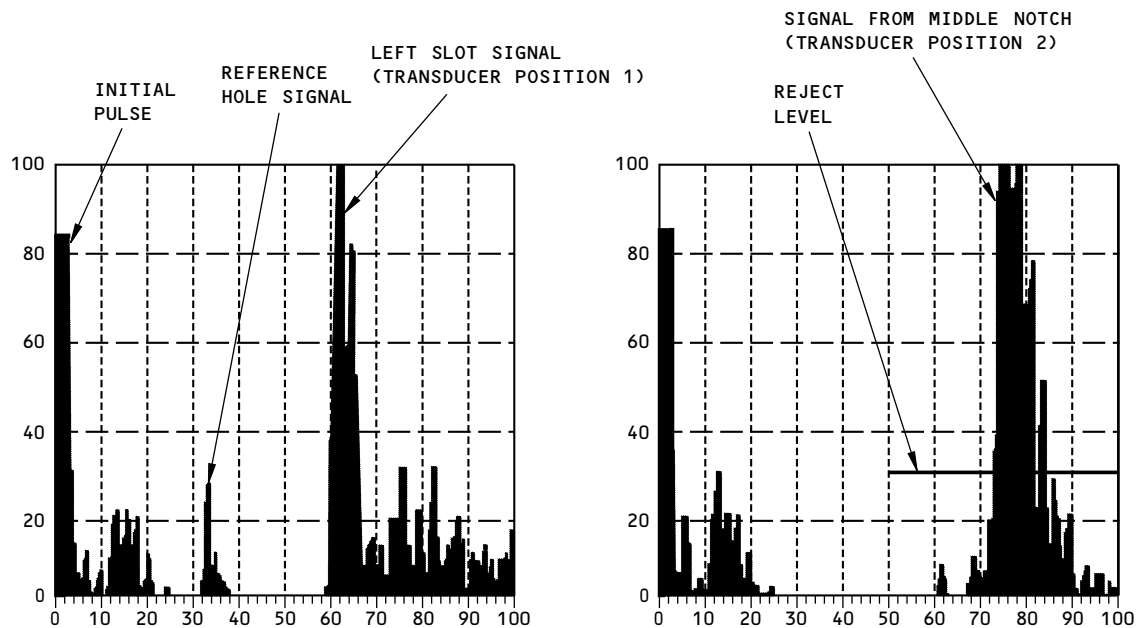
(C)

TURN THE TRANSDUCER TO THE LEFT TO SEE THE SLOT SIGNAL DECREASE AND THE NOTCH SIGNAL SHOW AT APPROXIMATELY 73 PERCENT OF FULL SCREEN WIDTH.

- ALL OF THE SIGNALS IN FIGURE 4 ARE SHOWN AFTER THE SLOT SIGNALS WERE SET AT 90 PERCENT OF FULL SCREEN HEIGHT AND THEN 6 dB ADDED.
- REFERENCE STANDARD NDT3024A REPLACED NDT3024 DURING THE APRIL 5, 2002 REVISION TO THIS PROCEDURE. IF YOU HAVE REFERENCE STANDARD NDT3024, IT IS NOT NECESSARY TO HAVE NDT3024A. THE ONLY DIFFERENCE BETWEEN THE TWO IS, THE WORD "HIGHER" HAS BEEN REPLACED WITH "MIDDLE".

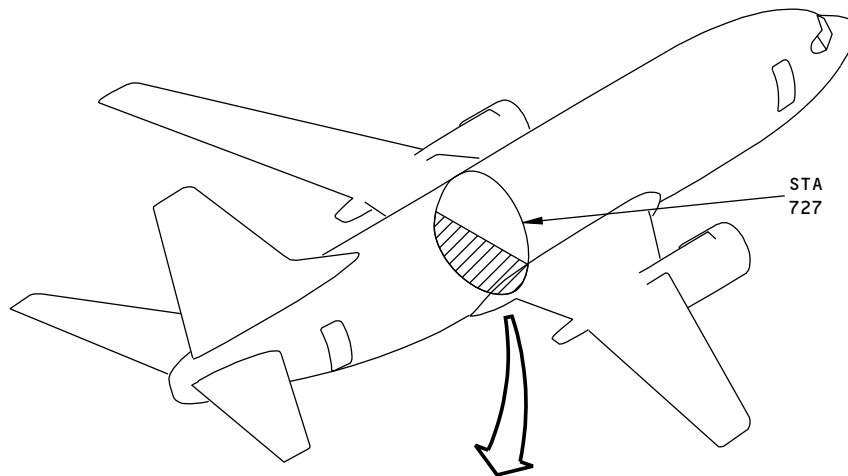
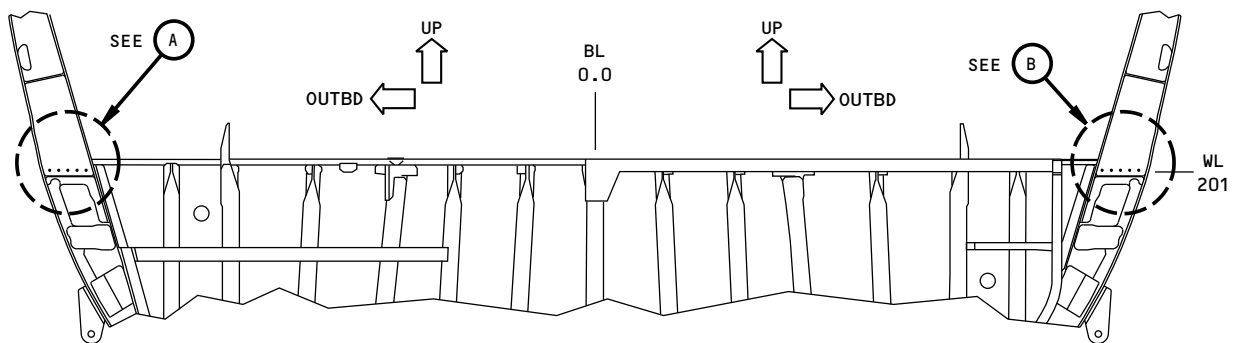
VIEW OF THE STATION 727 BULKHEAD  
AS YOU LOOK FORWARD

A. Examine the holes in the frame webs and inner chords at the STA 727 bulkhead for cracks as follows:

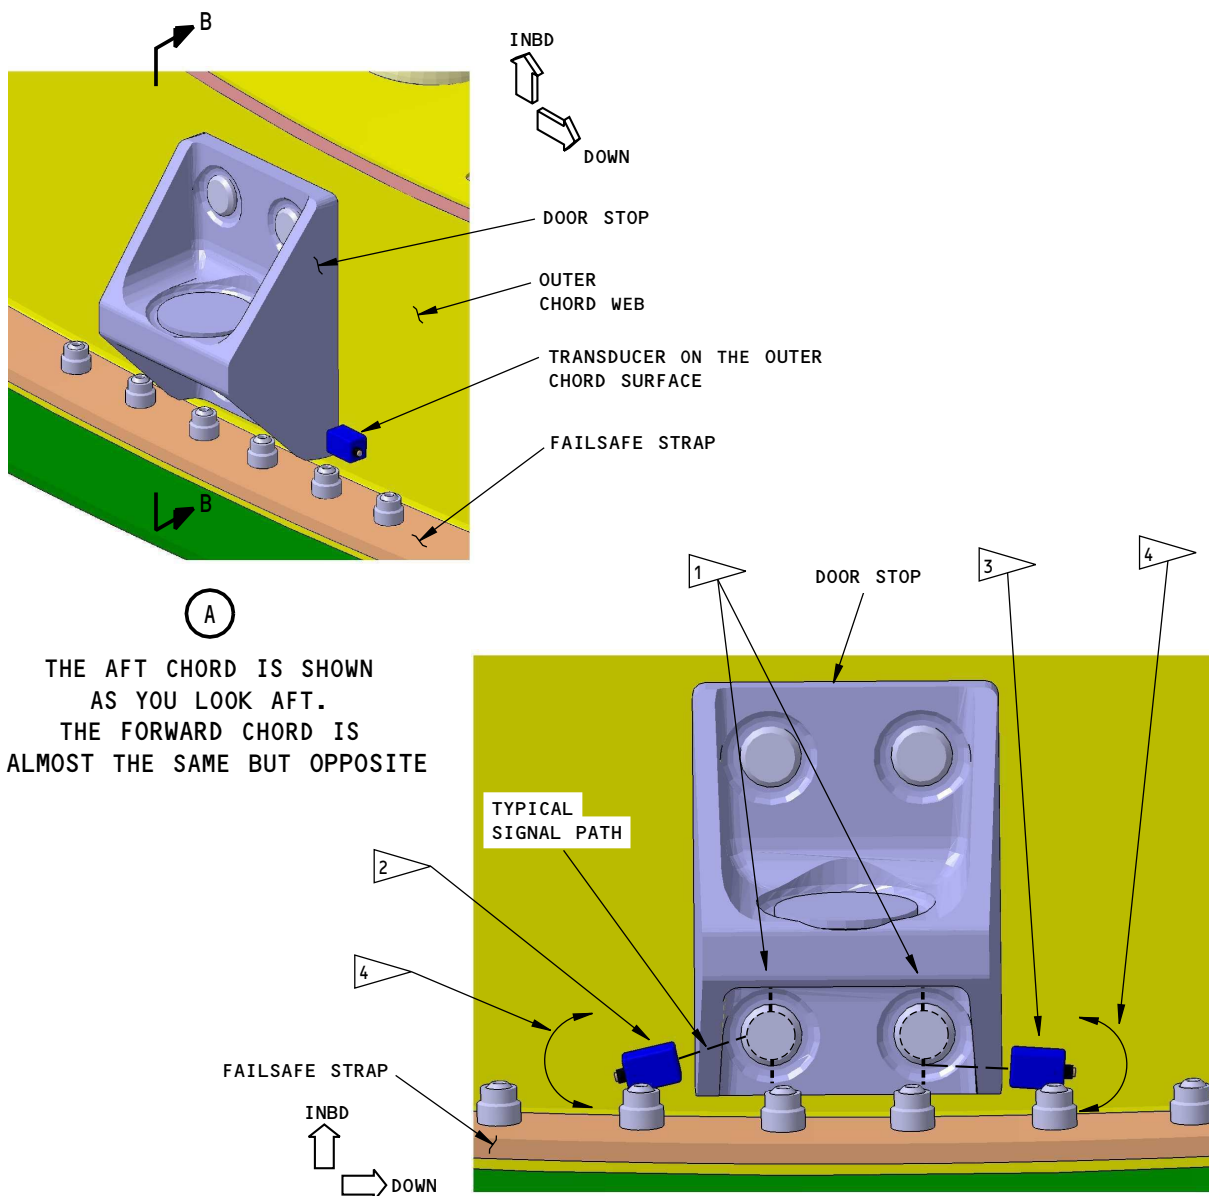
- EXAMINE THE OUTER CHORD OF THE FORWARD CARGO DOOR SURROUND AT EACH DOOR STOP FOR CRACKS ON EACH (INBOARD AND OUTBOARD) SIDE OF THE FASTENER HOLES AS SHOWN. THERE ARE 2 HOLES TO EXAMINE FOR EACH DOOR STOP.

- 2 TYPICAL TRANSDUCER DIRECTION TO GET A HOLE SIGNAL
- 3 TYPICAL TRANSDUCER DIRECTION TO LOOK FOR A CRACK SIGNAL
- 4 MOVE AND TURN THE TRANSDUCER IN THE AREA SHOWN TO FIND THE HOLE OR CRACK SIGNALS.

- (7) Turn the transducer away from the hole as shown by flagnote 3 in Figure 1 (see Section B-B) and monitor the screen display for crack signals. Do Paragraph 5.A.(3) thru Paragraph 5.A.(7) on the opposite side of the fastener hole.

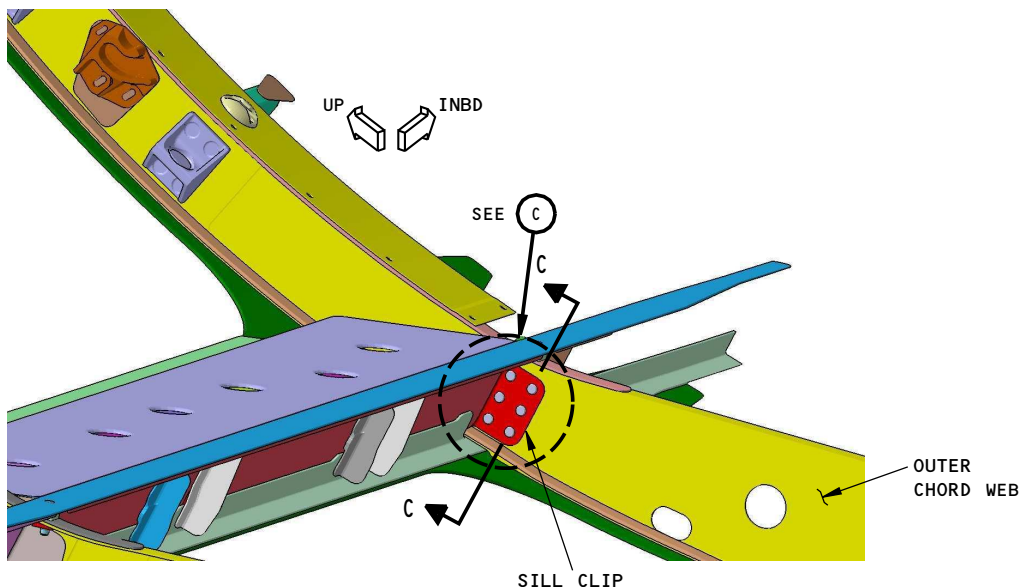
(B)

THE AFT CHORD IS SHOWN AS YOU  
LOOK AFT AND OUTBOARD.  
THE FORWARD CHORD IS ALMOST  
THE SAME BUT OPPOSITE

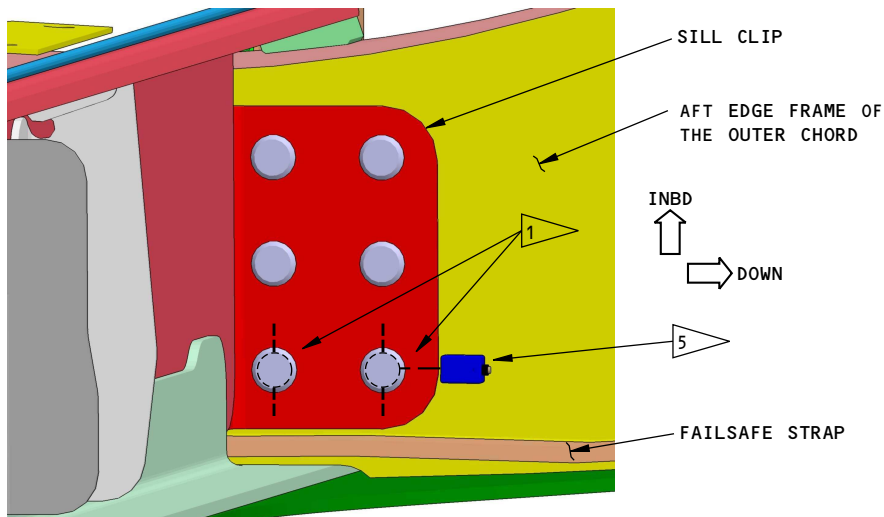
(C)

THE AFT CHORD IS SHOWN  
AS YOU LOOK AFT;  
THE FORWARD CHORD IS ALMOST  
THE SAME BUT OPPOSITE

- EXAMINE THE OUTER CHORD OF THE FORWARD CARGO DOOR SURROUND AT EACH LOWER SILL CLIP FOR CRACKS ON EACH (INBOARD AND OUTBOARD) SIDE OF 2 FASTENER HOLES AS SHOWN.

- 1 DTR CHECK FORM ITEM 53-30-08-2 INSPECTION AREA
- 5 TYPICAL TRANSDUCER POSITION TO GET A HOLE SIGNAL
- 6 TYPICAL TRANSDUCER POSITION TO LOOK FOR A CRACK SIGNAL
- 7 MOVE THE TRANSDUCER IN THE DIRECTION SHOWN TO FIND THE HOLE OR CRACK SIGNALS.

- (7) Move the transducer away from the hole as shown by flagnote 6 in Figure 1 and monitor the screen display for crack signals. Turn the transducer a small quantity as you move it to find off-angle cracks.

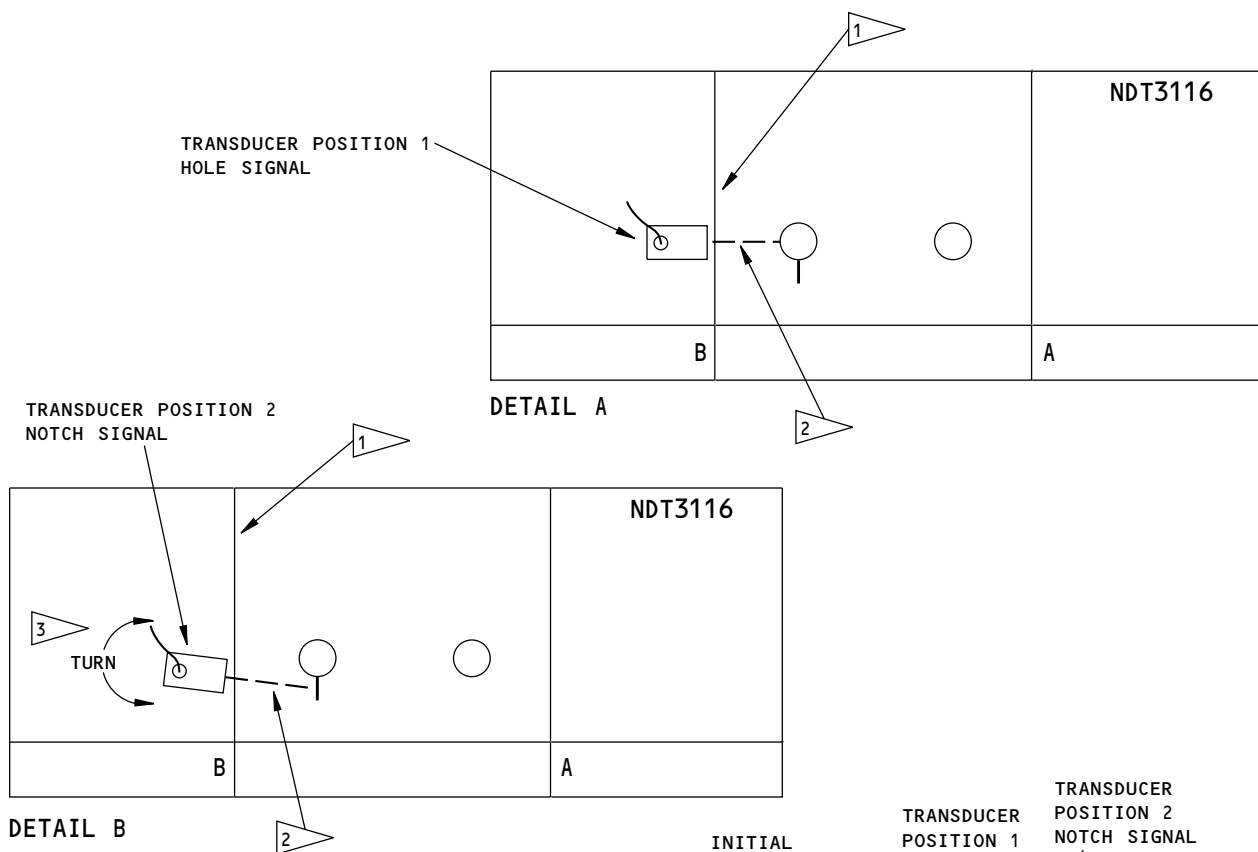
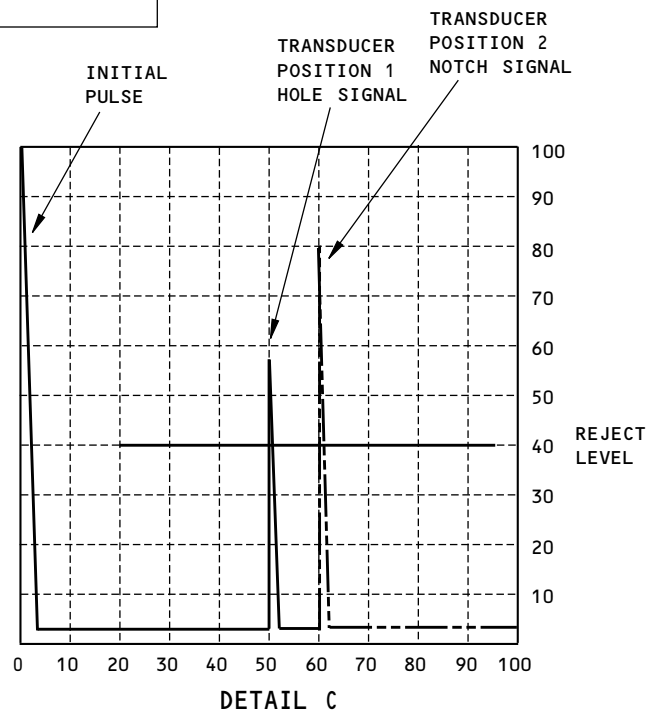
**Instrument Calibration with Reference Standard NDT3116  
Figure 3**

- THIS CALIBRATION IS FOR THE DOOR STOPS (SEE PARAGRAPH 4.A)

2 SOUND PATH

3 TURN THE TRANSDUCER A SMALL QUANTITY TO GET THE HOLE AND CRACK SIGNALS.

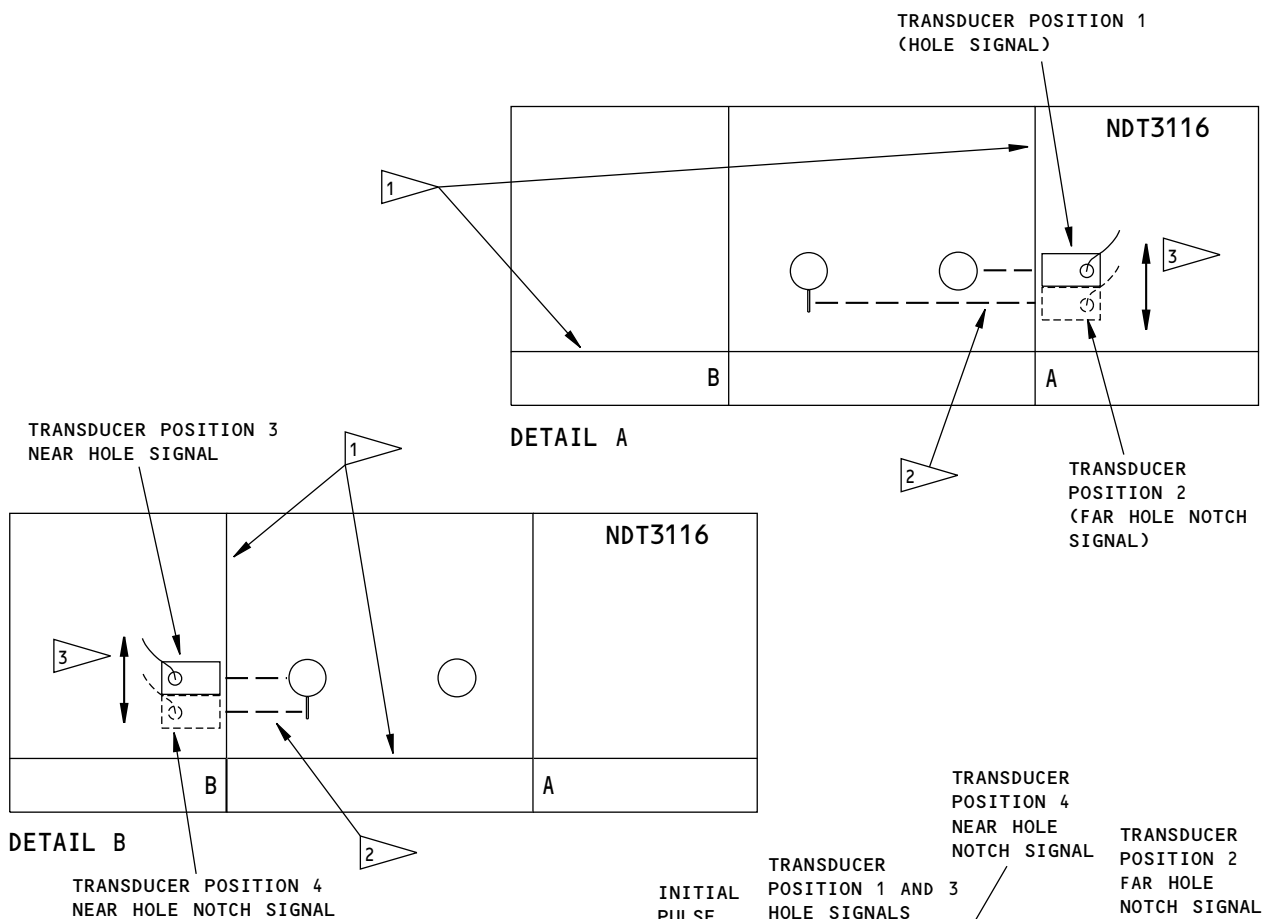
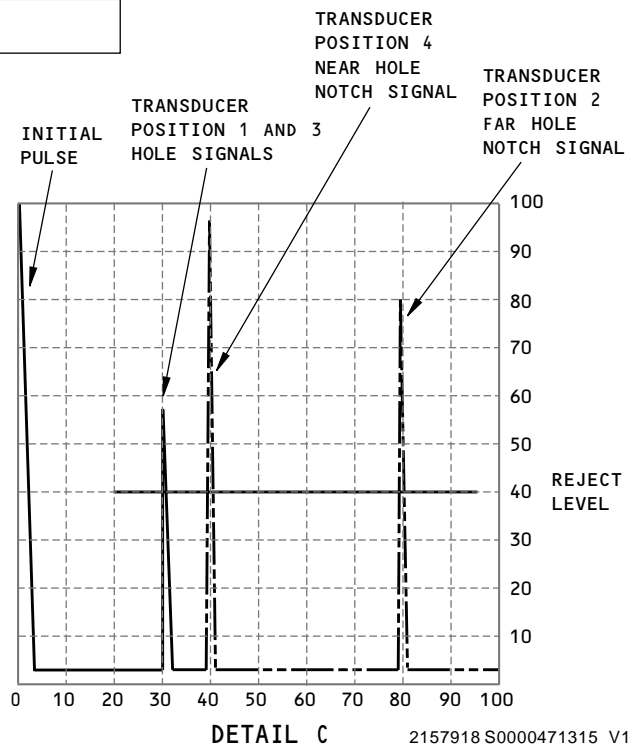
Instrument Calibration with Reference Standard NDT3116  
Figure 4

- THIS CALIBRATION IS FOR THE SILL CLIPS (SEE PARAGRAPH 4.B)
- START WITH THE FRONT EDGE OF THE TRANSDUCER PARALLEL TO THE NOTCH AND KEEP THE TRANSDUCER AS NEAR AS POSSIBLE TO SCRIBE LINE A OR B.

- BUT MAKE SURE THE TRANSDUCER DOES NOT GO ACROSS THE SCRIBE LINE DURING CALIBRATION.
- SOUND PATH
- MOVE THE TRANSDUCER A SMALL QUANTITY TO FIND THE HOLE AND CRACK SIGNALS. MOVE THE TRANSDUCER TO THE SIDE OF THE HOLE WITHOUT A NOTCH AND MONITOR THE SIGNAL. THERE MUST NOT BE A NOTCH SIGNAL ON THIS SIDE OF THE HOLE.

**NOTE:** This transducer position is used to find cracks on the near and the far holes. As shown in the calibration procedure in Paragraph 4.B., the near and far hole crack signals will be almost the same, but the near hole crack signals will be nearer to where the hole signal is (approximately 40% of full screen width). Far hole crack signals will be farther from the hole signal position (approximately 80% of full screen width).

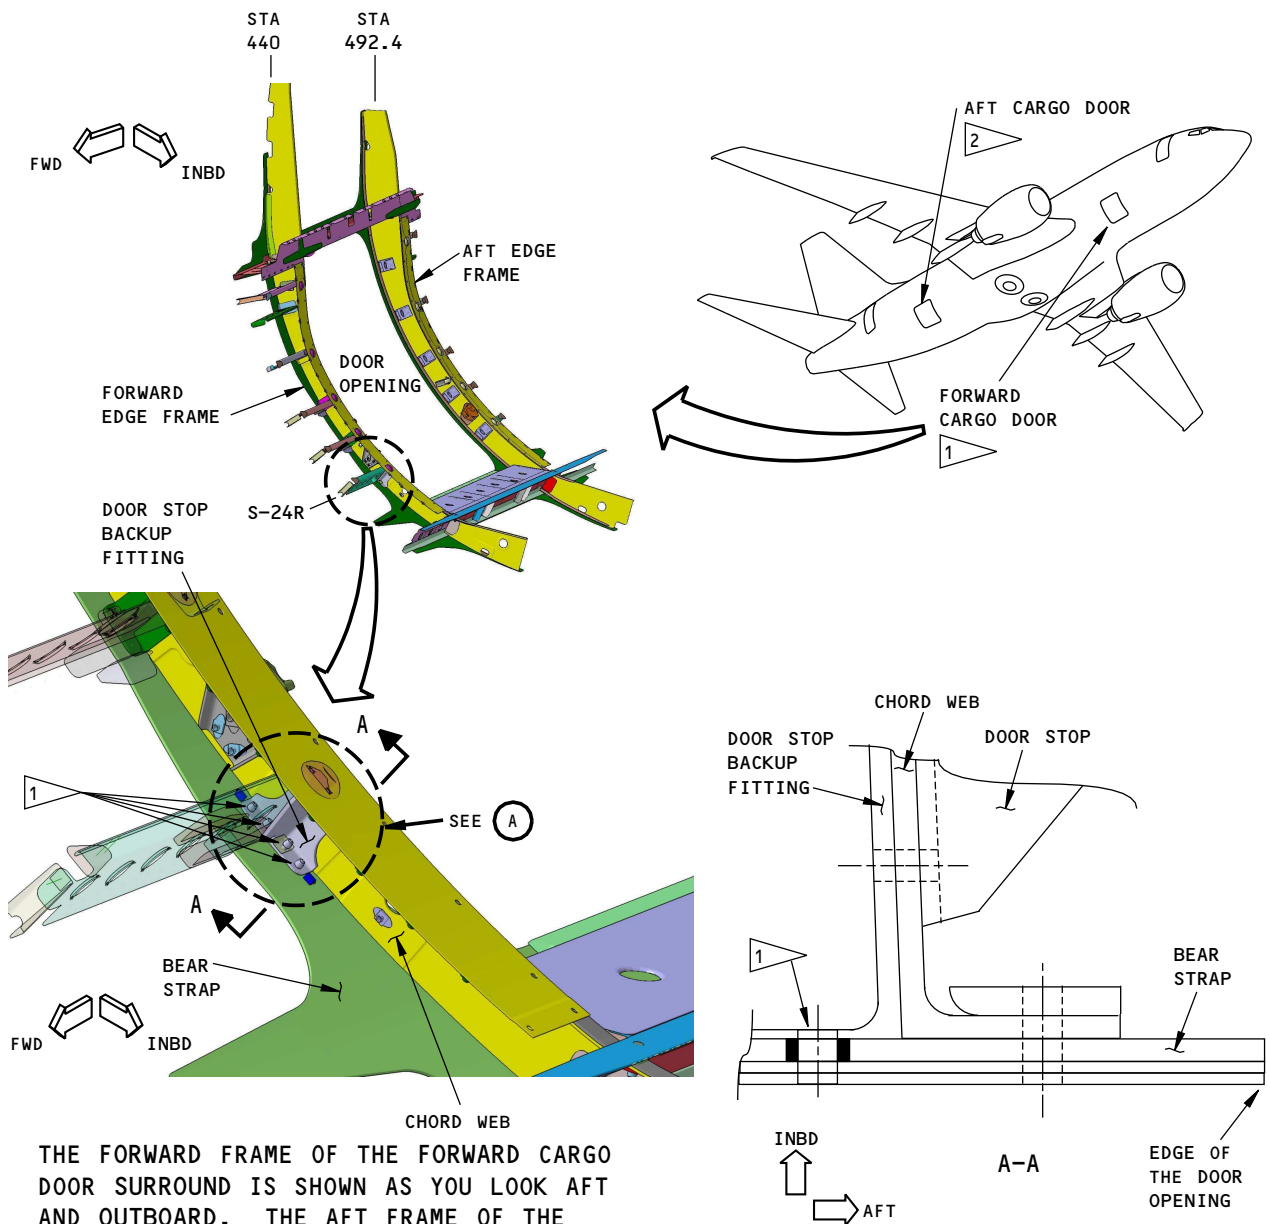
THE FORWARD FRAME OF THE FORWARD CARGO DOOR SURROUND IS SHOWN AS YOU LOOK AFT AND OUTBOARD. THE AFT FRAME OF THE FORWARD CARGO DOOR SURROUND IS ALMOST THE SAME BUT OPPOSITE

- A. Identify the inspection area shown in Figure 1.
- B. Remove sealant or loose paint. Clean the area that the transducer will touch.

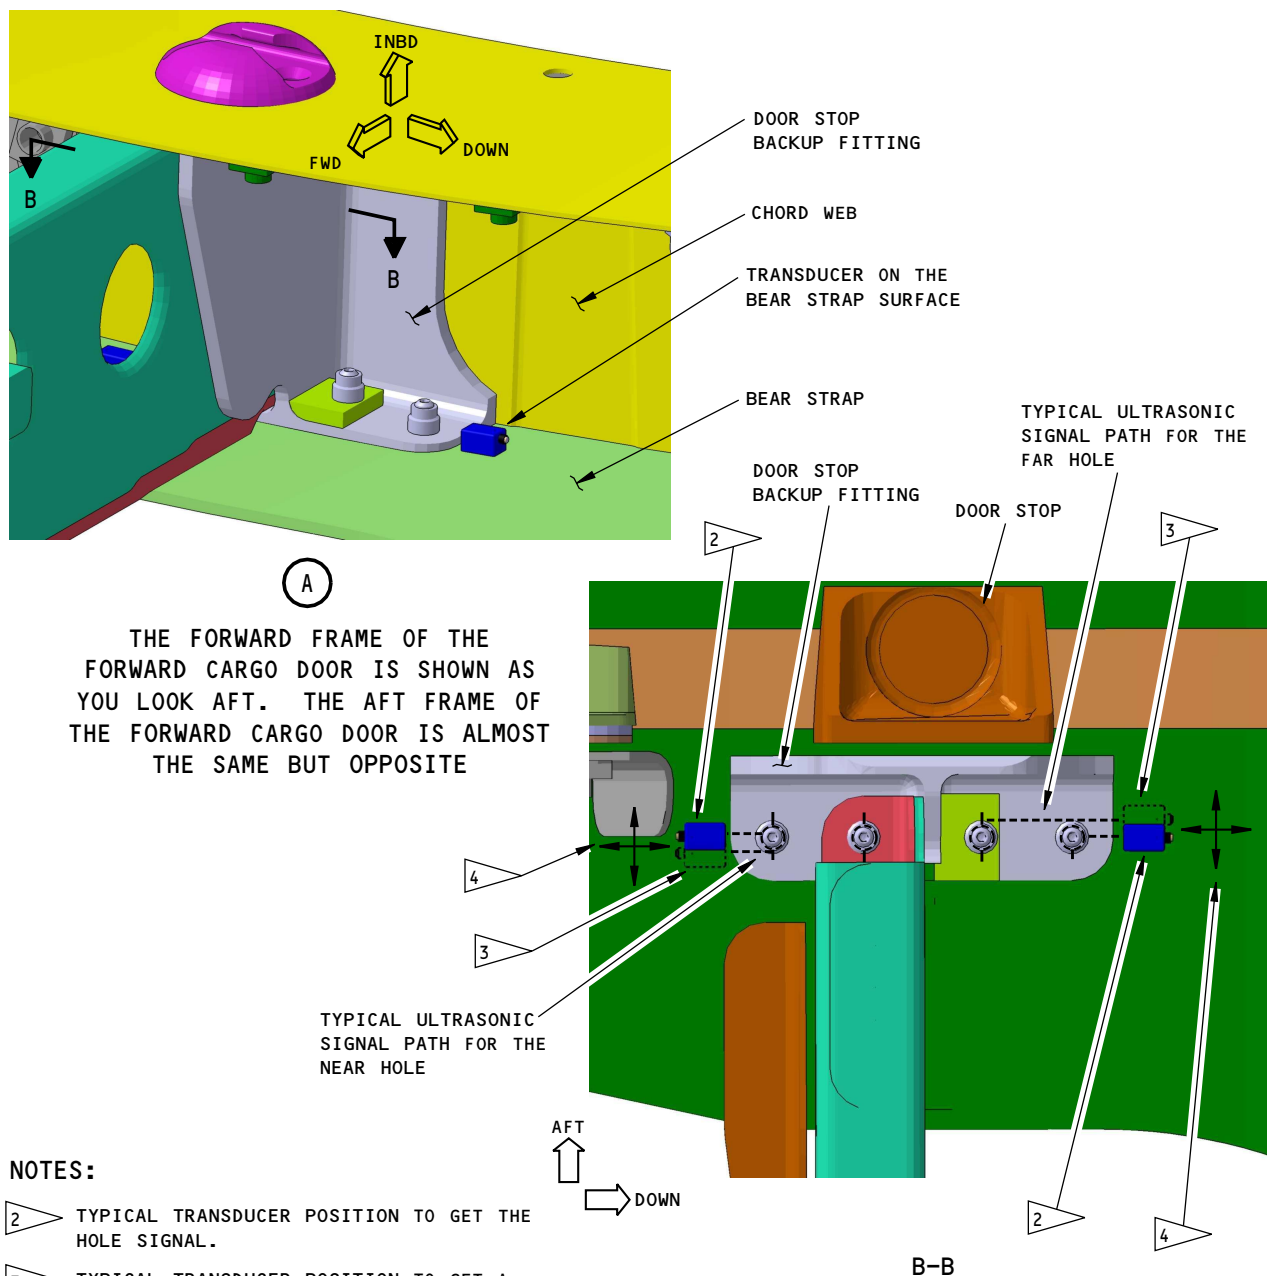
- 2 TYPICAL TRANSDUCER POSITION TO GET THE HOLE SIGNAL.
- 3 TYPICAL TRANSDUCER POSITION TO GET A CRACK SIGNAL.
- 4 MOVE THE TRANSDUCER IN AND OUT, BACK AND FORWARD AS SHOWN TO FIND THE HOLE OR CRACK SIGNALS. NOTE THAT NEAR AND FAR HOLE CRACK SIGNALS WILL LOOK ALMOST THE SAME, BUT THE FAR HOLE SIGNAL WILL BE FARTHER TO THE RIGHT ON THE INSTRUMENT DISPLAY.

- (7) Move the transducer away from the hole in the aft direction as shown by flagnote 4 in Figure 1 and monitor the screen display for crack signals. Turn the transducer clockwise and counterclockwise a small quantity as you move it to find off-angle cracks.

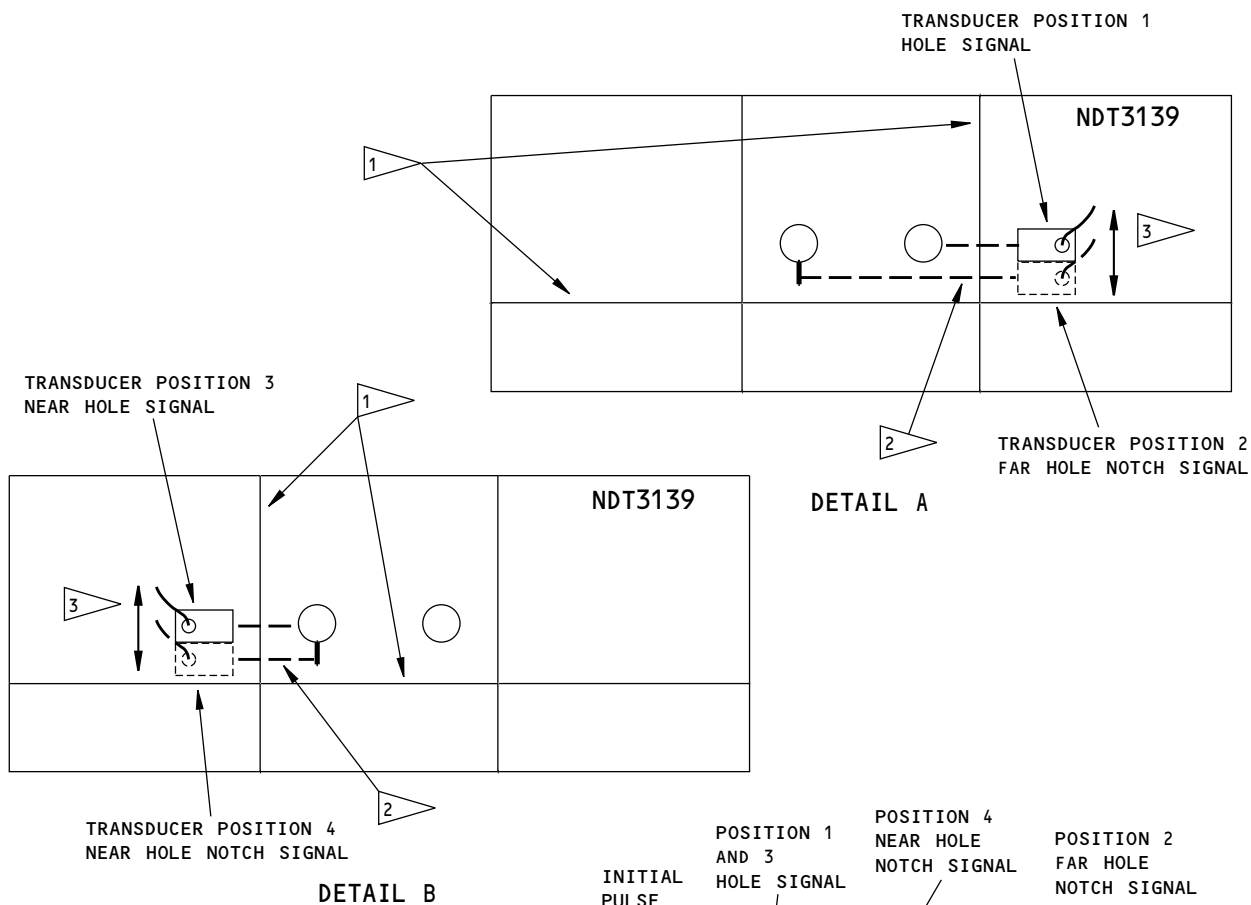
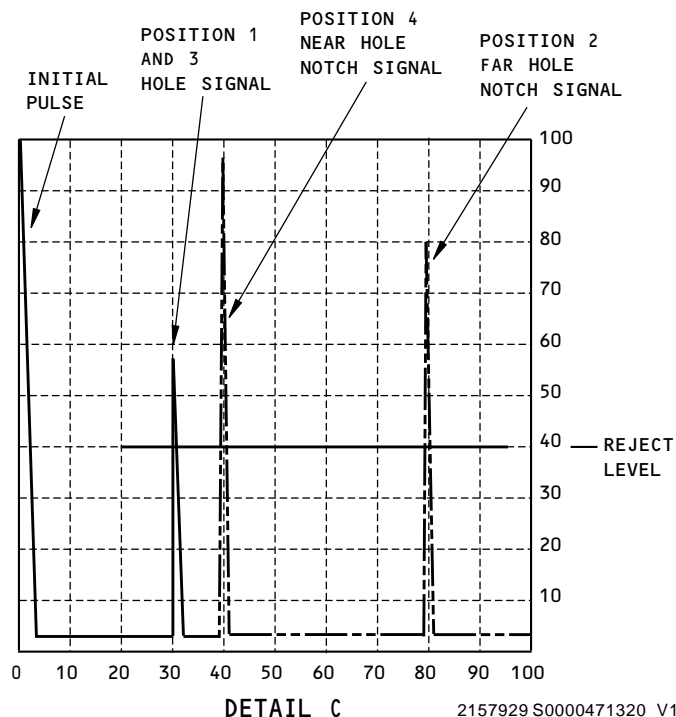
Instrument Calibration with Reference Standard NDT3139  
Figure 3

- START WITH THE FRONT EDGE OF THE TRANSDUCER PARALLEL TO THE NOTCH AND KEEP THE TRANSDUCER AS NEAR TO THE SCRIBE LINE AS POSSIBLE.

- 1 MAKE SURE THE TRANSDUCER DOES NOT GO ACROSS THE SCRIBE LINE DURING CALIBRATION.
- 2 SOUND PATH
- 3 MOVE THE TRANSDUCER A SMALL QUANTITY TO FIND THE HOLE AND CRACK SIGNALS. MOVE THE TRANSDUCER TO THE SIDE OF THE HOLE WITHOUT A NOTCH AND MONITOR THE SIGNAL. THERE MUST NOT BE A NOTCH SIGNAL ON THIS SIDE OF THE HOLE.

- A. Calibrate the instrument to examine the bear strap for cracks at the door stop backup fittings as follows:
- (1) Connect the transducer to the instrument.
  - (2) Put couplant on the reference standard at transducer position 1 as shown in Detail A in Figure 3.
  - (3) Set the initial pulse at 0% of full screen width (see Detail C in Figure 3).
  - (4) Put the transducer on the reference standard at Position 1 (see Detail A in Figure 3).
  - (5) Adjust the transducer to get a signal from the near hole.
  - (6) Adjust the hole signal so that it is at 30% of full screen width (see Detail C in Figure 3).
  - (7) Move the transducer to transducer position 2 (see Detail A in Figure 3) and monitor the signal that occurs from the EDM notch. Keep the transducer as close to the scribe line as possible.

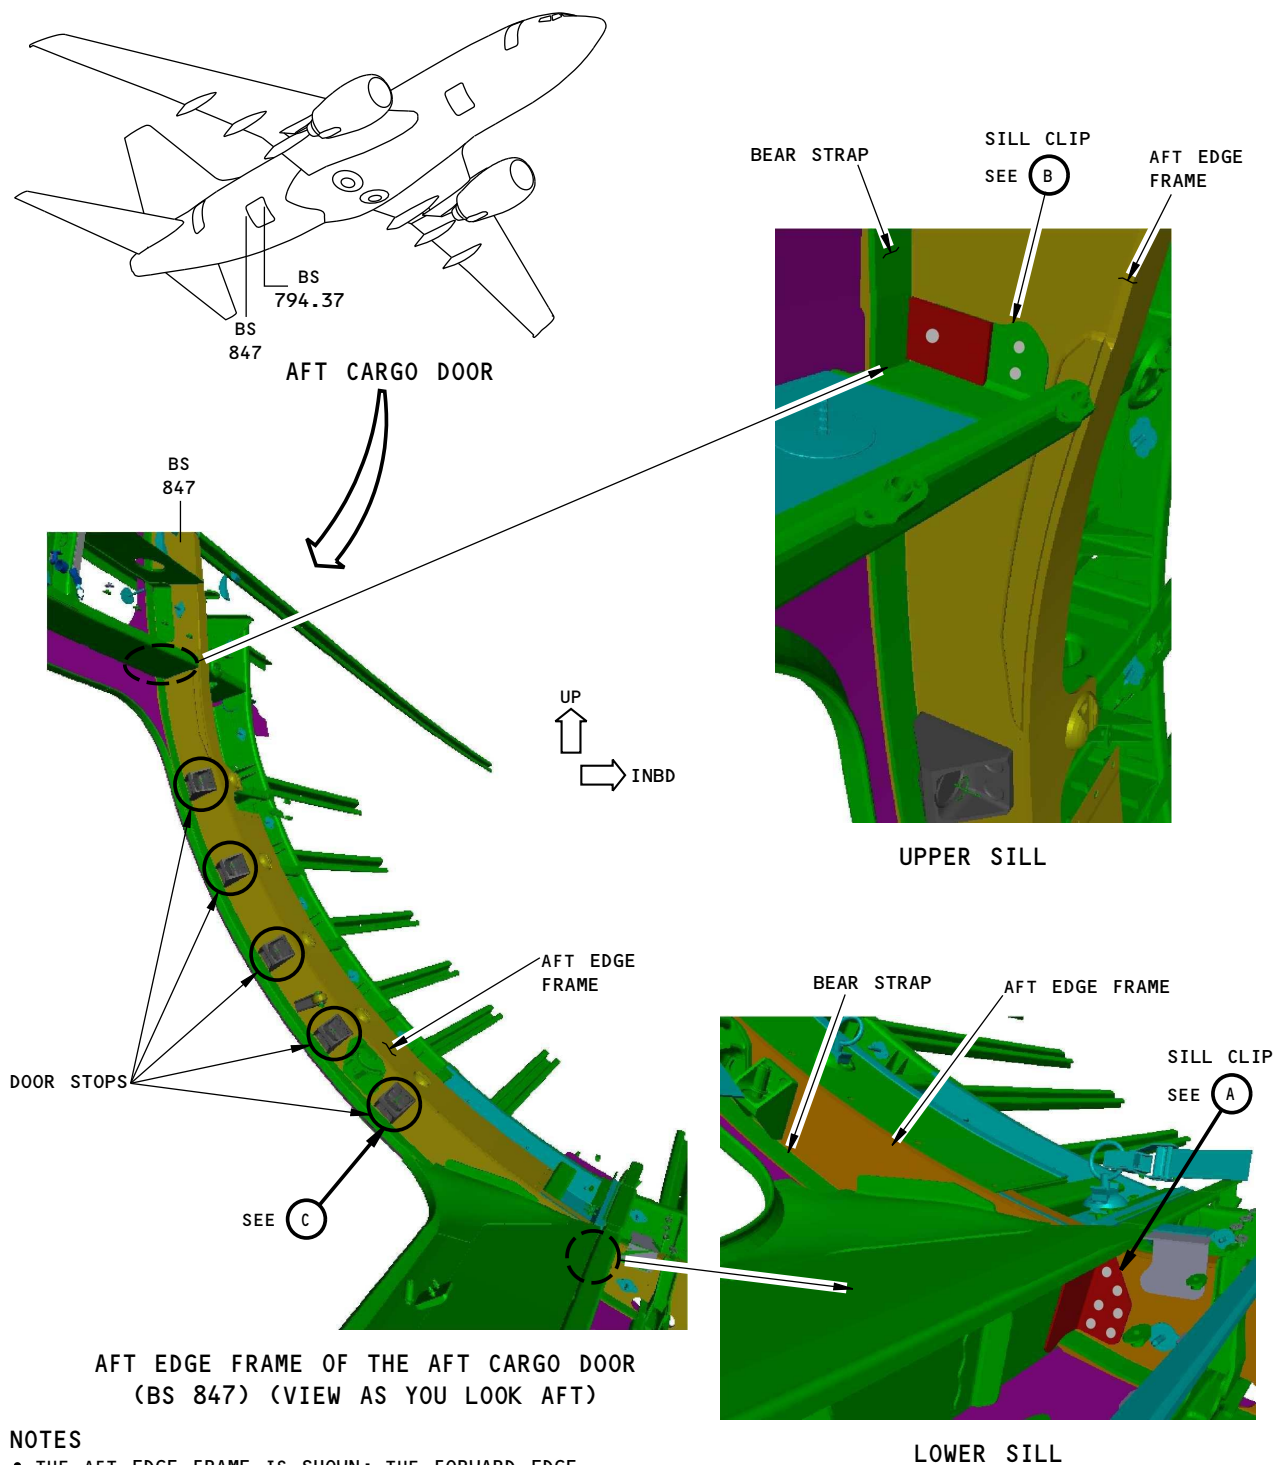
- THE AFT EDGE FRAME IS SHOWN; THE FORWARD EDGE FRAME IS OPPOSITE AND ALMOST THE SAME

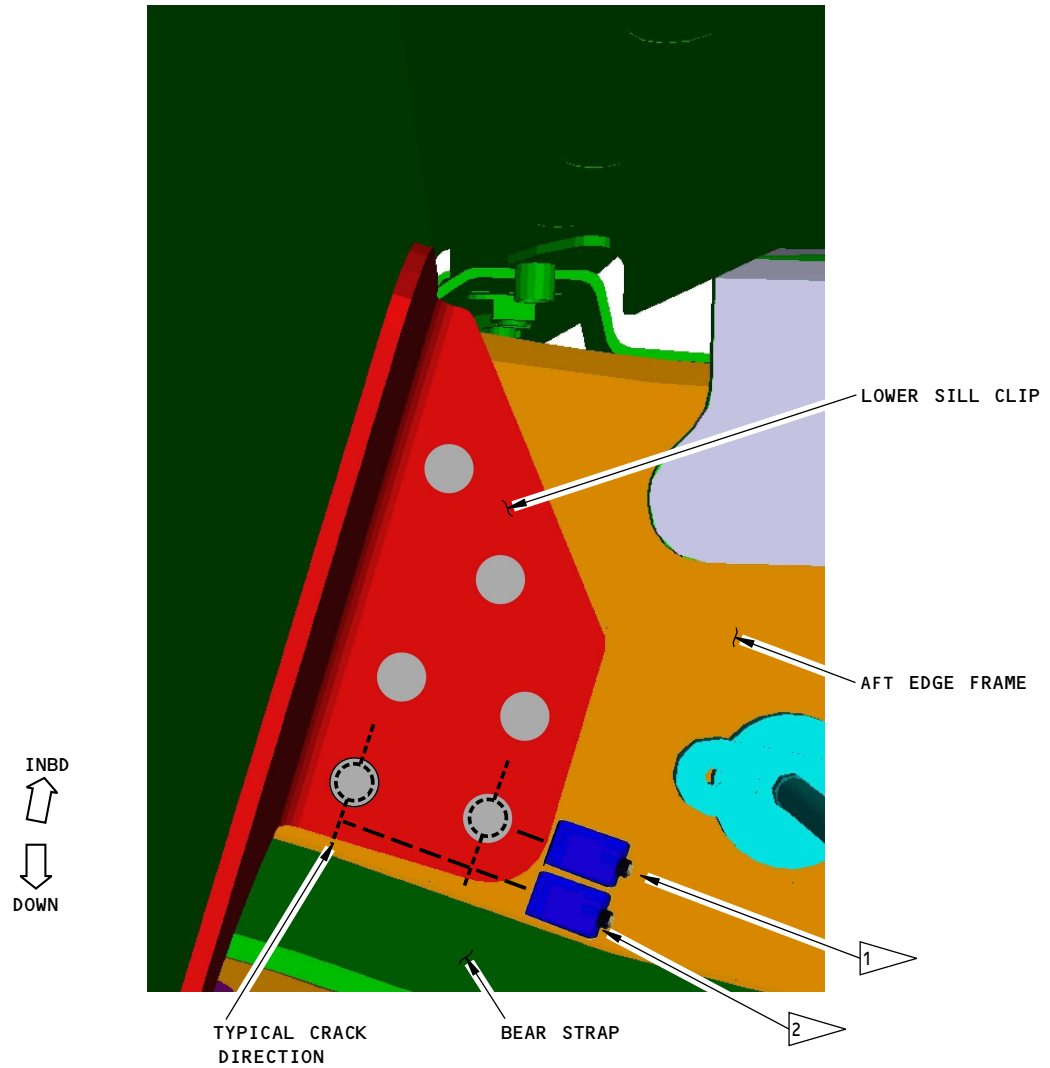
LOWER SILL OF THE AFT FRAME  
(VIEW AS YOU LOOK AFT)

TYPICAL TRANSDUCER POSITION TO LOOK FOR (AND GET) A CRACK SIGNAL

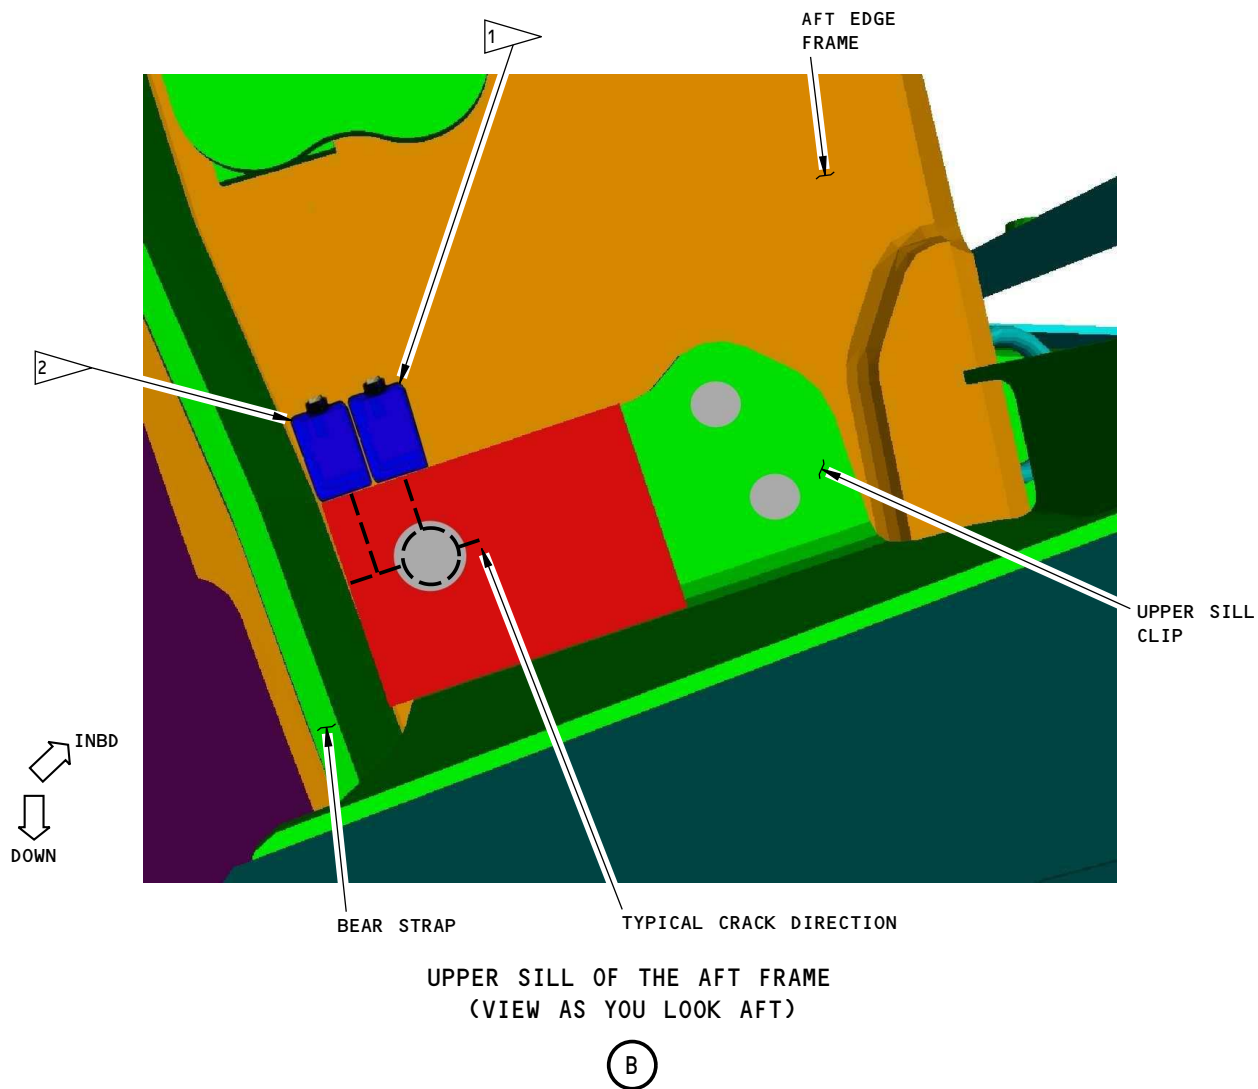
- EXAMINE THE AFT EDGE FRAME AT THE UPPER SILL CLIP FOR CRACKS ON EACH SIDE OF THE FASTENER HOLE AS SHOWN

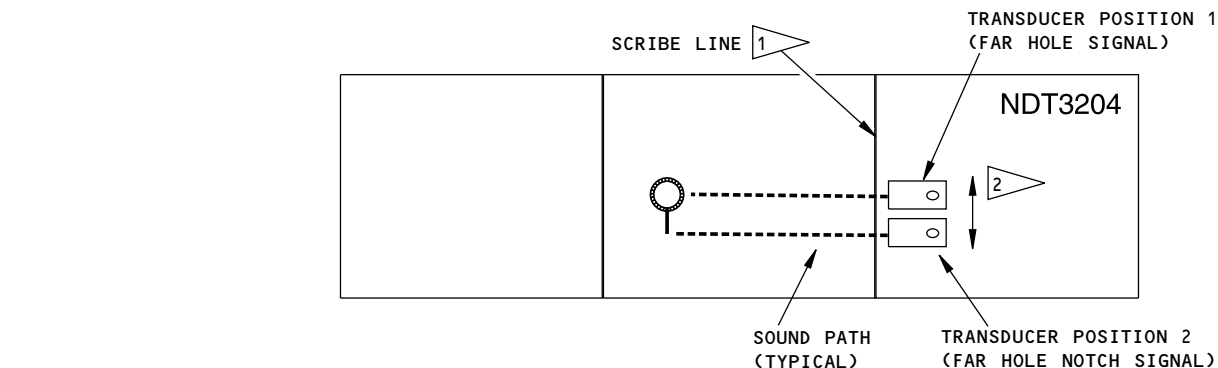
DETAIL A

- START WITH THE FRONT EDGE OF THE TRANSDUCER PARALLEL TO THE NOTCH AND KEEP THE TRANSDUCER AS NEAR AS POSSIBLE TO THE SCRIBE LINE.
- 1 MAKE SURE THE TRANSDUCER DOES NOT GO ACROSS THE SCRIBE LINE DURING CALIBRATION.
- 2 MOVE THE TRANSDUCER A SMALL DISTANCE TO SEE THE HOLE AND CRACK SIGNALS. ALSO MOVE THE TRANSDUCER TO THE SIDE OF THE HOLE WITHOUT A NOTCH AND MONITOR THE SIGNAL.

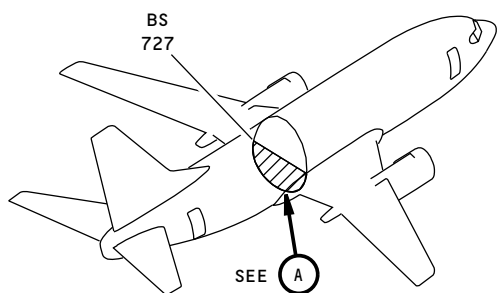
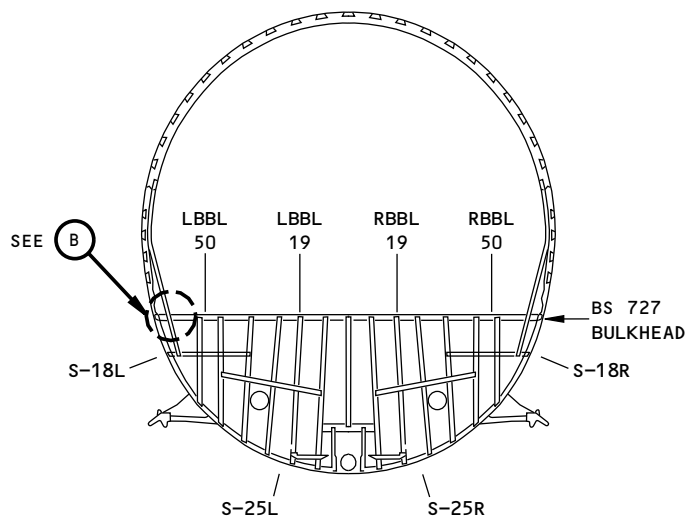
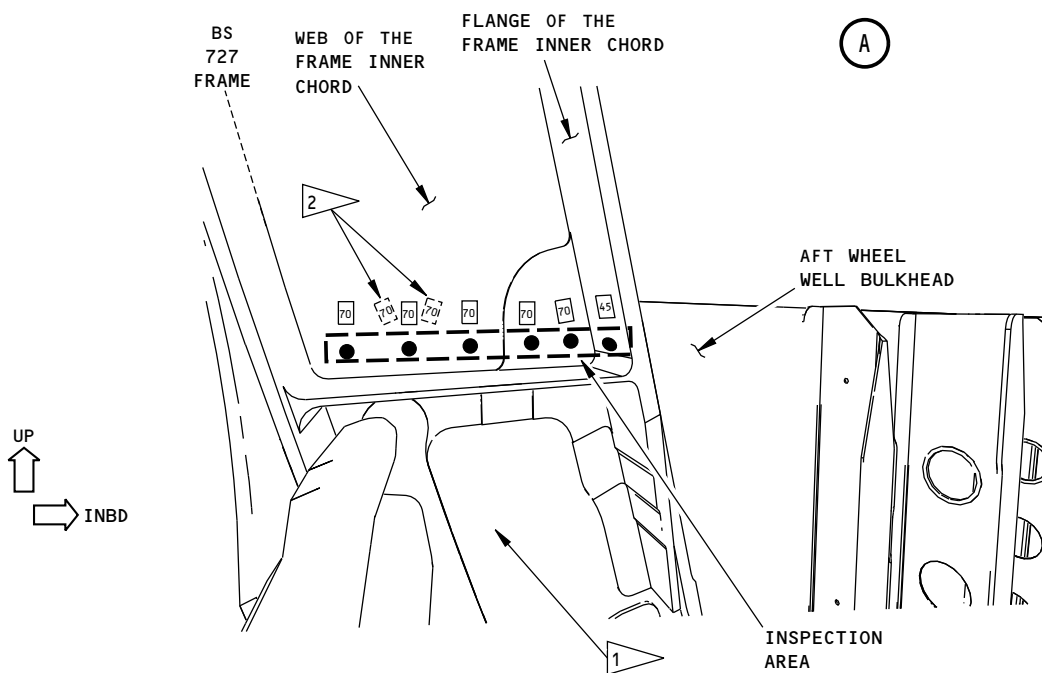
VIEW AS YOU LOOK FORWARD IN THE AFT CARGO BAY  
(THE LEFT SIDE IS SHOWN; THE RIGHT SIDE IS THE SAME)

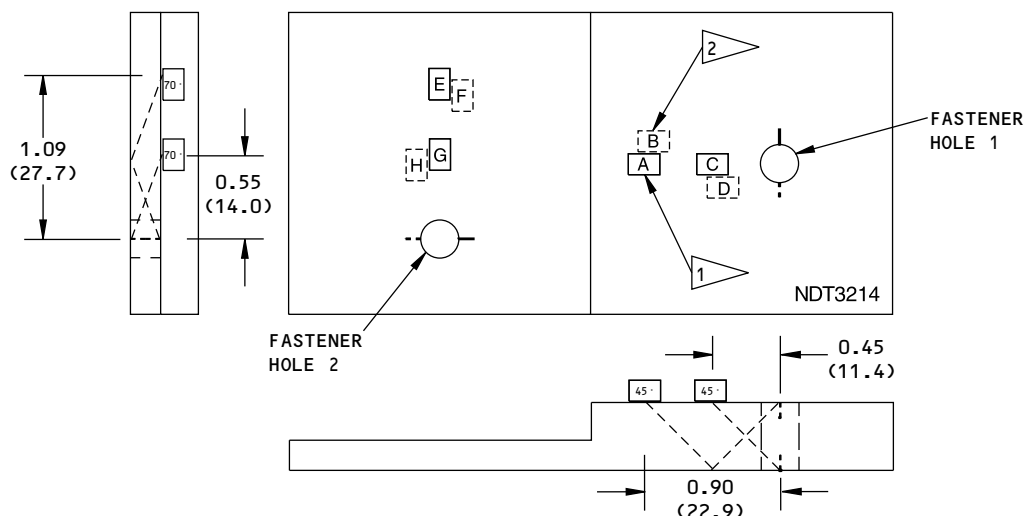
**CALIBRATION TRANSDUCER POSITIONS  
DETAIL I**

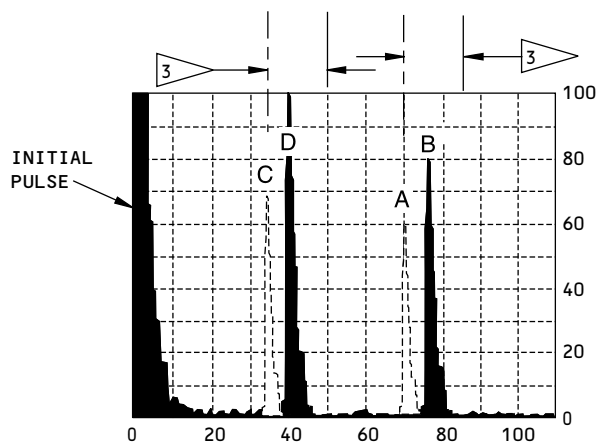
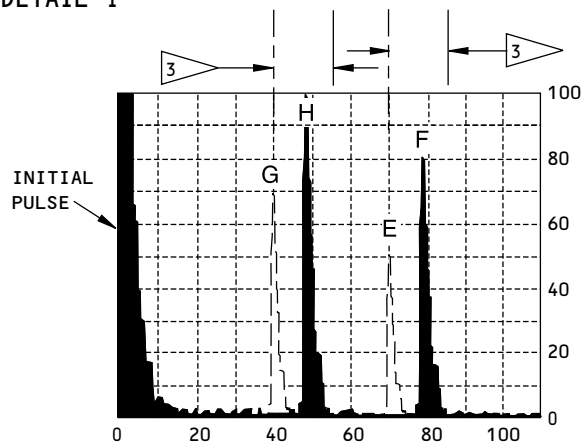
**CALIBRATION SCREEN DISPLAYS  
DETAIL II**

**CALIBRATION SCREEN DISPLAYS AT  
FASTENER HOLE 1 WITH A 45° TRANSDUCER**

**CALIBRATION SCREEN DISPLAYS AT  
FASTENER HOLE 2 WITH A 70° TRANSDUCER**

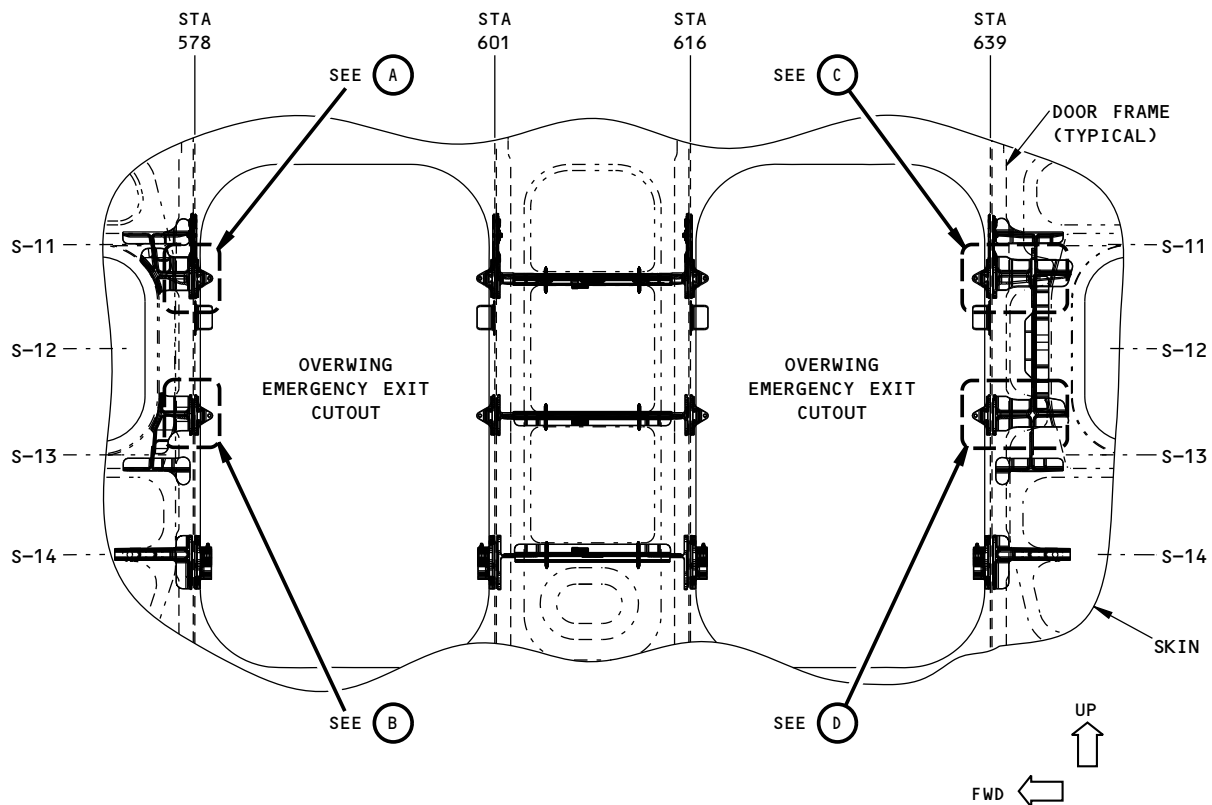
737-800/900/900ER  
OVERWING EMERGENCY EXIT CUTOUTS  
(THIS IS AN EXTERNAL VIEW OF THE AIRPLANE AS YOU LOOK IN)

**NOTE:** Different airplane models will have different overwing emergency exit cutout configurations. Make sure that you identify the applicable views in Figure 1 for the airplane model to be examined.
  - (2) Calibrate the instrument as specified in Paragraph 4.
  - (3) Examine the outer chord for cracks behind one of the backup fittings shown in Figure 1.
