REFERRAL — RAVENSGATE, 19 NOVEMBER

SITE	RAVENSGATE DAM	OPERATOR	CAIRNHOLD POWER	DEATHS	2
POLICE FINDING	MURDER-SUICIDE	RDSI POSITION	DISSENT	AUTHOR	CHIEF INSPECTOR R. HALSEY

DEATHS OF A. SARN AND I. BALLARD

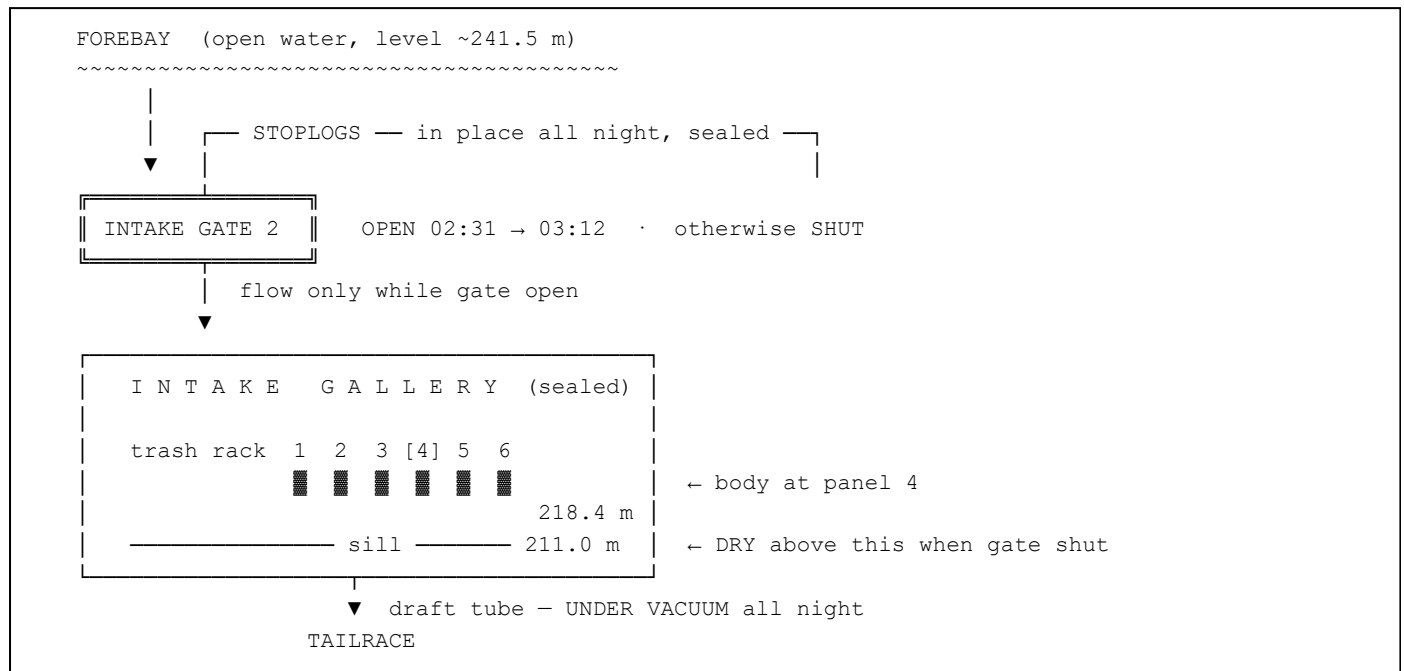
Structure	INTAKE GALLERY (SEALED)
Position	TRASH RACK PANEL 4
Elevation of body	218.4 m AOD
Relative to intake gate 2	DOWNSTREAM
Gallery condition on entry	DRY ABOVE SILL (211.0 m)

The deceased was found on the upstream face of trash rack panel 4, in a semi-prone position, held against the bars by nothing but her own weight and the shape of the panel. The gallery was dry above the sill and she was not in water at the time of recovery.

The deceased lay beneath a consolidated mat of storm debris — bracken, spruce needles, and a length of fence rail — packed hard against the rack and extending across panels 3 to 5. The mat was cut away to reach her. Approximately 40 kg of material was removed.
