DTC B1156/B1157/15 Front Airbag Sensor (RH) Malfunction

2002 4RUNNER (RM887U)

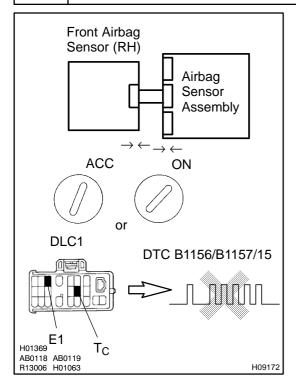
Check front airbag sensor (RH).

For the connector (on the front airbag sensor (RH)), measure the resistance between SR+ and SR-.

Resistance: 300 - 1500 Ω

Replace front airbag sensor (RH).
