## 737 NON-DESTRUCTIVE TEST MANUAL

### PART 4 - ULTRASONIC

#### FORWARD FLANGE OF THE OUTBOARD CHORD AT THE INTERSECTION OF STATION 727 AND STRINGER S-18A

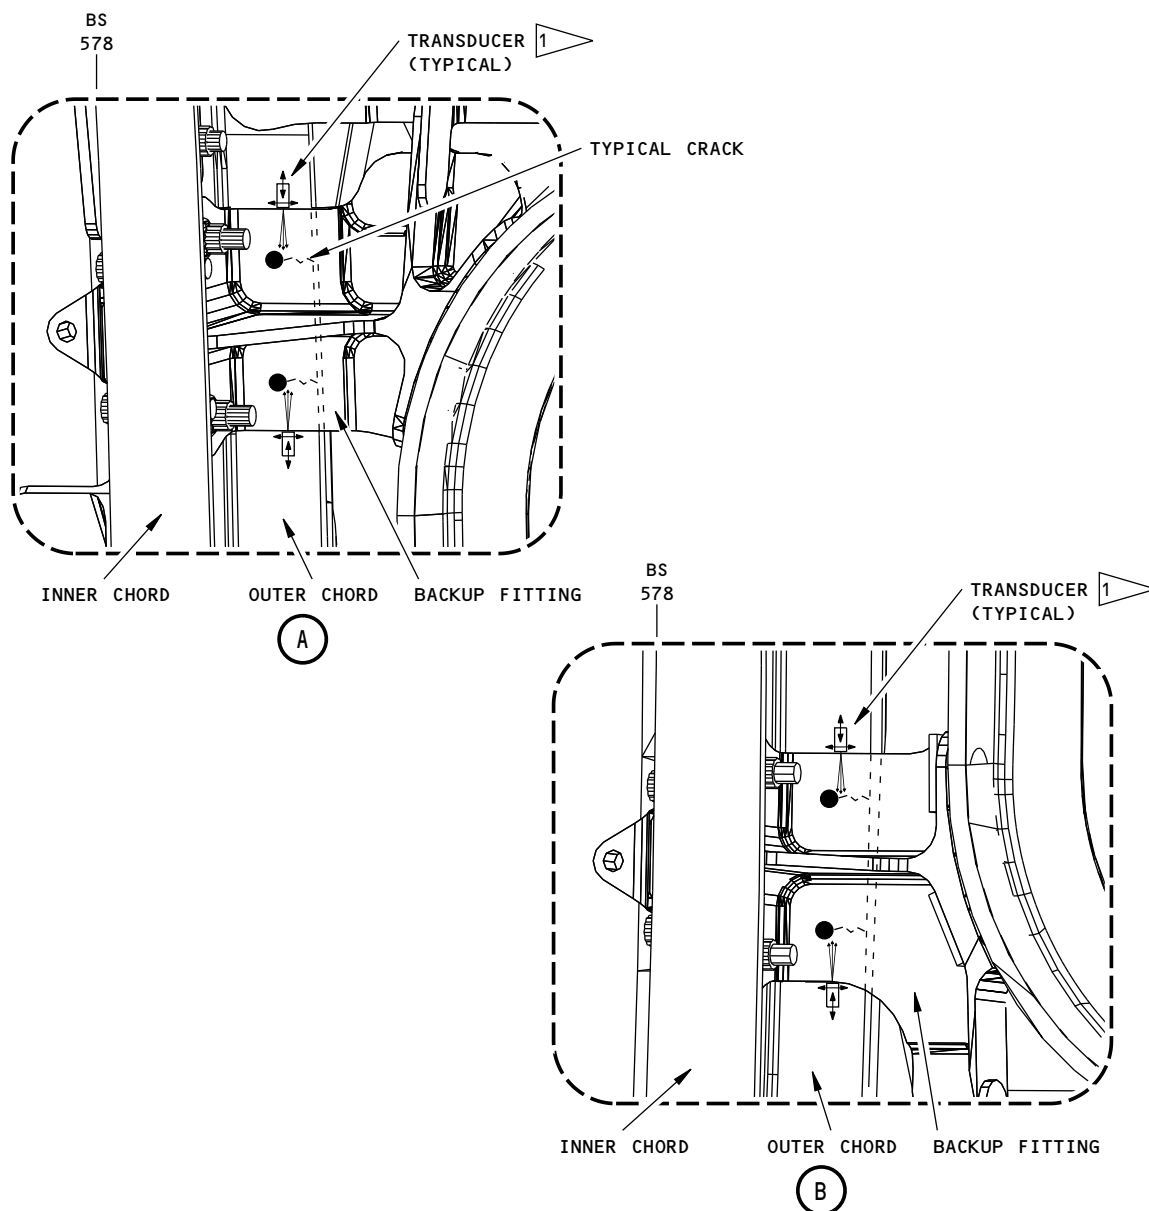
737-800/900/900ER  
OVERWING EMERGENCY EXIT CUTOUT  
SIDE VIEW AT BS 578  
(VIEWS ARE AS YOU LOOK OUT)

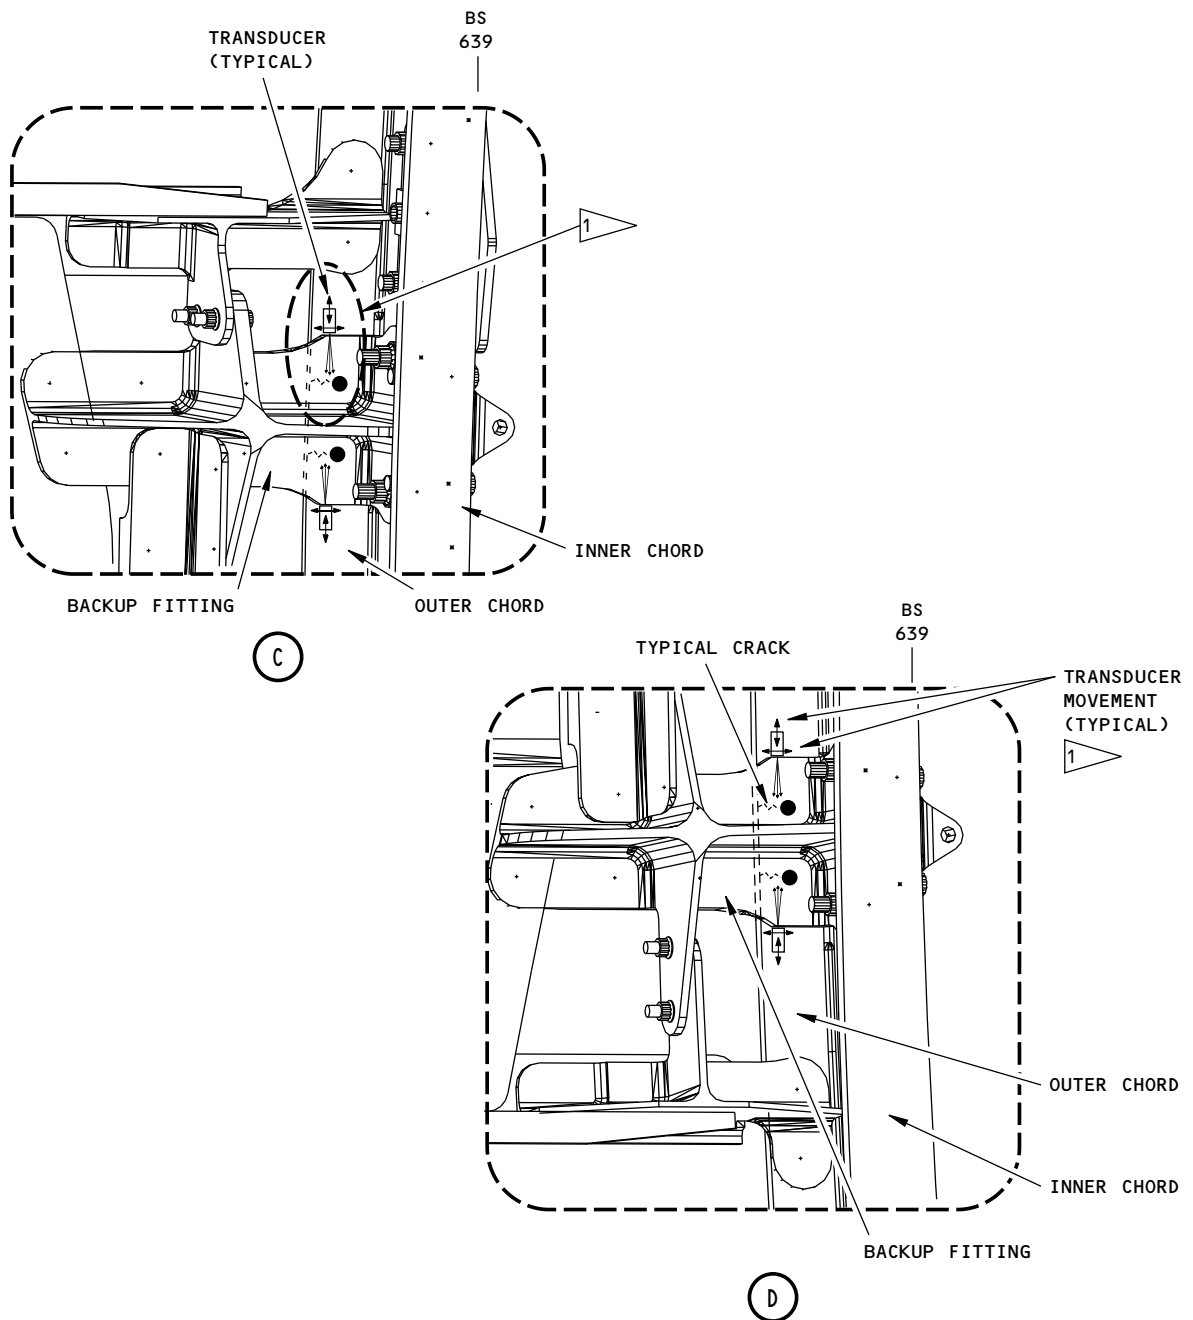
2375168 S0000543580\_V1

737-800/900/900ER  
OVERWING EMERGENCY EXIT CUTOUT  
SIDE VIEW AT BS 639  
(VIEWS ARE AS YOU LOOK OUT)

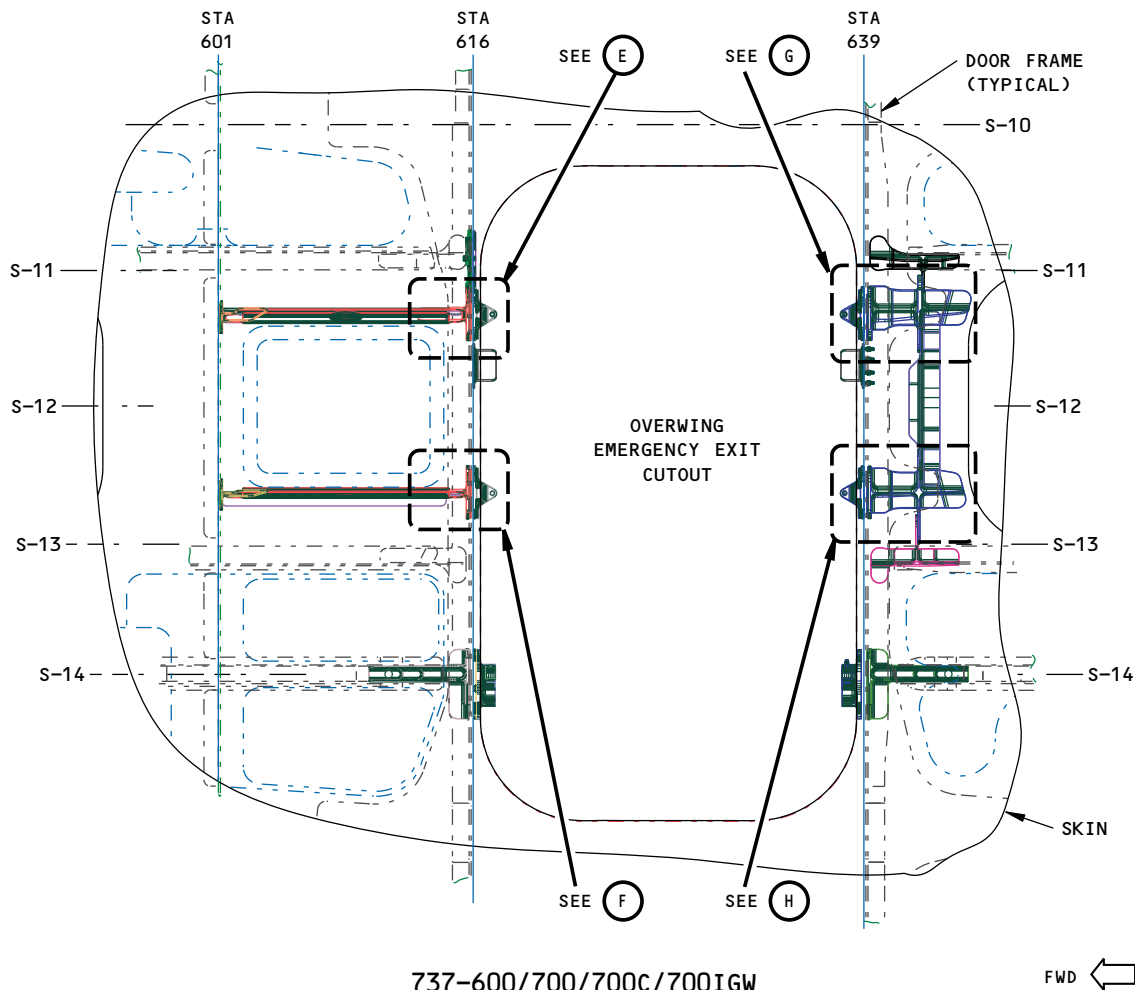
737-600/700/700C/700IGW  
OVERWING EMERGENCY EXIT CUTOUT  
(THIS IS AN EXTERNAL VIEW OF THE AIRPLANE AS YOU LOOK IN)

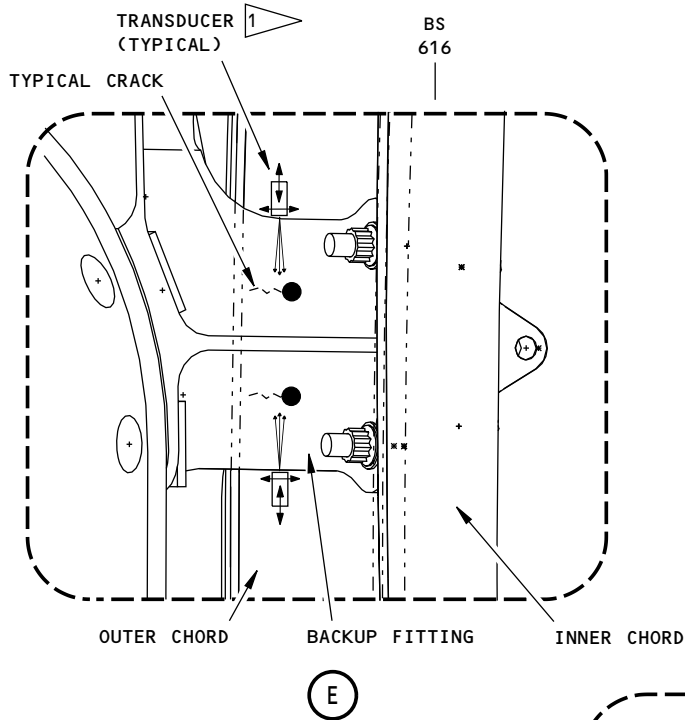
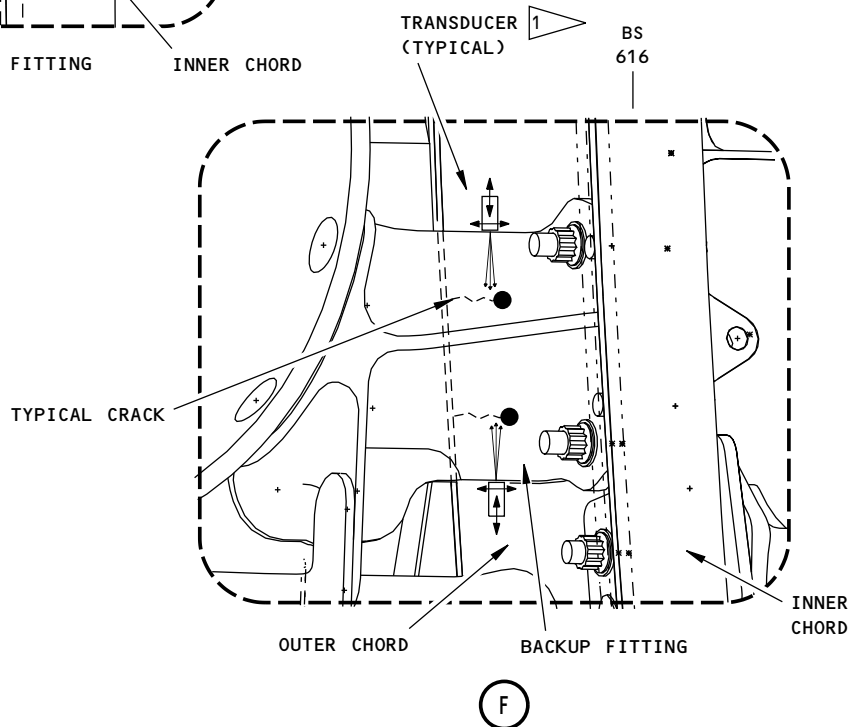
2375213 S0000543582\_V1

737-600/700/700C/700IGW  
OVERWING EMERGENCY EXIT CUTOUT  
SIDE VIEW AT BS 616  
(VIEWS ARE AS YOU LOOK OUT)

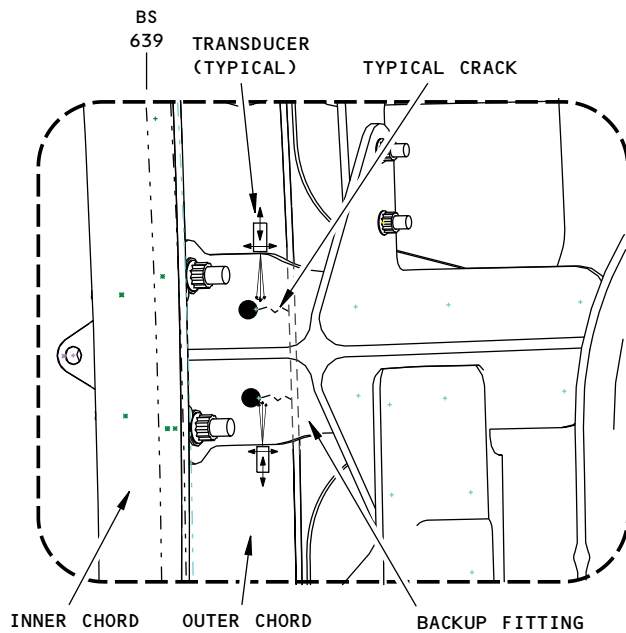
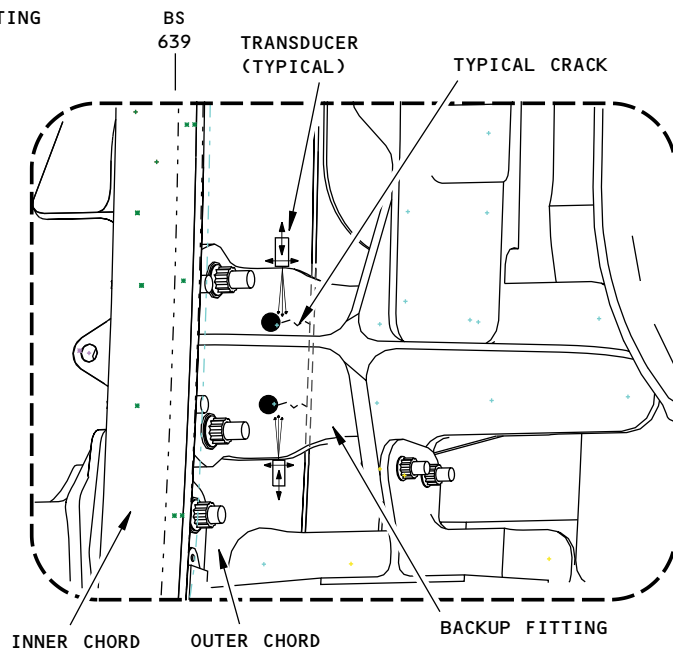
737-600/700/700C/700IGW  
OVERWING EMERGENCY EXIT CUTOUT  
SIDE VIEW AT BS 639  
(VIEWS ARE AS YOU LOOK OUT)

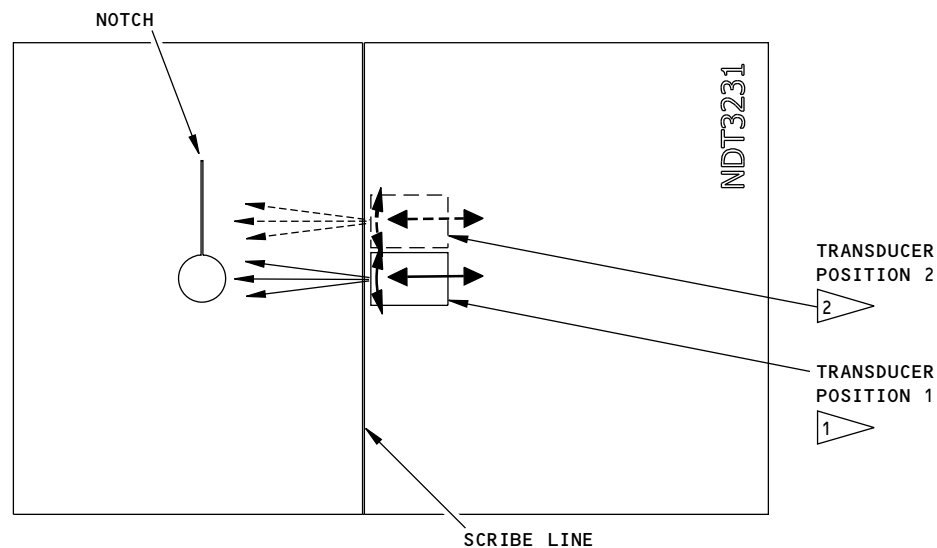
TRANSDUCER POSITIONS  
DETAIL 1

- (c) Move the transducer a minimum of one full transducer width away from the cutout of the overwing emergency exit. Then turn the transducer a small quantity clockwise and counterclockwise and monitor the screen display for signals that occur to the right of the signal from the fastener hole.
- (d) Do Paragraph 5.A.(3)(a) thru Paragraph 5.A.(3)(c) again for each of the backup fitting inspection locations identified in Figure 1.
- (e) Do Paragraph 5.A.(3)(a) thru Paragraph 5.A.(3)(d) again to examine the outer chord for cracks behind the backup fittings on the opposite side of the airplane.

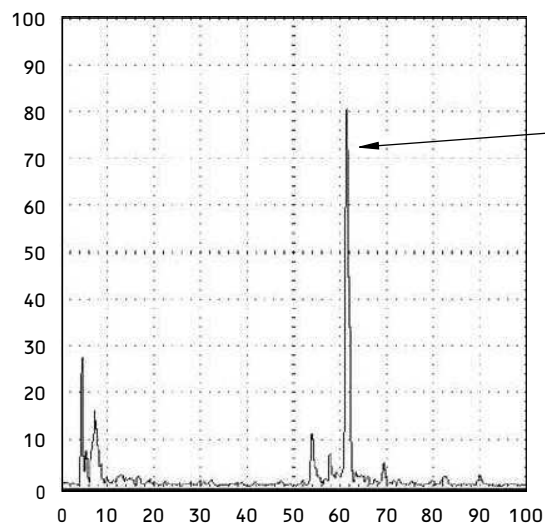
TRANSDUCER POSITION 1 SIGNAL  
DETAIL 2

CALIBRATION SIGNALS FOR THE TRANSDUCER POSITIONS

- 3 EXAMINE AREAS THAT CAUSE SIGNALS TO OCCUR THAT ARE 40% (OR MORE) OF FSH AND WITHIN 20% OF FSW TO THE RIGHT OF THE HOLE SIGNAL. THE SIGNAL FROM THE FASTENER HOLE WILL CHANGE IN FSW AS THE DISTANCE FROM THE EDGE OF THE BACKUP FITTING TO THE FASTENER HOLE CHANGES AT SOME LOCATIONS.

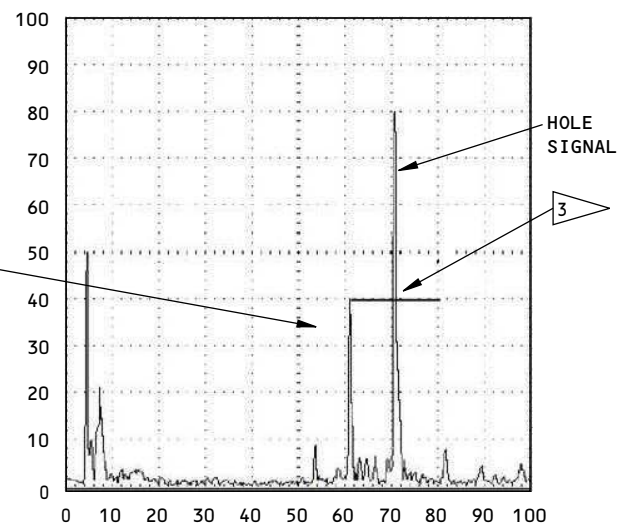
TRANSDUCER POSITION 2 SIGNAL  
DETAIL 3
