Field facade sound insulation

Standardized facade level difference $D_{2m,nT}$ measured in accordance with ISO 10052:2021 (survey method, octave bands). Rating per ISO 717-1:2020.

Report no.: EXAMPLE-10052-FACADE

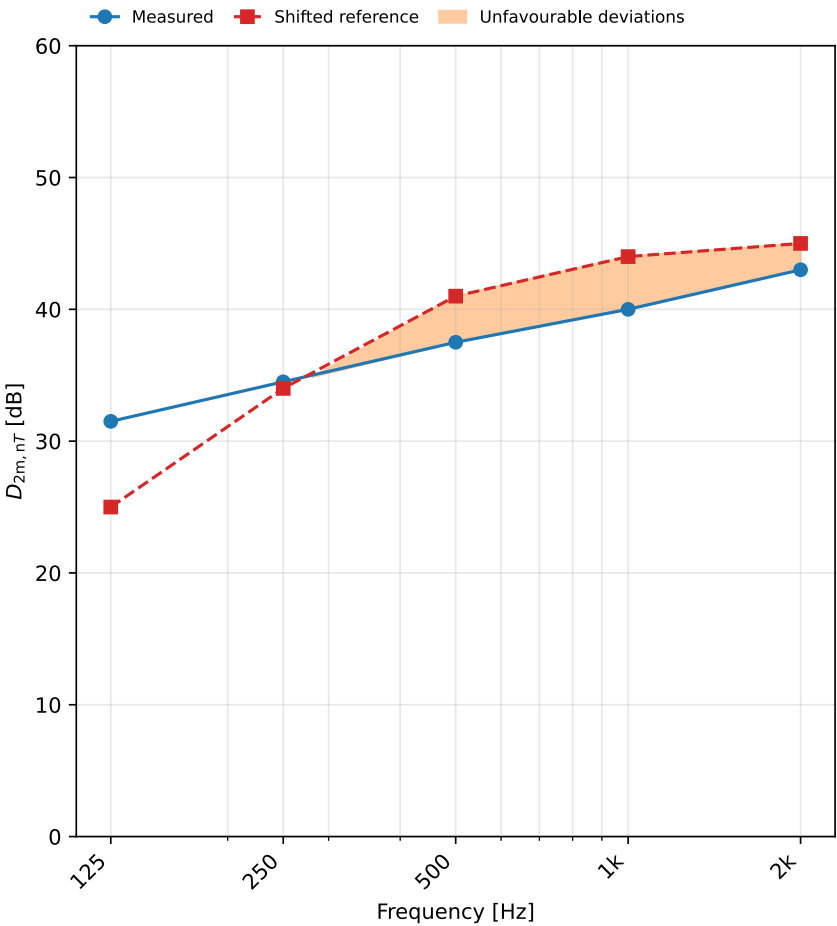
Octave-band $D_{2m,nT}$ [dB]

$D_{2m,nT,w} (C; C_{tr}) = 41 (-1; -3) \text{ dB}$

Result vs requirement: $D_{2m,nT,w} = 41 \text{ dB}$, required $\geq 33 \text{ dB}$ → **PASS**
