Field facade sound insulation

Standardized facade level difference $D_{2m,nT}$ measured in accordance with ISO 16283-3:2016 (field measurement).
Rating per ISO 717-1:2020.

Report no.: EXAMPLE-16283-3

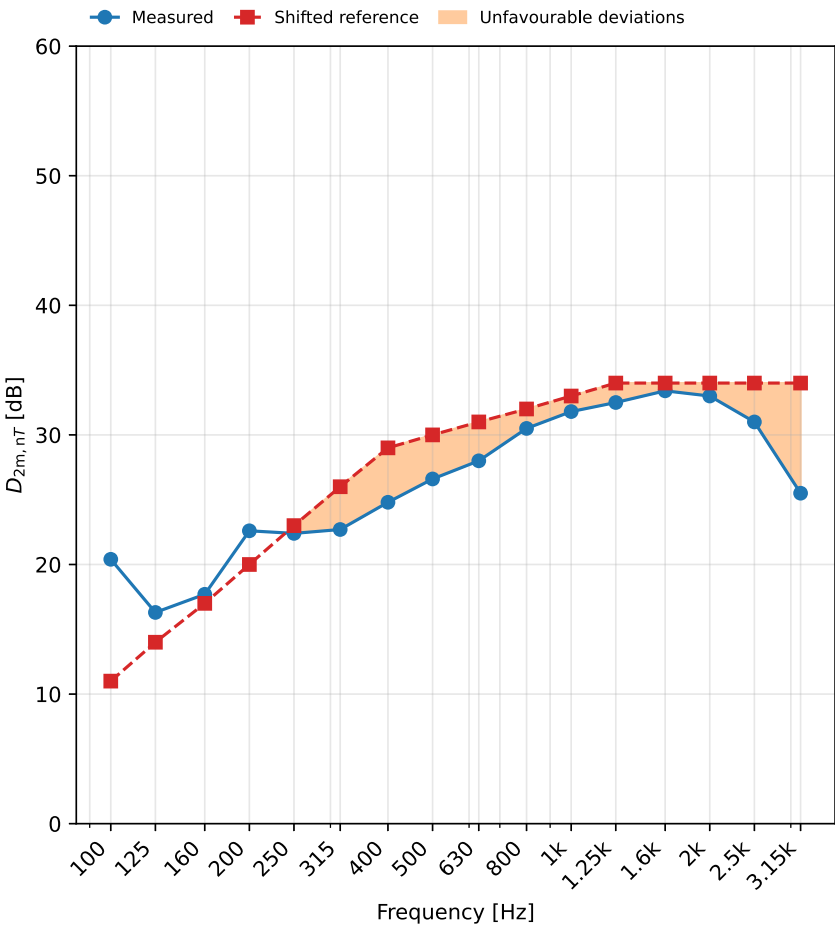
One-third-octave $D_{2m,nT}$ [dB]

$D_{2m,nT,w} (C; C_{tr}) = 30 \text{ (-2; -3) dB}$

Result vs requirement: $D_{2m,nT,w} = 30 \text{ dB}$, required $\geq 30 \text{ dB}$ → **PASS**
