mcp430fr5969: spi_data_outlet_issue

Part Number: [MSP430FR5969](#)

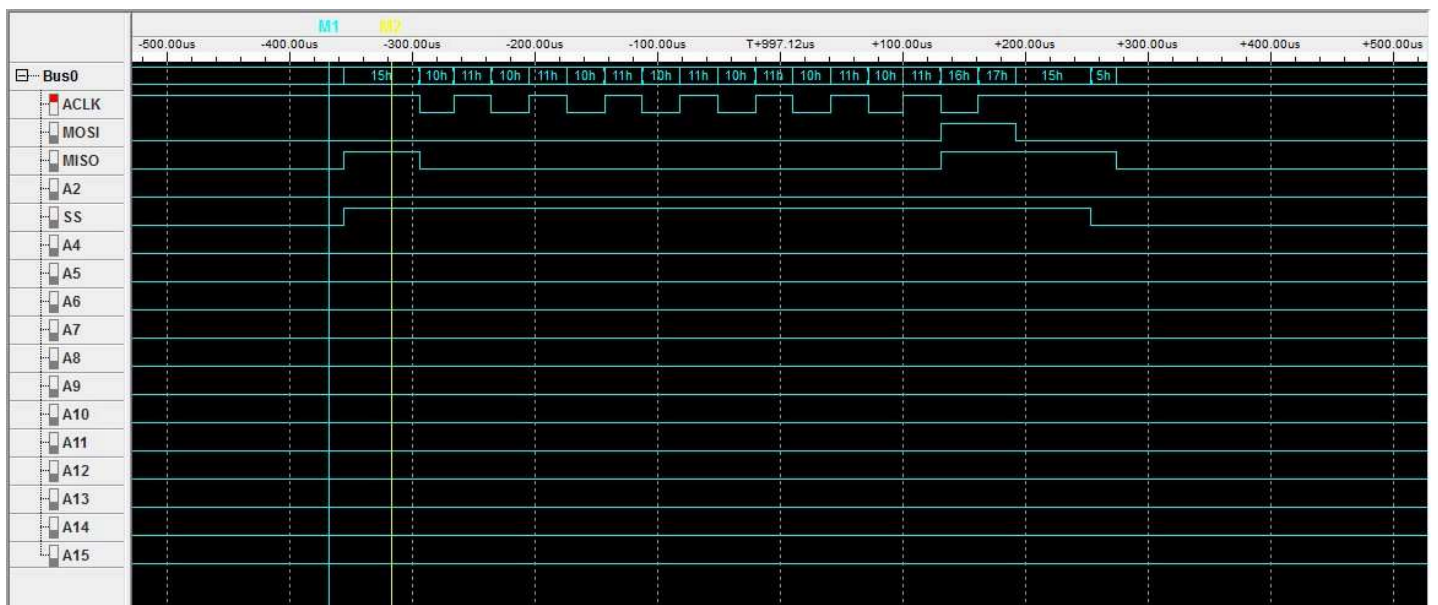
I am developing a code based on SPI module. Now I am working on example codes related to spi(4 pin mode). My doubt is regarding, I am sending data(0x01) to slave and Echoed back to master with the same data. But in Logical Analyzer I have noticed the following data. When i Debugged, I got 0x01 in master and 0x80 in slave. Is there a problem being in my code or whether there is some other issue.(Note: A2 pin is not connected). If it is worked then i would like to interface the same uC with BLE.

What are your UC[A/B]xCTLW0 register settings and what slave device are you communicating with? The fact that you are getting a response means that the connections and timing are correct but some control bit is most likely misunderstood between devices. It could be the UCMSB bit since 0x80 is the reverse direction of 0x01. You could confirm this with further test data points.
