Field impact sound insulation of floors

Standardized impact sound pressure level L'_{nT} measured in accordance with ISO 16283-2:2020 using the tapping machine. Rating per ISO 717-2:2020.

Report no.: EXAMPLE-16283-2

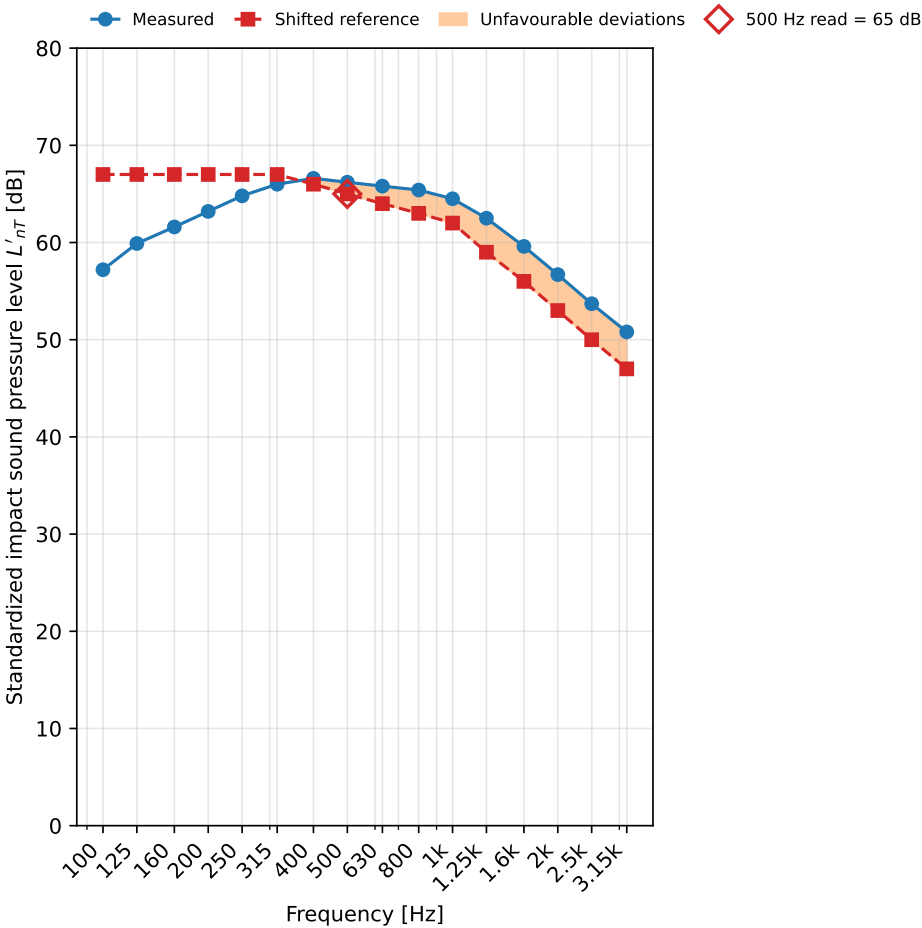
One-third-octave L'_{nT} [dB]

$$L'_{nT,w}(C_I) = 65 \text{ (-5) dB}$$

Result vs requirement: $L'_{nT,w} = 65 \text{ dB}$, required $\leq 58 \text{ dB}$ → **FAIL**
