pifanctl v1 Release Acceptance Field Manual

Status: Live v1 alpha runtime and thermal observations recorded through 2026-10-07 **Release target:** 1.0.0

Decision: Not ready for a stable release. Hardware-specific acceptance remains open.

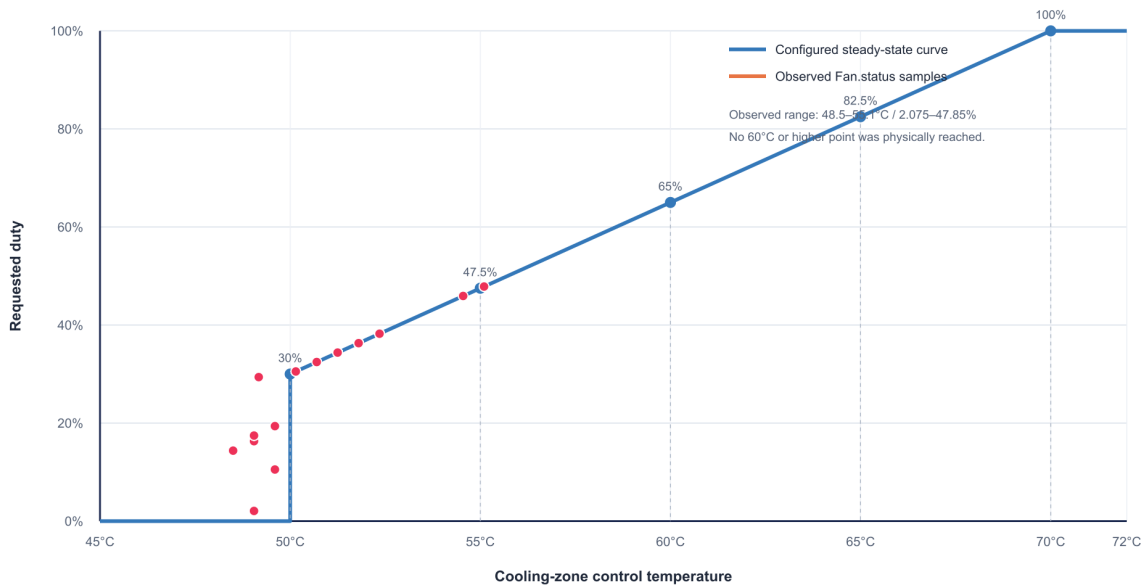
Measured MicroK8s temperature and fan-command response

The test is not an isolated causal measurement. The hottest readings came from raspi-51, not the stress target raspi-41, and the cluster hosts other services. The stress target peaked at 50.147°C, while the hottest rack member peaked at 55.1°C. A later `kubecttl top nodes` sample showed about 19% CPU on both raspi-40 and raspi-41, and about 6% on raspi-50 and raspi-51, after the load had ended. The data demonstrate changing cluster telemetry and corresponding Fan status, but they do not prove that the injected load alone caused the raspi-51 temperature peak.

This figure plots the node selected for load, the concurrently hottest node, the cluster maximum, the Fan status control temperature, and the requested duty. Gaps between test stages remain gaps in time. Fan status is not measured PWM voltage or RPM.

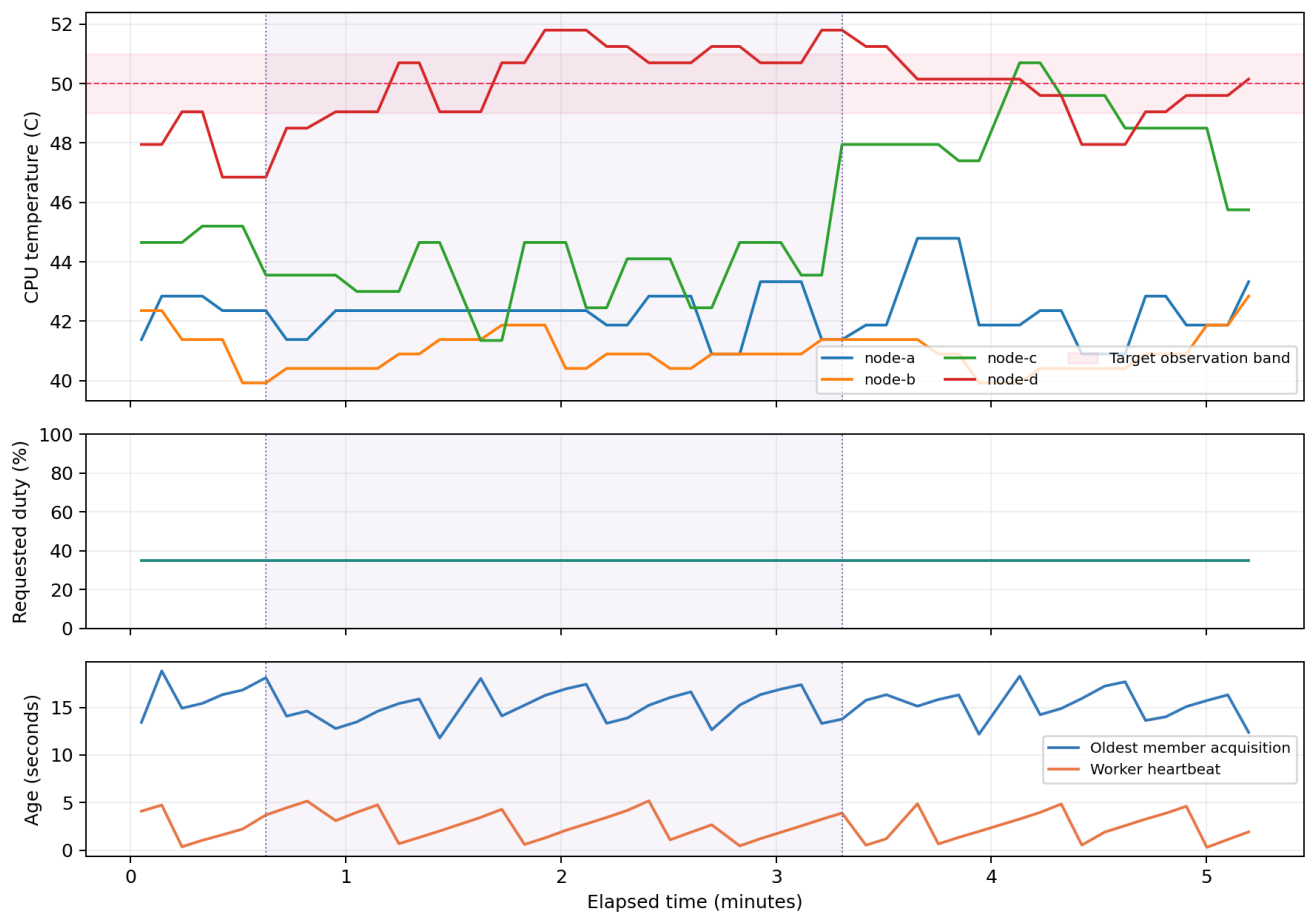
Fixed-load measured response

Historical verdict under legacy-1c: failed thermal stability; collection and cleanup passed. Section 16 records the approved 3 C reassessment of these unchanged measurements. Trial UTC: 2026-10-06 21:19:10 to 21:24:33. Alpha.6 remained deployed with unchanged fan/curve settings and source-matched GitOps state. A temporary nonprivileged Pod heated one assigned member; a read-only probe identified that member as a Raspberry Pi 5 Model B Rev 1.0. This does not identify or validate Pi 5 actuator hardware.

The 50 C target is an acceptance observation band. The existing temperature curve and hysteresis remain the control policy; this trial does not add setpoint regulation. The measured temperature varied across the band and exceeded it. Ending at a lower temperature does not establish a stable plateau or complete return to baseline.

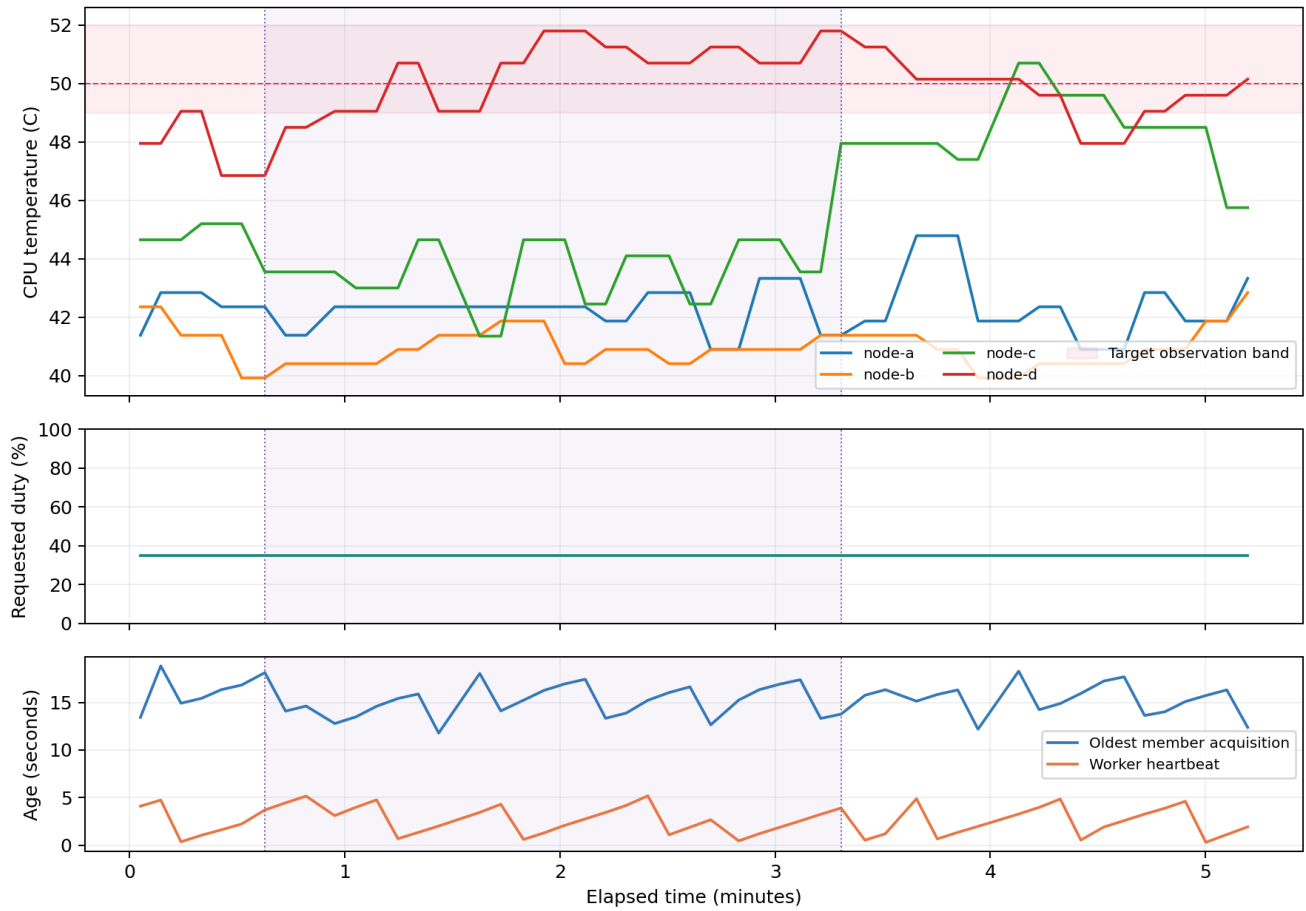
Approved observation band: unchanged measured response

Reassessment check	Result from unchanged source data
Approved 50 C observation interval	49-52 C; maximum total span 3 C
Qualifying source-clock interval	2026-10-06 21:19:55.071883 to 21:22:15.307699 UTC: 140.24 seconds
Measured temperature interval	49.05-51.8 C, total span 2.75 C
Requested duty	35.04%, constant across the qualifying interval
Telemetry integrity	Every member acquisition clock retained; zero invalid load observations
Original criterion	Still failed: 0 qualifying seconds at the legacy 1 C span

Shading spans sampled load observations. Duty is a command, not RPM or measured voltage.
