The Firmware Supply-Chain Security Is Broken: Can We Fix It?

*Alex Matrosov, Alex Ermolov,
Richard Hughes & Kai Michaelis*

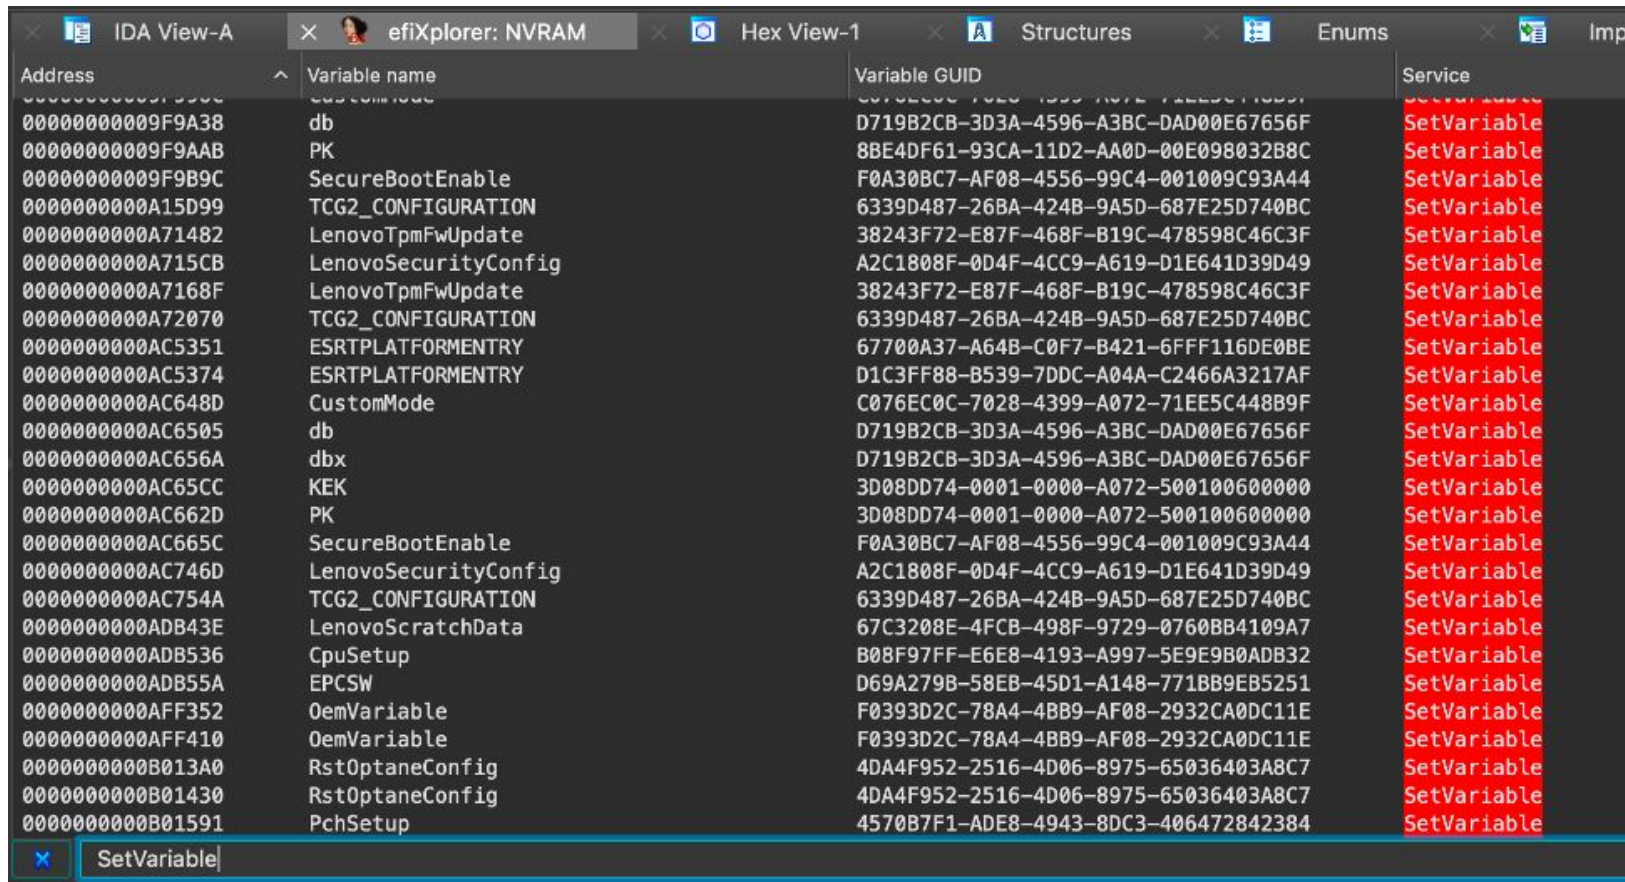
github.com/binarly-io/efiXplorer

Address	Variable name	Variable GUID	Service
00000000009F9A38	db	D719B2CB-3D3A-4596-A3BC-DAD00E67656F	SetVariable
00000000009F9AAB	PK	8BE4DF61-93CA-11D2-AA0D-00E098032B8C	SetVariable
00000000009F9B9C	SecureBootEnable	F0A30BC7-AF08-4556-99C4-001009C93A44	SetVariable
0000000000A15D99	TCG2_CONFIGURATION	6339D487-26BA-424B-9A5D-687E25D740BC	SetVariable
0000000000A71482	LenovoTpmFwUpdate	38243F72-E87F-468F-B19C-478598C46C3F	SetVariable
0000000000A715CB	LenovoSecurityConfig	A2C1808F-0D4F-4CC9-A619-D1E641D39D49	SetVariable
0000000000A7168F	LenovoTpmFwUpdate	38243F72-E87F-468F-B19C-478598C46C3F	SetVariable
0000000000A72070	TCG2_CONFIGURATION	6339D487-26BA-424B-9A5D-687E25D740BC	SetVariable
0000000000AC5351	ESRTPLATFORMENTRY	67700A37-A64B-C0F7-B421-6FFF116DE0BE	SetVariable
0000000000AC5374	ESRTPLATFORMENTRY	D1C3FF88-B539-7DDC-A04A-C2466A3217AF	SetVariable
0000000000AC648D	CustomMode	C076EC0C-7028-4399-A072-71EE5C448B9F	SetVariable

0000000000AC6505	db	D719B2CB-3D3A-4596-A3BC-DAD00E67656F	SetVariable
0000000000AC656A	dbx	D719B2CB-3D3A-4596-A3BC-DAD00E67656F	SetVariable
0000000000AC65CC	KEK	3D08DD74-0001-0000-A072-500100600000	SetVariable
0000000000AC662D	PK	3D08DD74-0001-0000-A072-500100600000	SetVariable
0000000000AC665C	SecureBootEnable	F0A30BC7-AF08-4556-99C4-001009C93A44	SetVariable
0000000000AC746D	LenovoSecurityConfig	A2C1808F-0D4F-4CC9-A619-D1E641D39D49	SetVariable
0000000000AC754A	TCG2_CONFIGURATION	6339D487-26BA-424B-9A5D-687E25D740BC	SetVariable
0000000000ADB43E	LenovoScratchData	67C3208E-4FCB-498F-9729-0760BB4109A7	SetVariable
0000000000ADB536	CpuSetup	B08F97FF-E6E8-4193-A997-5E9E9B0ADB32	SetVariable
0000000000ADB55A	EPCSW	D69A279B-58EB-45D1-A148-771BB9EB5251	SetVariable
0000000000AFF352	OemVariable	F0393D2C-78A4-4BB9-AF08-2932CA0DC11E	SetVariable
0000000000AFF410	OemVariable	F0393D2C-78A4-4BB9-AF08-2932CA0DC11E	SetVariable
