pifanctl v1 Release Acceptance Field Manual

Status: Live v1 alpha runtime and thermal observations recorded through 2026-10-06 **Release target:** 1.0.0

Decision: Not ready for a stable release. Hardware-specific acceptance remains open.

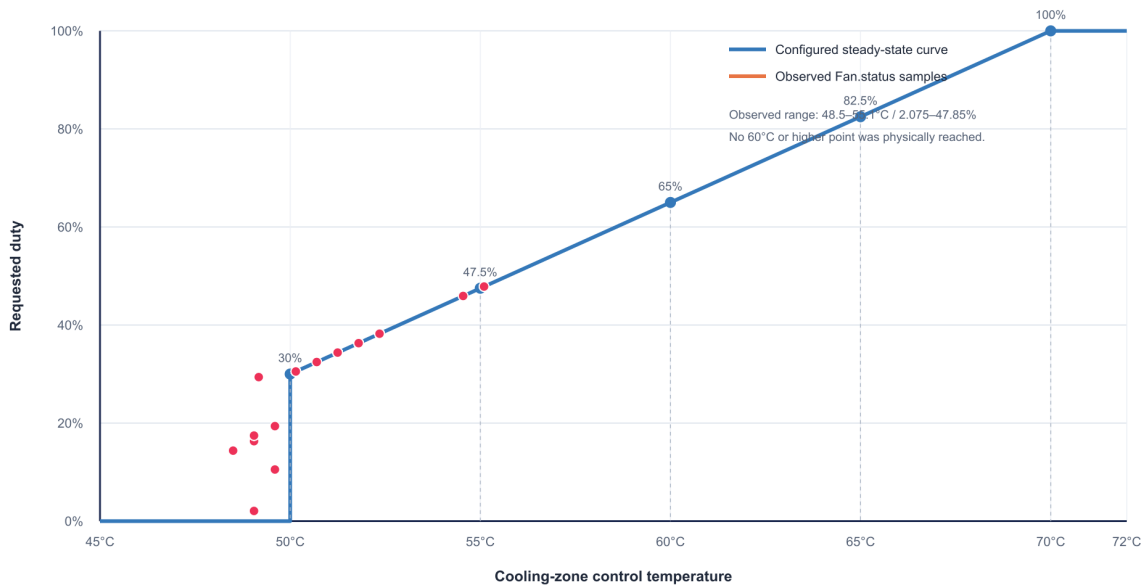
Measured MicroK8s temperature and fan-command response

Stage	Applied load	Highest member reading	raspi-41 reading	Fan resource observation	Result
A	1 vCPU, up to 150 seconds	51.8°C	49.173°C maximum	Requested duty 29.375% to 36.3%	Partial; 55°C band not reached
B	2 vCPU, up to 120 seconds	52.35°C	50.147°C maximum	Requested duty reached 38.225%	Partial; brief readings only, no stable hold
C	3 vCPU, up to 120 seconds	55.1°C on raspi-51	49.173°C maximum	At control temperature 55.1°C, status requested 47.85%	Partial; hottest member was not the load target and did not remain at 55.1°C
D	Five-minute no-load observation, begun about seven minutes after the final stress stage	54.55°C maximum during the interval	Recorded separately in the CSV	Control temperature 49.05°C to 54.55°C; requested duty 17.45% to 45.925%	No stable plateau established; this delayed interval does not measure the immediate cooldown transient

The expected steady-state commands from the configured curve are 30% at 50°C, 47.5% at 55°C, 65% at 60°C, 82.5% at 65°C, and 100% at 70°C. The trial reached a short 55.1°C control-temperature snapshot and reported 47.85%, consistent with the configured curve. It did not reach 60°C or higher, and no temperature band was held long enough to claim thermal stabilization.

The test is not an isolated causal measurement. The hottest readings came from raspi-51, not the stress target raspi-41, and the cluster hosts other services. The stress target peaked at 50.147°C, while the hottest rack member peaked at 55.1°C. A later `kubecttl top nodes` sample showed about 19% CPU on both raspi-40 and raspi-41, and about 6% on raspi-50 and raspi-51, after the load had ended. The data demonstrate changing cluster telemetry and corresponding Fan status, but they do not prove that the injected load alone caused the raspi-51 temperature peak.

This figure plots the node selected for load, the concurrently hottest node, the cluster maximum, the Fan status control temperature, and the requested duty. Gaps between test stages remain gaps in time. Fan status is not measured PWM voltage or RPM.

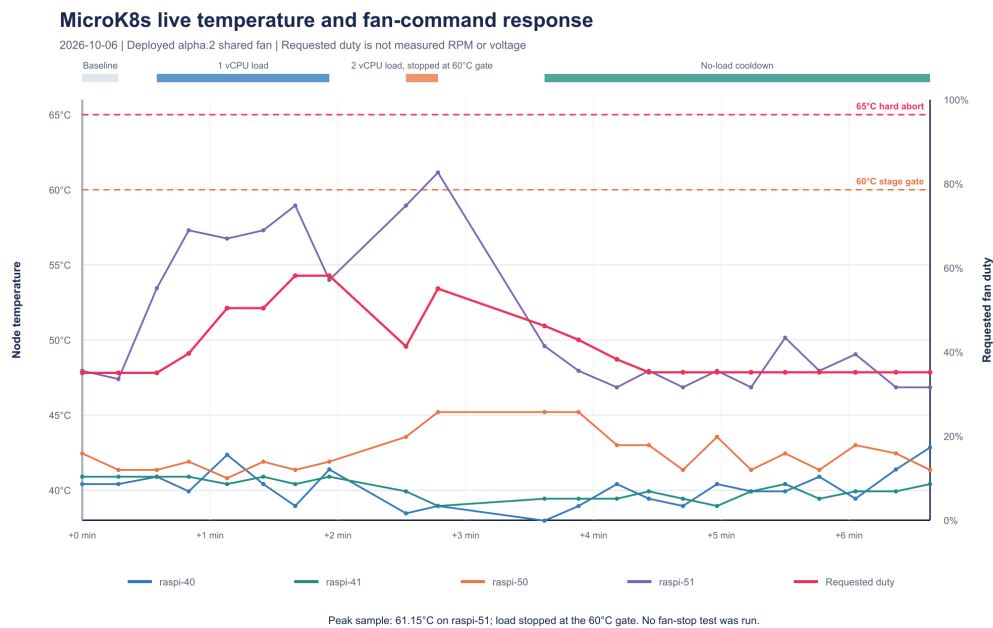
Observation	Result
Baseline hottest member	raspi-51, 47.95°C; requested duty 35.04%
1 vCPU stage	Peak 58.95°C; requested duty reached 58.14%; Pod exited after 85 seconds
2 vCPU stage	Sampled peak 61.15°C; requested duty 55.06%; stopped at the 60°C stage gate and Pod removed
No-load follow-up	12 samples over 3 minutes; raspi-51 was 46.85°C in the final sample, with requested duty 35.18%
Monitoring and controller	Four node series remained fresh; maximum observed sample age was under 4 seconds; controller stayed Ready

These observations show the shared controller's requested duty rising while the hottest member warmed and falling during cooldown. They do not establish a stable target-temperature hold, prove that injected CPU load alone caused every temperature change, or measure electrical PWM, fan RPM, or airflow. The exact board model for `raspi-51` remains unrecorded. No fan-stop, fault-injection, reboot, or power-loss test was run. Fan rotation was not directly observed during this remote follow-up.

Raw timestamped samples, including the aborted-stage observation and cooldown, are in [thermal-load-observations-2026-10-06.csv](#). The plot separates each node's temperature from the requested fan duty and marks both the 60°C stage gate and 65°C hard abort limit.

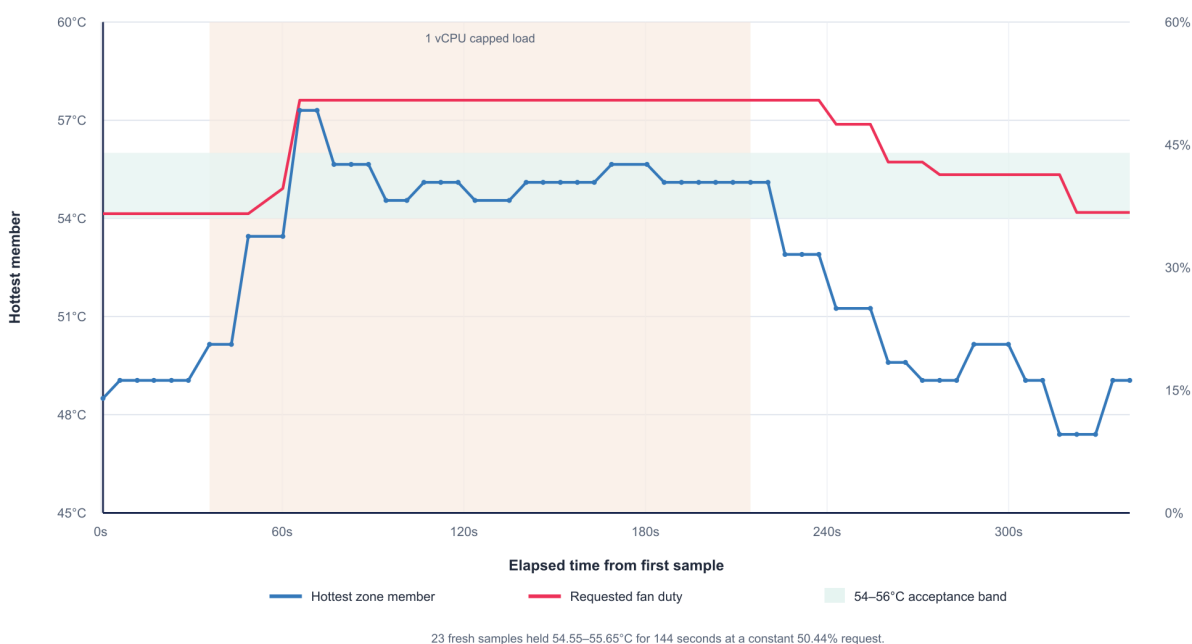
Measured 55°C shared-rack response

Measurement	Result
Baseline hottest member	raspi-51, 49.05°C; 36.58% requested duty
Applied load	1 vCPU CPU limit on raspi-51; maximum load duration 180 seconds
Load-stage peak	57.3°C; requested duty peaked at 50.44%; neither the 58°C soft stop nor 62°C hard stop was reached
Stable target interval	23 fresh observations from 2026-10-06 14:22:48 UTC through 14:25:12 UTC; 144 seconds in the 54–56°C band

Measurement	Result
Temperature and requested duty in the interval	54.55–55.65°C; fixed at 50.44% requested duty (0 percentage-point span)
Telemetry freshness	Maximum observed source age for the full run was 17.83 seconds; longest gap between stable-interval source observations was 10 seconds
Physical fan observation	User confirmed normal rotation before the load; continuous observation during the run was not recorded. No RPM/tachometer measurement or electrical PWM waveform was recorded
Cooldown and cleanup	After load removal, the hottest member returned to 47.4–49.05°C in the recorded cooldown window. The temporary load Pod was absent on follow-up. Operator and worker were Ready with zero restarts; Fan and CoolingZone were Ready.

This run **passes the 55°C temperature-band stability criterion** for the tested alpha.3 runtime and rack configuration. It does not prove measured RPM, airflow, PWM voltage/polarity, or fan-failure detection. The initial rise to 57.3°C and the later sensor readings are part of the observed response, not a claim that the entire load stage stayed at the target. Only the 55°C target was tested with this criterion; 50°C and 60°C target runs remain open. The cooldown samples demonstrate a return toward baseline but are not a calibrated cooling-capacity or time-to-stability measurement.

Fresh source observations from the v1 worker; requested duty is a command, not measured RPM or PWM voltage.
