pifanctl v1 Release Acceptance Field Manual

Status: Live v1 alpha runtime and thermal observations recorded through 2026-10-07 **Release target:** 1.0.0

Decision: Not ready for a stable release. Hardware-specific acceptance remains open.

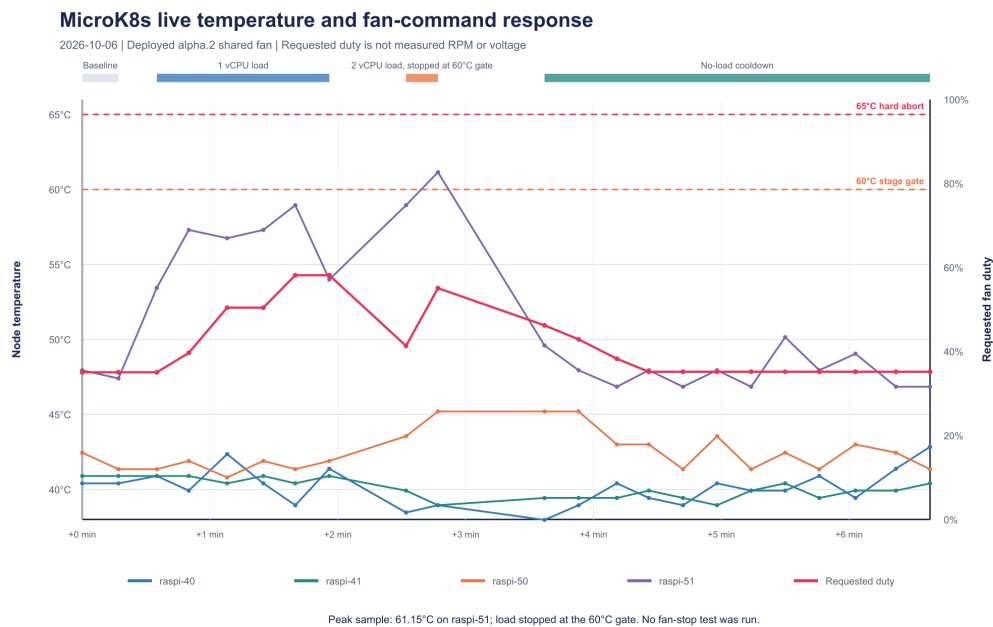
These observations show the shared controller's requested duty rising while the hottest member warmed and falling during cooldown. They do not establish a stable target-temperature hold, prove that injected CPU load alone caused every temperature change, or measure electrical PWM, fan RPM, or airflow. The exact board model for `raspi-51` remains unrecorded. No fan-stop, fault-injection, reboot, or power-loss test was run. Fan rotation was not directly observed during this remote follow-up.

Raw timestamped samples, including the aborted-stage observation and cooldown, are in [thermal-load-observations-2026-10-06.csv](#). The plot separates each node's temperature from the requested fan duty and marks both the 60°C stage gate and 65°C hard abort limit.

The live experiment is a response check for the deployed alpha.2 shared-fan topology only. It does not validate the v1 CRD operator, Pi 5 PWM, fail-safe behavior after hardware or process faults, electrical signal polarity, or physical cooling capacity.

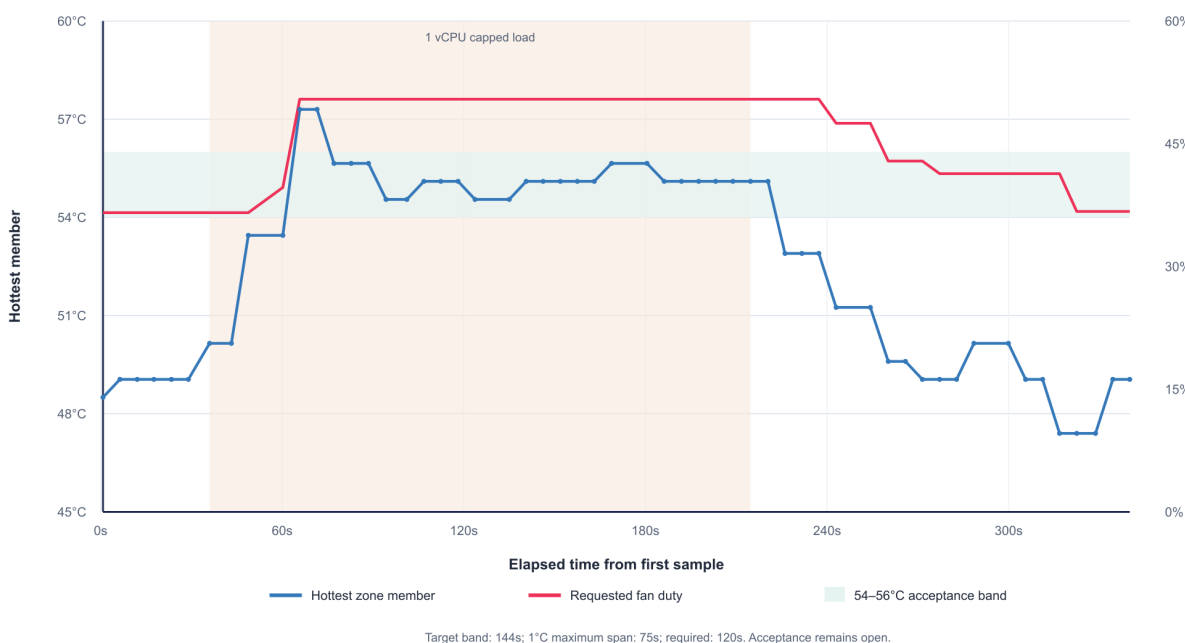
Measured 55°C shared-rack response

This run **does not pass the original 55°C stability criterion**. The entire 144-second band interval spans 1.10°C, exceeding the required 1°C total range. The longest qualifying 1°C interval is 75 seconds, shorter than the required 120 seconds. The archived source clock is the minimum across members; individual member observation timestamps were not retained, so these 23 composite observations must not be described as independent hottest-node sensor samples. It does not prove measured RPM, airflow, PWM voltage/polarity, or fan-failure detection. The initial rise to 57.3°C and the later sensor readings are part of the observed response, not a claim that the entire load stage stayed at the target. Only the 55°C target was examined in this worker run; acceptance at 50°C, 55°C, and 60°C remains open. The cooldown samples demonstrate a return toward baseline but are not a calibrated cooling-capacity or time-to-stability measurement.

Fresh source observations from the v1 worker; requested duty is a command, not measured RPM or PWM voltage.

Do not label 1.0.0 stable until every applicable release gate has evidence for the exact release candidate. Hardware or topologies not tested must be listed as unsupported. Preserve the v0 rollback archive until the release decision is recorded.
