Gear Graphs

A Guide To
Interpreting
The Squiggly Lines

Resolve the many causes of Errors in Hobbing and Shaving by
unlocking the information in Gear Graphs

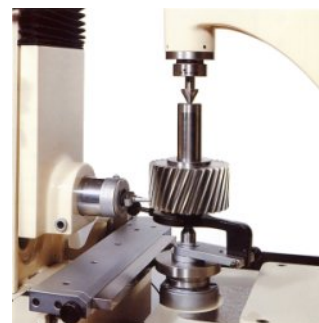
Fig.1: SH450

The machine in FIG.1 is the SH450 from Frenco International. This type of machine uses a base disc that is equal to the base circle diameter of the gear being measured.

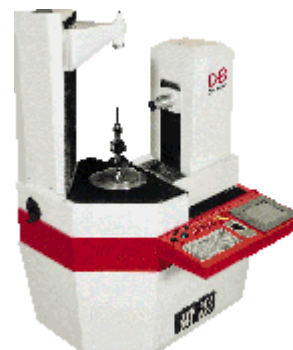
Fig.2: Euro 500

The machine in FIG.2 is the Euro 500 from David Brown Gear Metrology; this is a radically new CNC Analytical Gear Tester using state of the art technology with a revolutionary new design. The aerostatic bearings provide non-contact motion to all axes resulting in no wear. The controls are in a familiar windows environment.
