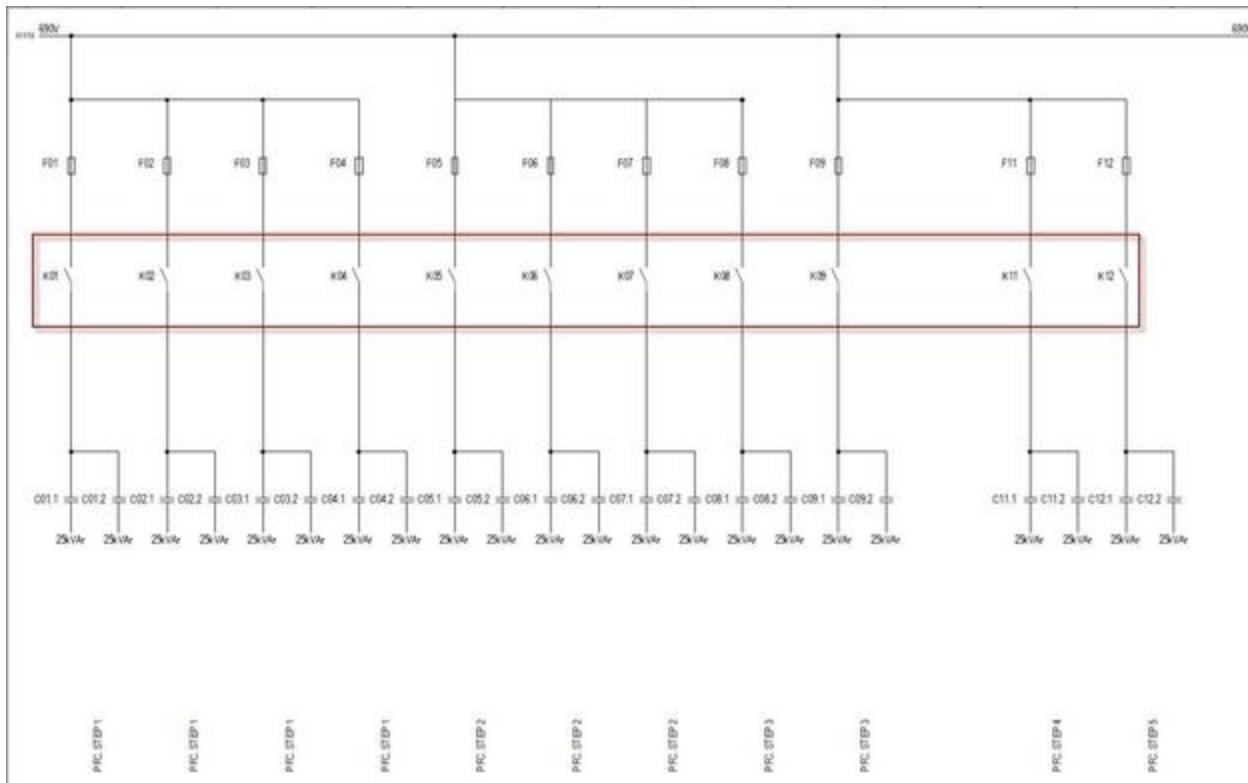
AT THE +AT3 CABINET:

Check the capacitor contactors function in AT3 panel.

If found defective, replace the contactor ( Position K01-K12):

Part number for capacitor contactor (K01-K12):

Relevant spare parts	
Description	Item No.
CONT K350K10230 W/RC-UNIT 230V	<a href="#">60096832</a>
