Bridge FW Development January 2023

WiFi | BCT | IPv6 | FW Upgrade | Bootloader | Onion | MT768

1. WiFi Feature implementation

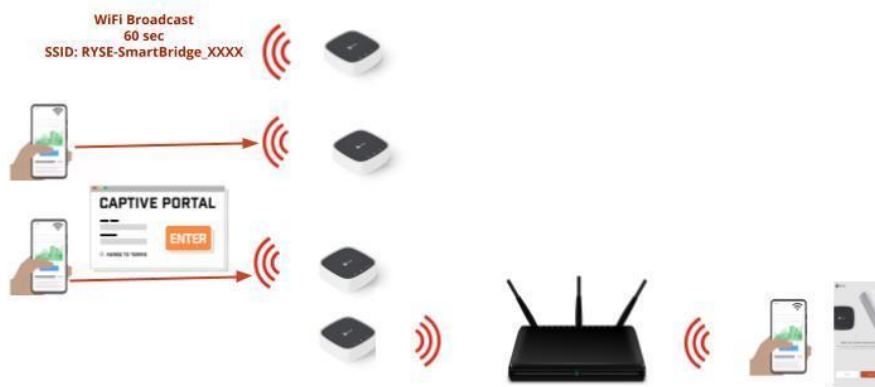
Solution 1

The first solution consist of using only wifi access to the bridge to configure the WiFi access of the bridge to the gateway

On startup >

If no known WiFi is recorded or known WiFi not found >

Start broadcasting WiFi network "RYSE-SmartBridge_XXXX" (hostname) for 60 sec >

User connects to this network >

Redirected user to webpage >

webpage displays available WiFi networks >

User selects desired SSID and enters username and pass >

bridge confirms connection >

stops broadcasting SSID

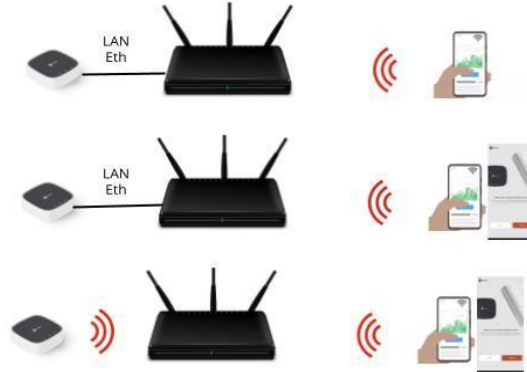
Solution 2

The second solution consist of using (only in the configuration phase) ethernet access between the bridge and the gateway

In any time the user can plugin the bridge to the router with eth cable >

the bridge connect to the LAN and to the cloud>

the user use the ryse mobile app in his mobile to configure WiFi network>

User selects desired SSID and enters username and pass >

bridge confirms connection >

User can unplug the bridge and use the WiFi connection

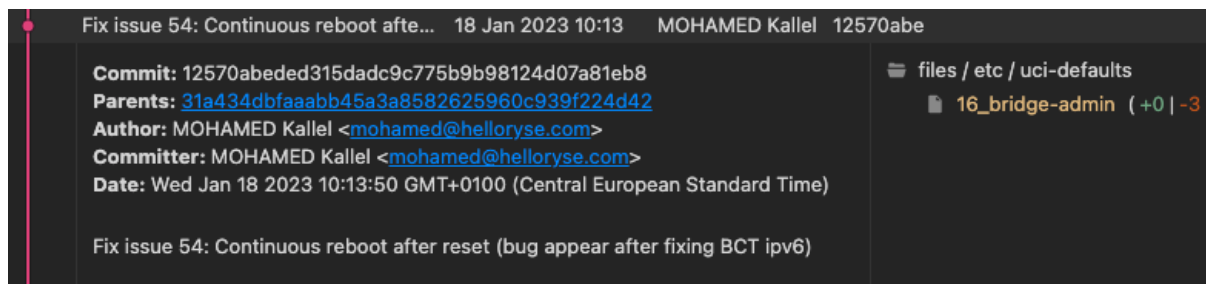
this fix was pushed to bridge_firmware git repository in Jan 13 2023

The screenshot shows a git commit interface. The commit message is "Fix issue 54: Continuous reboot after reset (bug appear after fixing BCT ipv6)". The commit hash is 12570abed315dadc9c775b9b98124d07a81eb8. The commit was made by MOHAMED Kallel on Wed Jan 18 2023. The diff shows changes to the file `etc/uci-defaults/16_bridge-admin`, with a change of +0 lines and -3 lines.

After investigation the issue and checking many scenarios by changing the init scripts of avahi and admin, I found that the admin app is starting in early phase and I found that the admin is launched by the uci-default script `16_bridge-admin`:

I removed these lines and the issue is fixed.

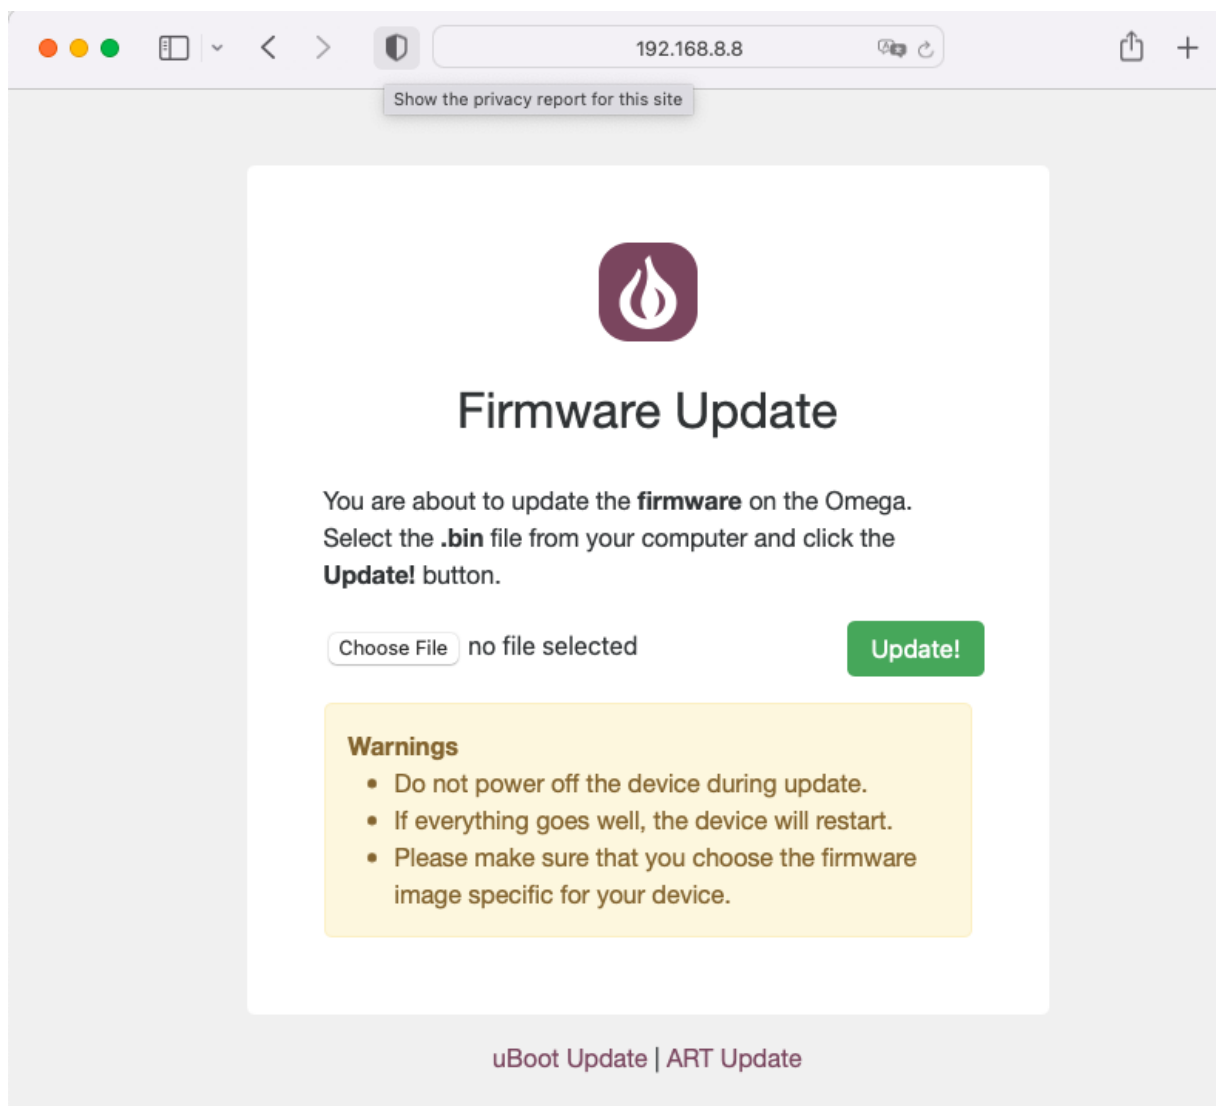
8- From the PC web browser connect to the IP address of the bridge (bootloader address)

9- and then upgrade the new firmware
