## Replace the defective pressure sensor

## AVN Combi Hydraulic (POS 12).

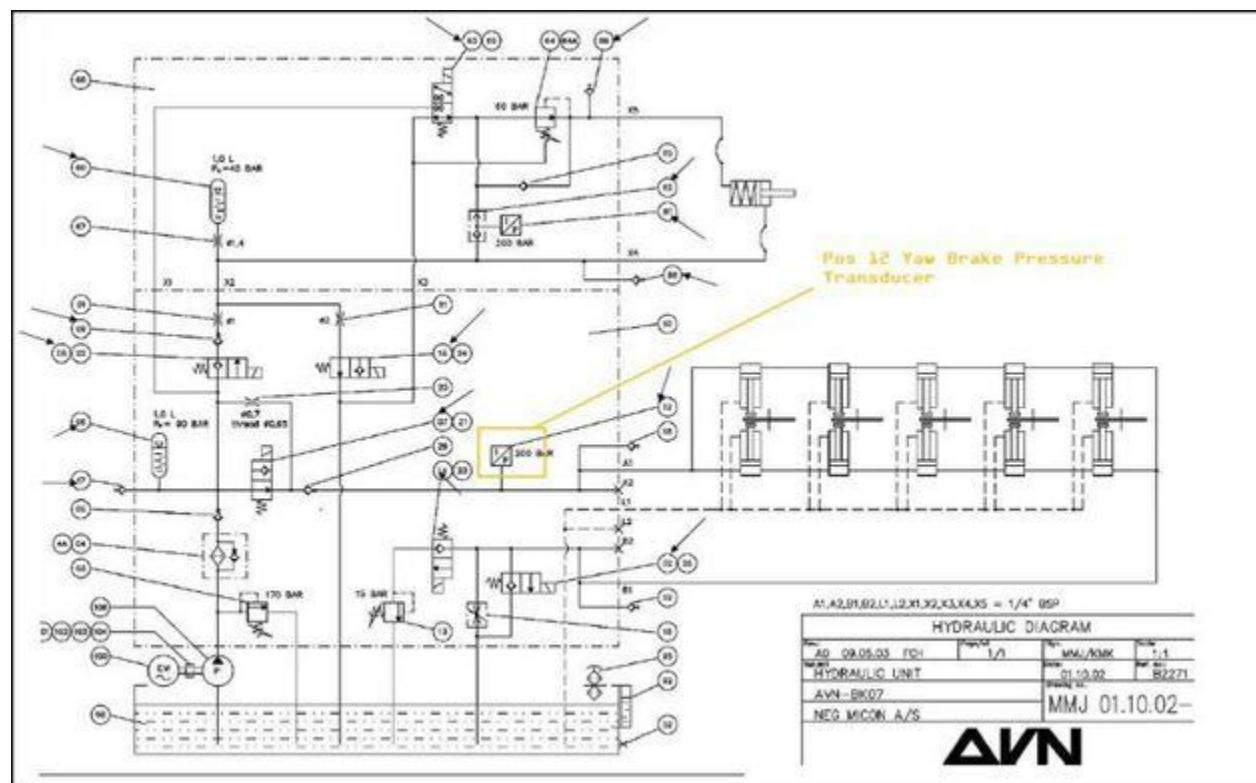
If the Yaw Brake pressure shows the negative values,

Check the loose connection in yaw brake pressure switch connection socket.

Replace Pressure switch If necessary

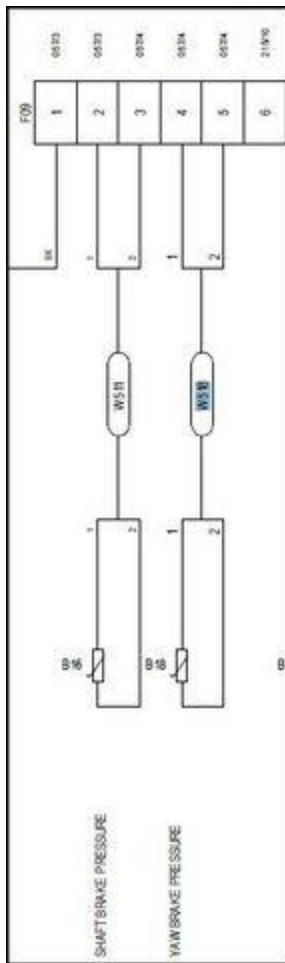
F09 Varistor 4 &5 terminals

Check W518 cable continuity and check loss connection in F09 Varistor at AN1 Junction Box

## Replace Defective varistor

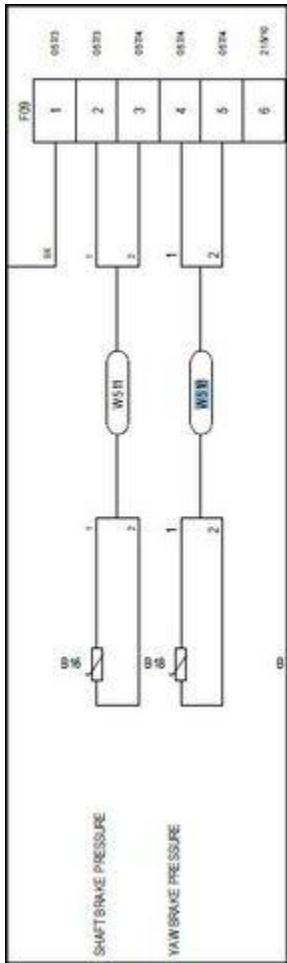
Check the Loose connection in Nacelle TOI Input terminal U01 Terminal no 203.

### Replace the Defective TOI

Replace TOI If required
