TEAC FD-235HF 218U

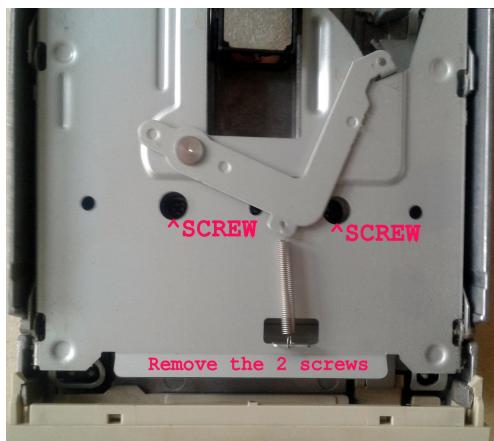
First check the switches, normally closed but contact resistance for all three was in K Ohms range.
So you must replace or clean them.

Remove the motor.

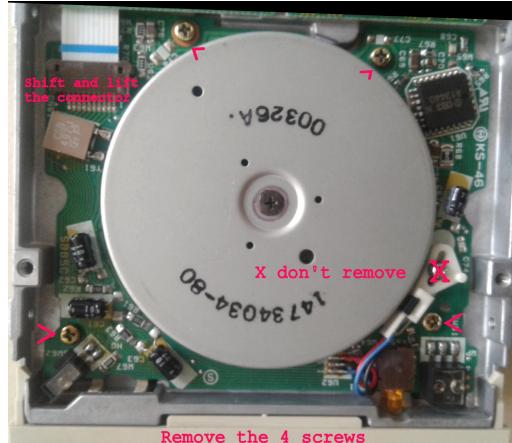
Remove the motor board.

^ - Spray contact cleaner - ^

Push the switches until the contact resistance is near to 0 Ohm (50 times pushing).
Put the motor board back in the drive.

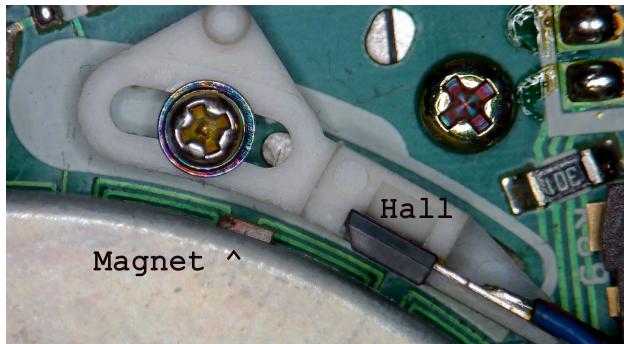
WP & CIN switch

HD Switch

Index sensor

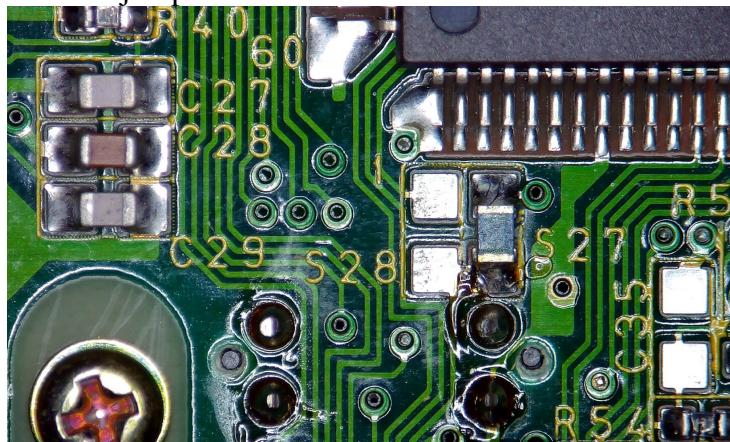
Option-1 ready signal from U1, change the jumper.

Remove jumper on S27

Place jumper on S28

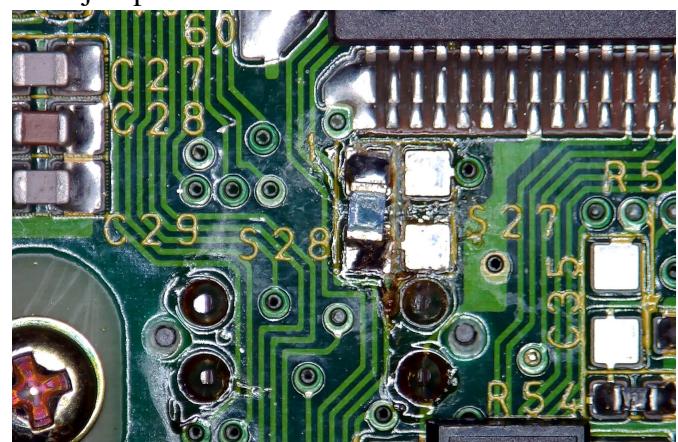
Jumper block, see RDY schematic.pdf

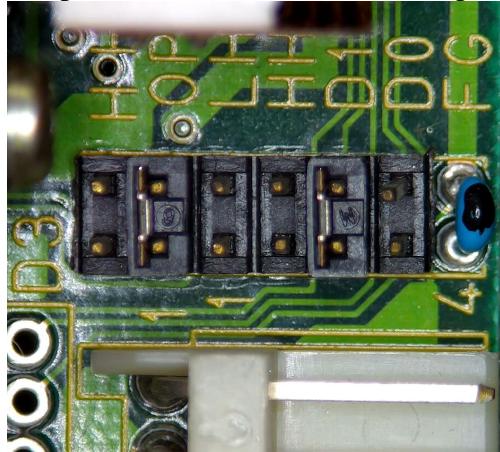
Option-2 ready signal with PRINT-2, remove the jumper from S27 / S28

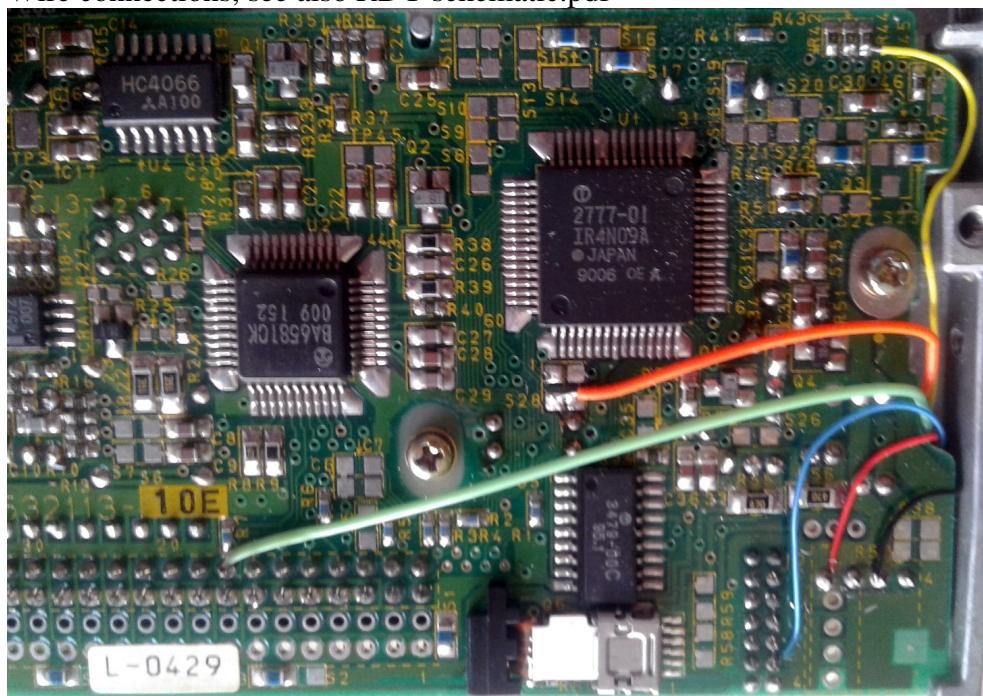
Wire connections, see also RDY schematic.pdf

^ location print
