ControlLogix Standard Redundancy Firmware, Revision 16.57

1756-RM, 1757-SRM

1756-L61, 1756-L62, 1756-L63, 1756-L64

These release notes describe enhancements, corrected anomalies, and known anomalies specific to redundancy system firmware, revision 16.57.

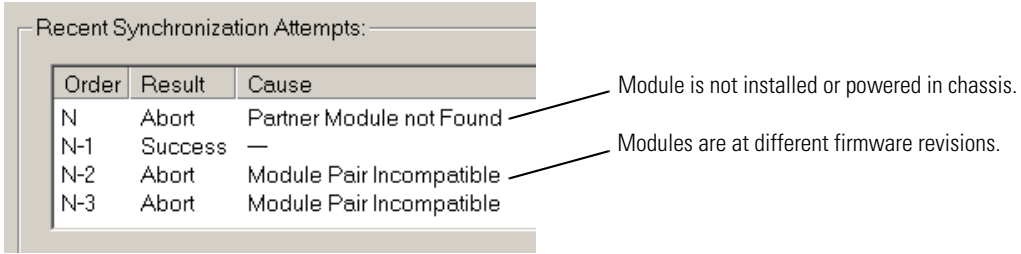
System Component	Enhancement
1756-RM, 1756-RMXT	<p>Synchronization failure reports enhanced by adding 'Partner Module not Found' cause.</p> <p>In previous revisions, if synchronization failed due to either of the causes described below, then failure was indicated by the same cause statement in the synchronization log of the RMCT. For both types of failures, 'Module Pair Incompatible' was indicated as the cause. Causes included:</p> <ul style="list-style-type: none"> • partner modules at incompatible firmware revisions, or have mismatched configurations • a secondary module is not installed or powered <p>With this firmware revision, the 1756-RM module is able to differentiate between partner incompatibilities and a missing secondary module. The RMCT indicates a missing secondary module by stating 'Partner Module not Found' in the Cause column of the Recent Synchronization Attempts log.</p>

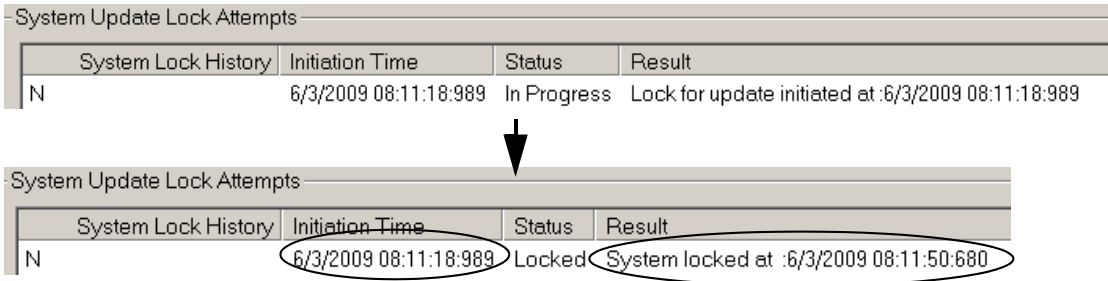
<p style="text-align: right;">Lgx00083165</p> <p>The timestamps of Lock for Update and Initiate Locked Switchover commands are more precise.</p> <p>In previous firmware revisions, when the redundant system was locked for an update or a locked switchover was initiated, the 1756-RM module would indicate the same time for both the initiation and completion of those commands.</p> <p>With this revision, the initiation and completion of each of these commands is timestamped accordingly and the difference in time between initiation and completion can be observed.</p>

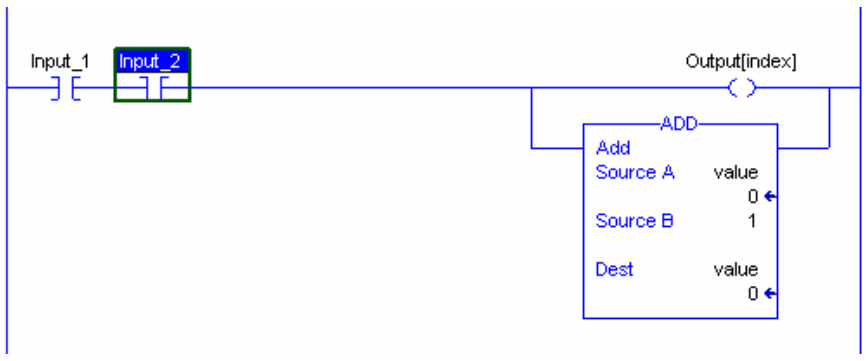
System Component	Description
1756-L61, 1756-L62, 1756-L63, 1756-L64	<p>Fault handlers can be defined at the controller and program scope levels. These fault handlers are typically used to handle major recoverable faults that can occur during runtime execution of an application due to programming errors. A typical example of this would be handling indirect addressing that has gone out of range; <code>MyTag[index]</code>, where <code>index</code> is larger than the size of the array.</p> <p>Faults can also be handled by the controller during pre-scan of the controller program on the transition to Run mode. Again, for example, the handling of indirect addressing that has gone out of range.</p> <p>There is an anomaly when these methods attempt to handle a fault.</p> <p>These are the possible ways the anomaly can manifest itself:</p> <ul style="list-style-type: none"> • The controller will experience a major non-recoverable fault. I/O goes to their configured safe state, and the user application is cleared from memory. At this point, a Code 1 Type 60 or 61 major recoverable fault will be logged in the controller. This requires you to redownload the application. • Tag data corruption. • Online saving or uploading failures. • Anomalous program execution. <p>For example, if a rung is being scanned false and there is an instruction that has false execution, the fault handler executes so the remainder of the rung will scan true. In the example below, the OTE instruction has an index out of range. After returning from the fault handler, the ADD instruction will execute, even though the rung input conditions are false.</p>

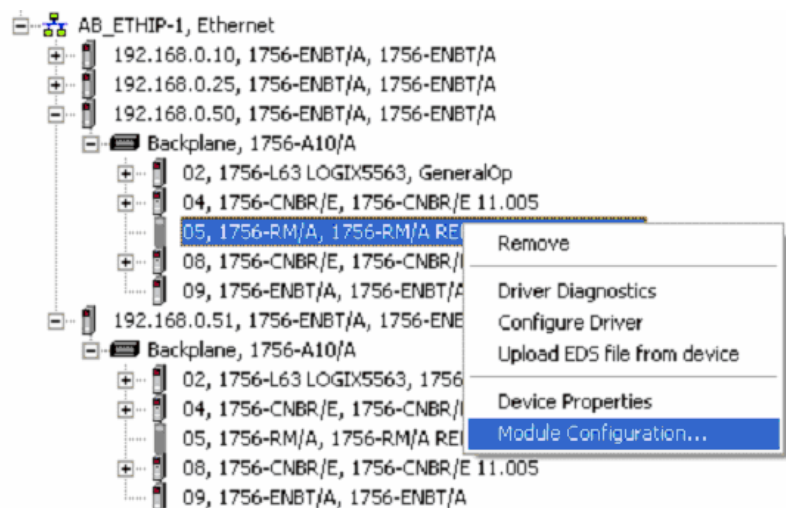
3. Right-click your redundancy module and choose Module Configuration.

The Module Configuration dialog box opens.

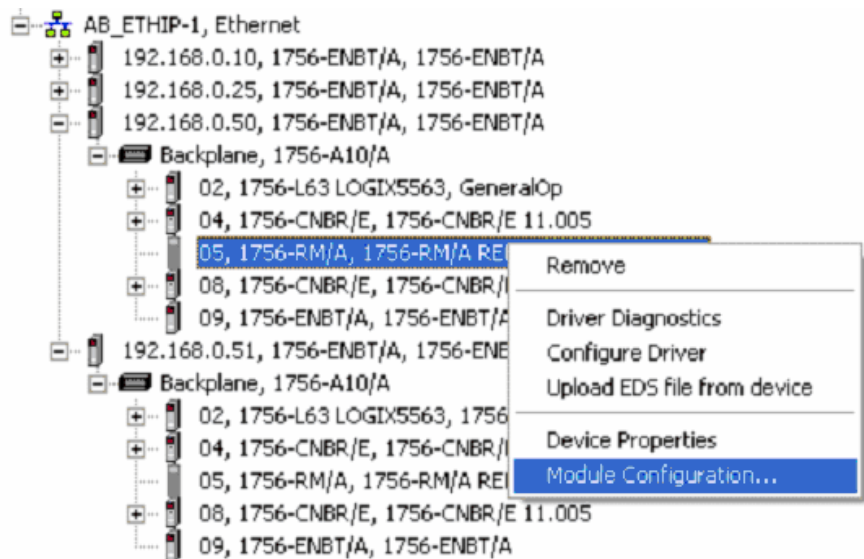
2. Open RSLinx Classic software and browse to the redundancy module.
3. Right-click the redundancy module and choose Module Configuration.

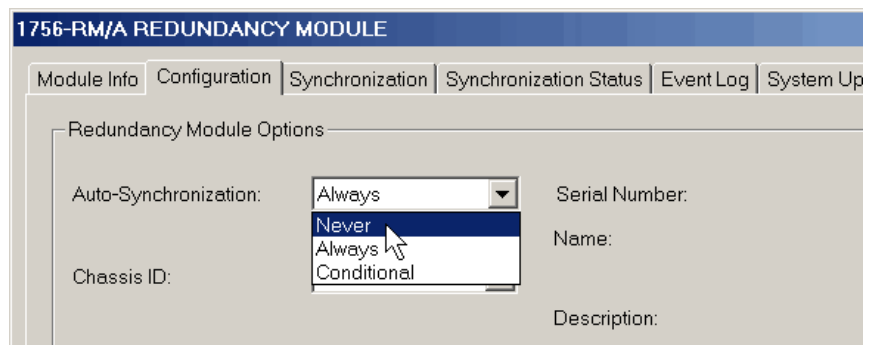
4. Click the Configuration tab.
5. From the Auto-Synchronization pull-down menu, choose Never.

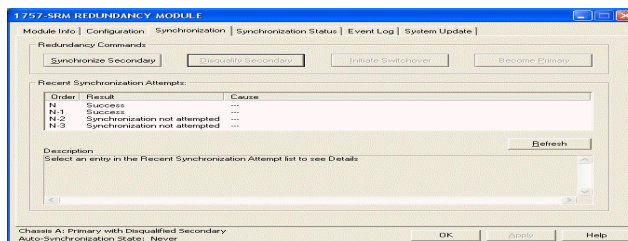
6. Click Apply, then click Yes.
7. Click the Synchronization tab.

8. Click Disqualify Secondary, then click Yes.

The secondary chassis is disqualified as indicated at the bottom-left of the RMCT and on the redundancy module's status display.

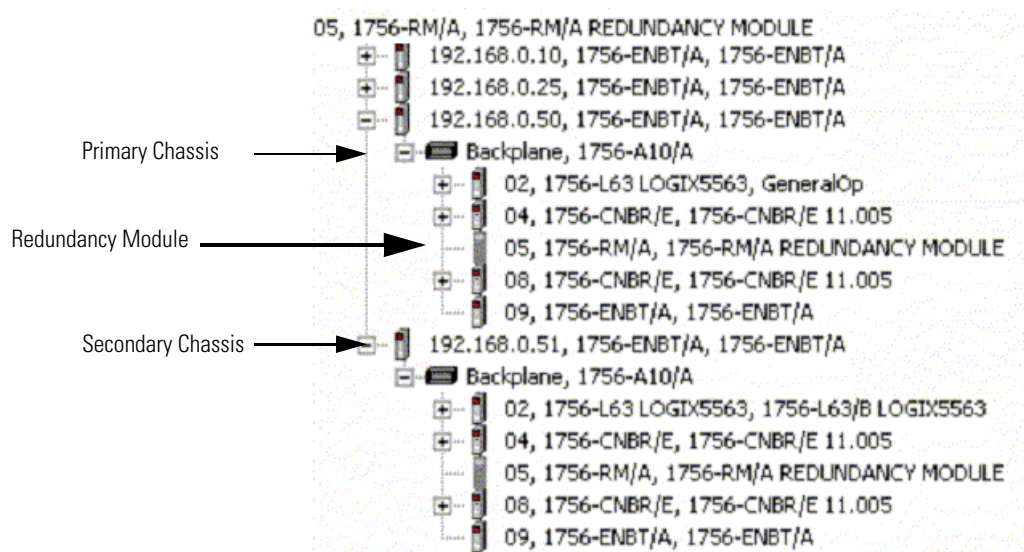
3. Browse to the redundancy module and select it.

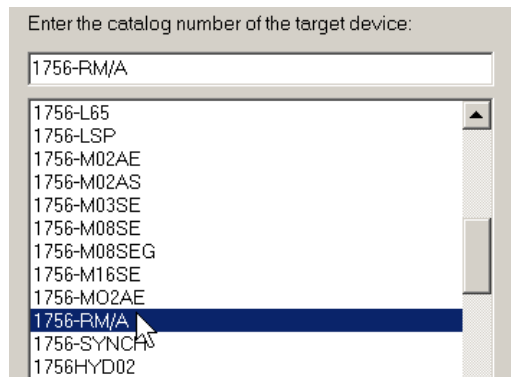
1. Launch ControlFlash software and click Next.
2. Select the redundancy module catalog number and click Next.

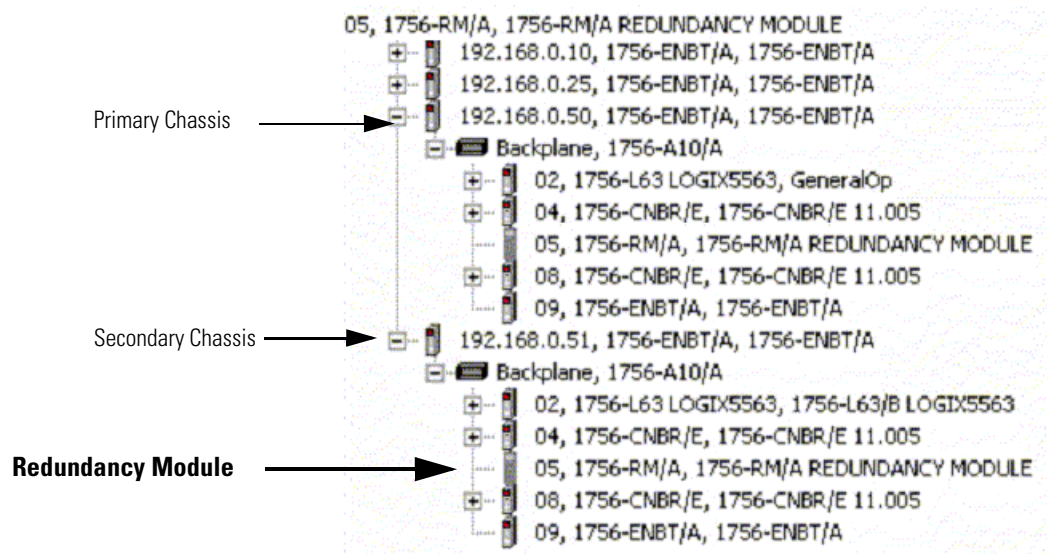
3. Browse to the redundancy module and select it.

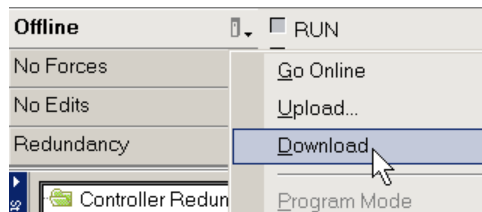
15. Download the project to the secondary controller.

The secondary controller is at the higher network address of the the two available for the redundant chassis.

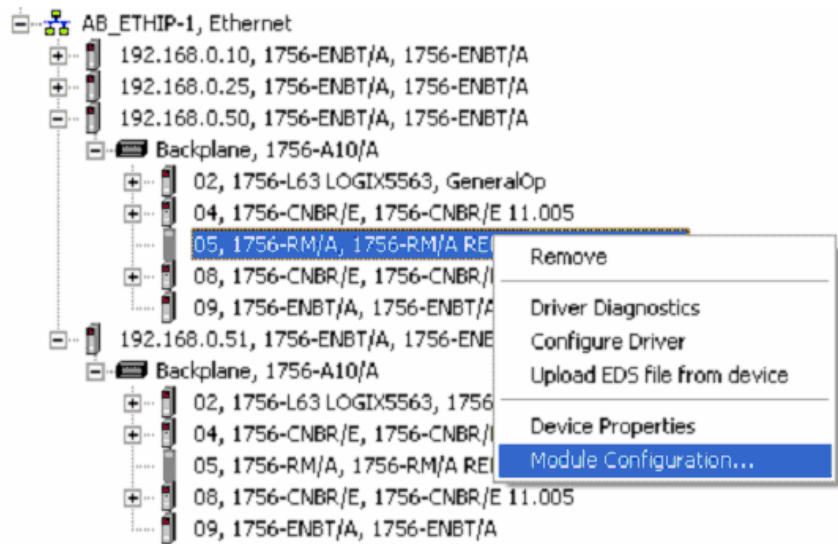
1. Open the RMCT for the 1756-RM module in the primary chassis.

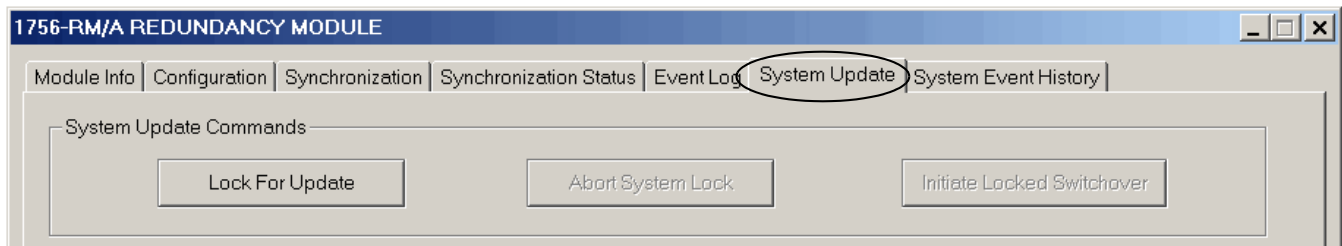
2. Click the System Update tab.

3. Click Lock for Update, then click Yes.
4. Wait for the system to lock.

The System Update Lock Attempts log indicates when the system lock is complete.

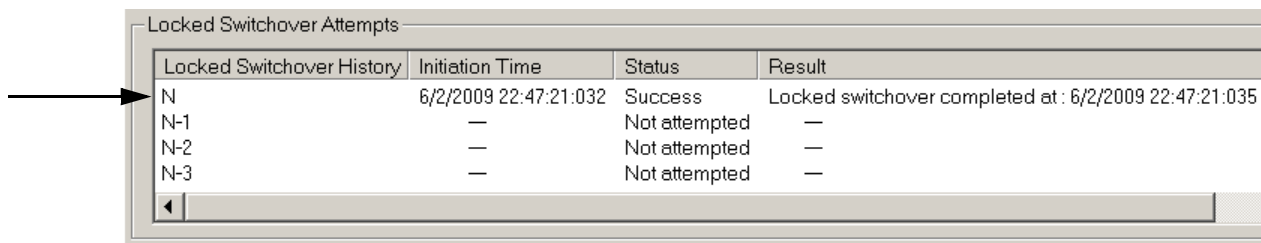
This step results in your secondary chassis assuming control and becoming the primary chassis. When the switchover is complete, the Locked Switchover Attempts log indicates success.

Locked Switchover History	Initiation Time	Status	Result
N	6/2/2009 22:47:21:032	Success	Locked switchover completed at : 6/2/2009 22:47:21:035
N-1	—	Not attempted	—
N-2	—	Not attempted	—
N-3	—	Not attempted	—

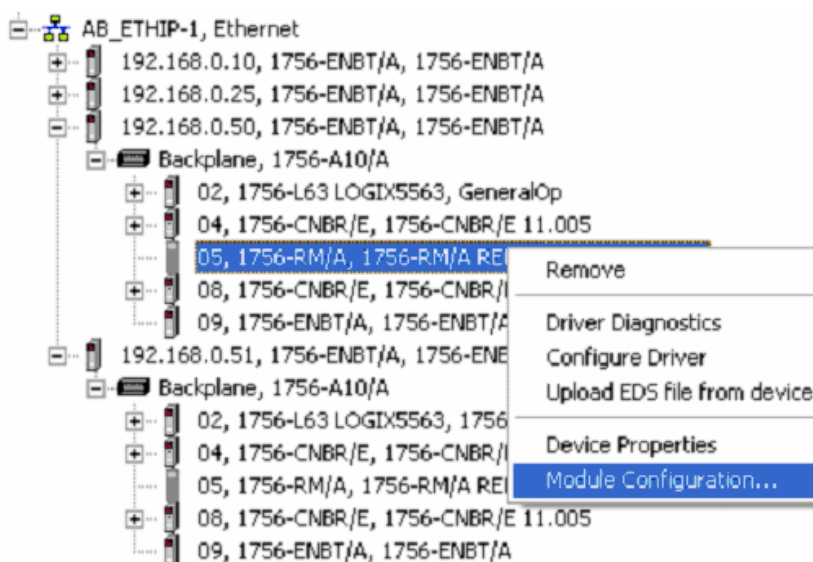
1. Launch the RMCT for the 1756-RM module in the primary chassis.

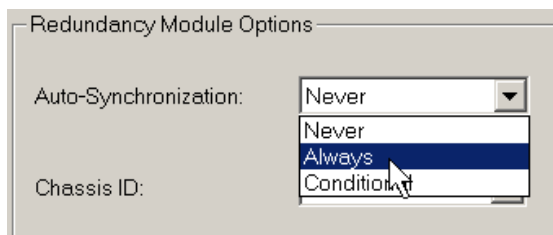
2. Click the Configuration tab.
3. From the Auto-Synchronization pull-down menu, choose the frequency that suits your application.

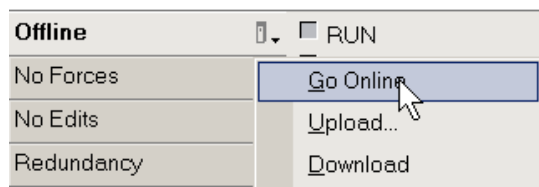
4. In RSLogix 5000 programming software, go online with the secondary controller.
