# Keystone3 Wallet Audit: Final Report

Nov 22, 2023

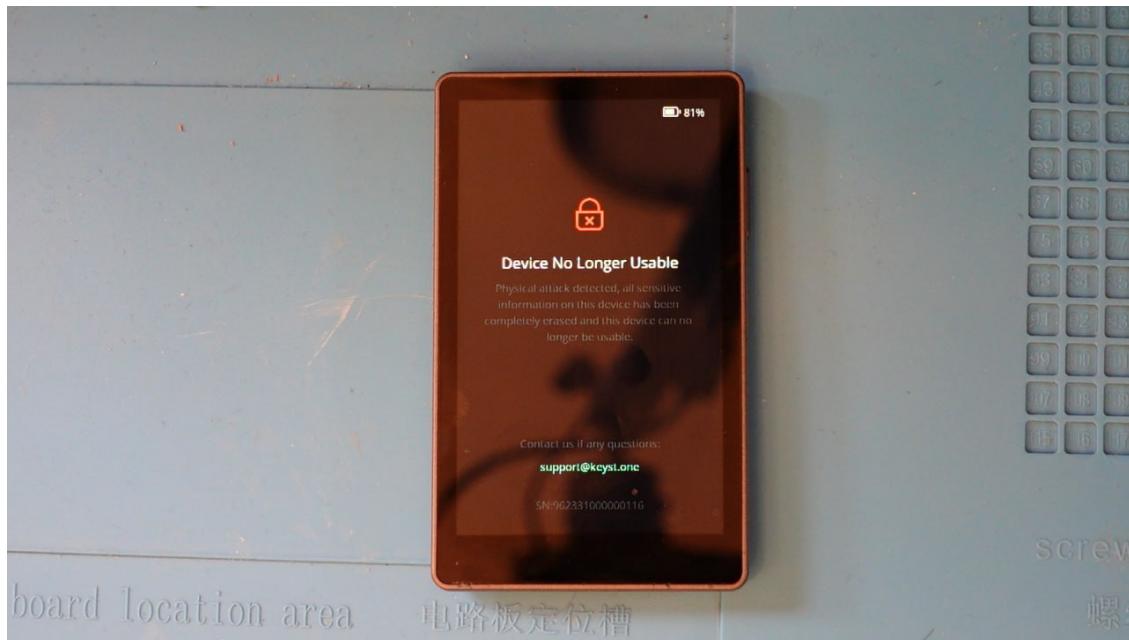
From left to right, Keystone3 case, screen, mesh PCB and main PCB.

The construction of the Keystone3 requires the protective mesh PCB to be removed to access all of the sensitive signals and components. Removing the protective mesh PCB triggers a tamper event on the device. Keystone3 is the first wallet tested by Keylabs that utilizes a fully functional tamper circuit that renders the device non-functional after a tamper event and for which the team was not able to discover a trivial bypass. Because the tamper circuit is powered by the coin cell battery it is capable of detecting a tamper event even if the primary lithium-polymer battery is disconnected or drained.

Keystone3 device rendered no longer usable after a tamper event was detected.

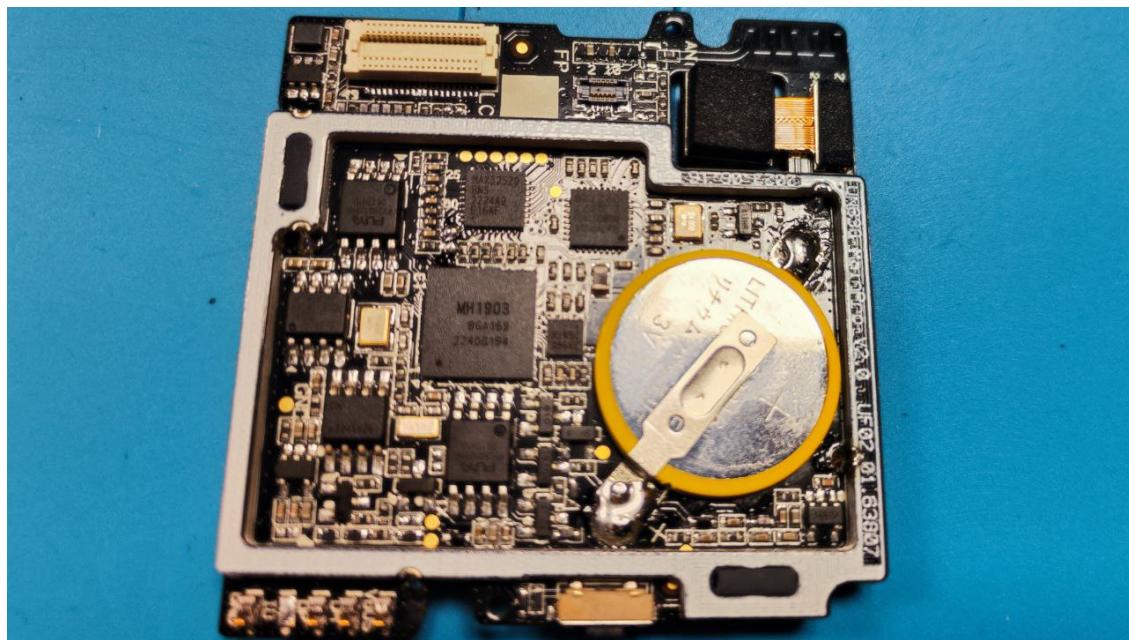
All sensitive components on the Keystone3 are located underneath the mesh PCB. These include the MCU, the three secure elements as well as external memories for the various components. As these memories are not readily accessible and the tamper response was deemed to be sufficient, the security of these memories was not further evaluated.

Keystone3 Primary PCB with coin cell backup battery visible
