MANUFACTURING QUALITY ASSURANCE REPORT

Session Identifier: Multiple Clips

INSPECTION DATE	2026-02-13 08:27:16
VIDEO SOURCE	Multiple Clips
RAG COLLECTION	multimodal_data
OVERALL VERDICT	FAIL

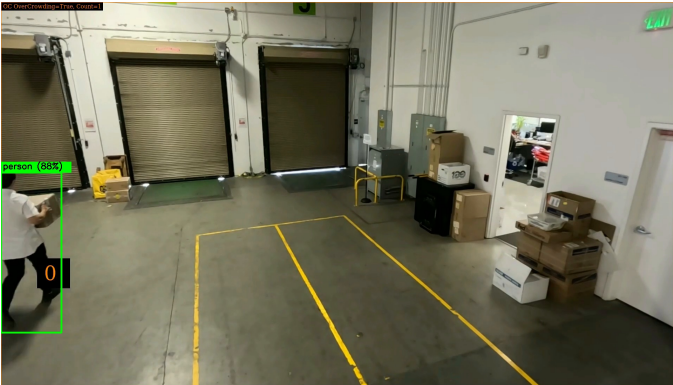
Finding 1: Inspection Finding

TIMESTAMP 08:26:39
SOP SECTION PPE & Safety Protocols
COMPLIANCE SCORE 0%

Consistent absence of required PPE (high-visibility vests and safety helmets) across all observable periods where individuals were present, with no mitigating factors or exceptions noted.

[0.0s - 5.0s]: No PPE observed, no forklift present

[4.0s - 9.0s]: The worker is not wearing a high-visibility vest or a safety helmet. The worker is not near the forklift in these frames.

- [12.0s - 17.0s]: **Personal Protective Equipment (PPE) Compliance:**
- **High-visibility safety vests:** Not applicable; no one is wearing a vest.
 - **Safety helmets:** Not applicable; neither individual is wearing a helmet.
 - **Proximity to the moving forklift:** Not applicable; no forklift is visible in the scene.

[16.0s - 21.0s]: Not wearing PPE
